Passengers trapped in doors and dragged in north London, 23, 27 and 29 June 2022

Summary of the incidents

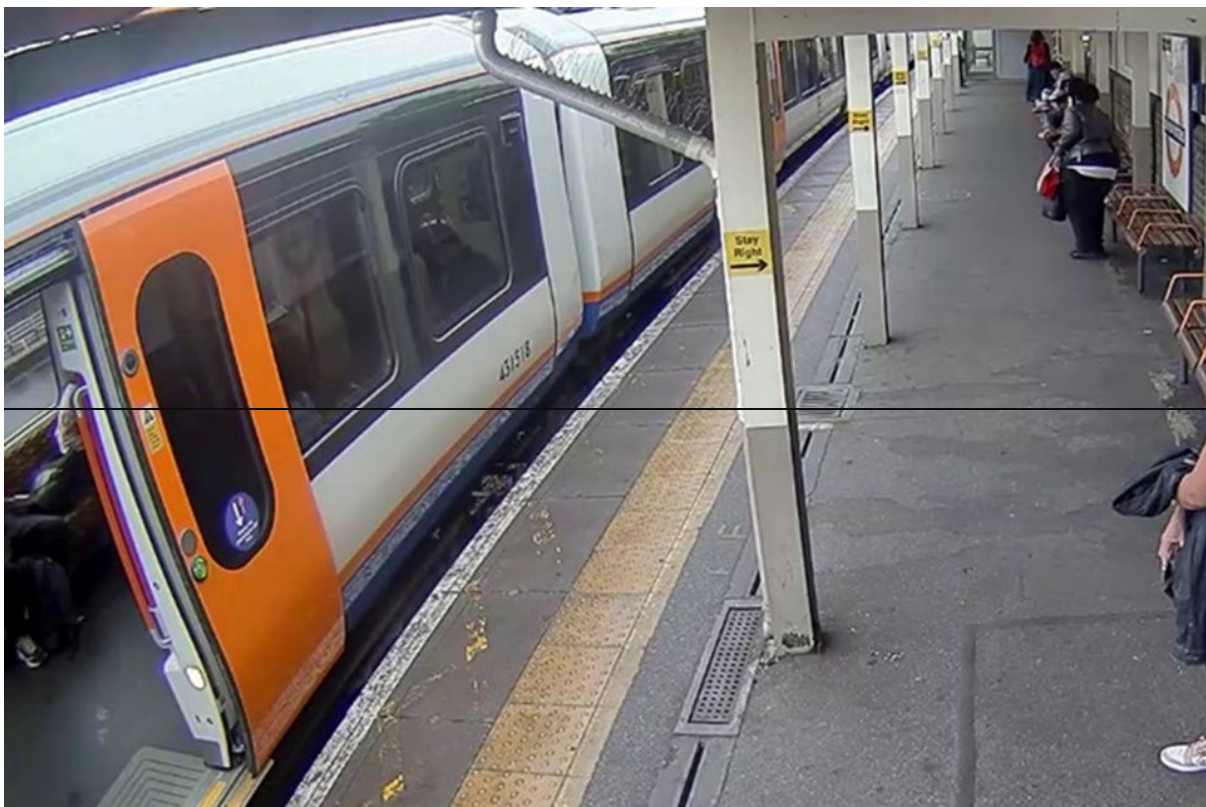
At around 09:11 hrs on 23 June 2022, a passenger's hand became trapped in the closing doors of a train departing from Seven Sisters station. The passenger, along with two other people, had rushed towards the train while the doors were closing, and placed their hand between the doors.

The train departed with the passenger's hand still trapped, and they ran alongside the train for about nine metres before freeing their hand from the doors. The train reached a maximum speed of 8 mph (13 km/h) before the driver applied the brakes, and the train stopped after travelling for a total distance of about 36 metres.

The train at Seven Sisters station on 23 June 2022 (image courtesy of Arriva Rail London).

The driver of the train at Seven Sisters was unaware that the passenger was trapped in the doors when he initially departed from the station. He subsequently stopped the train when he became concerned about the situation being shown on the monitors. After the incidents, Arriva Rail London checked the alignment of the cameras of the trains involved. It discovered that the relevant camera on the Seven Sisters train was misaligned and that this meant that the trapped passenger was visible on the monitor only from the neck down.

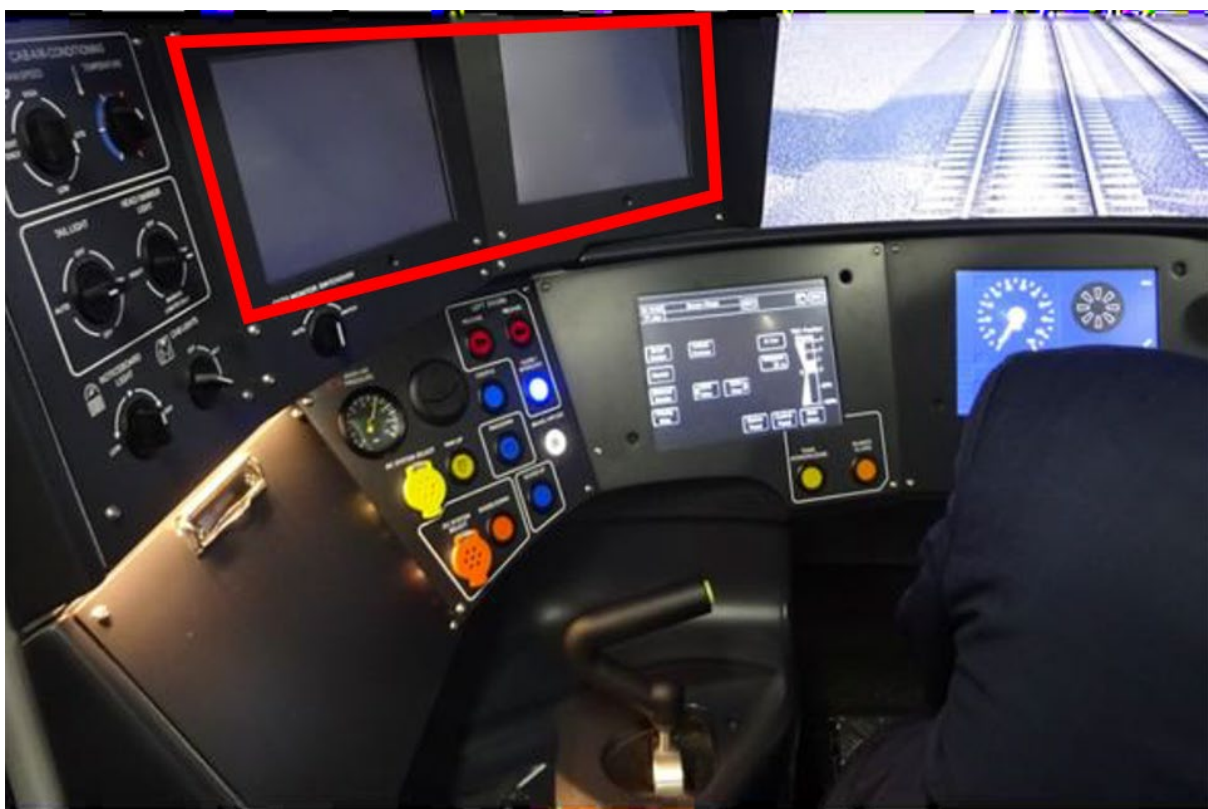
To facilitate this check, bodyside cameras on each coach of the train are used to allow the driver to monitor the threshold between the platform edge and the train during station stops and for a short period after the train restarts, while it is travelling below 3.7 mph (6 km/h). Drivers view images from these cameras on two 264 mm monitor screens in the driving cab, each capable of displaying up to six images, depending on the length of the train. There is one image for each coach, plus an additional image covering a blind spot at the front of the train (that is, five images for a four-coach train, nine images for an eight-coach train).

Interior of the class 710 driving cab with the DOO monitor screens highlighted (image courtesy of Arriva Rail London).

Witness evidence indicated that the quality of the image displayed on the monitors might not always be adequate for drivers to detect the presence of small objects such as those involved in these incidents. Witnesses also stated that some of the white lines on platform edges need repainting, potentially affecting the ability of drivers to detect whether the white line is being broken by a protruding object during train dispatch.
