ACCIDENT

Aircraft Type and Registration:	Boeing A75N1(PT17) Stearman, N707TJ	
No & Type of Engines:	1 Pratt &Whitney R-985 engine	
Year of Manufacture:	1940 (Serial no: 75-950)	
Date & Time (UTC):	4 September 2021 at 1448 hrs	
Location:	In the sea off Sandbanks, Poole, Dorset	
Type of Flight:	Private	
Persons on Board:	Crew - 2	Passengers - None
Injuries:	Crew - None	Passengers - N/A
Nature of Damage:	Aircraft destroyed	
Commander's Licence:	Private Pilot's Licence	
Commander's Age:	57 years	
Commander's Flying Experience:	4,494 hours (of which 3,581 were on type) Last 90 days - 175 hours Last 28 days - 62 hours	
Information Source:	AAIB Field Investigation

Synopsis

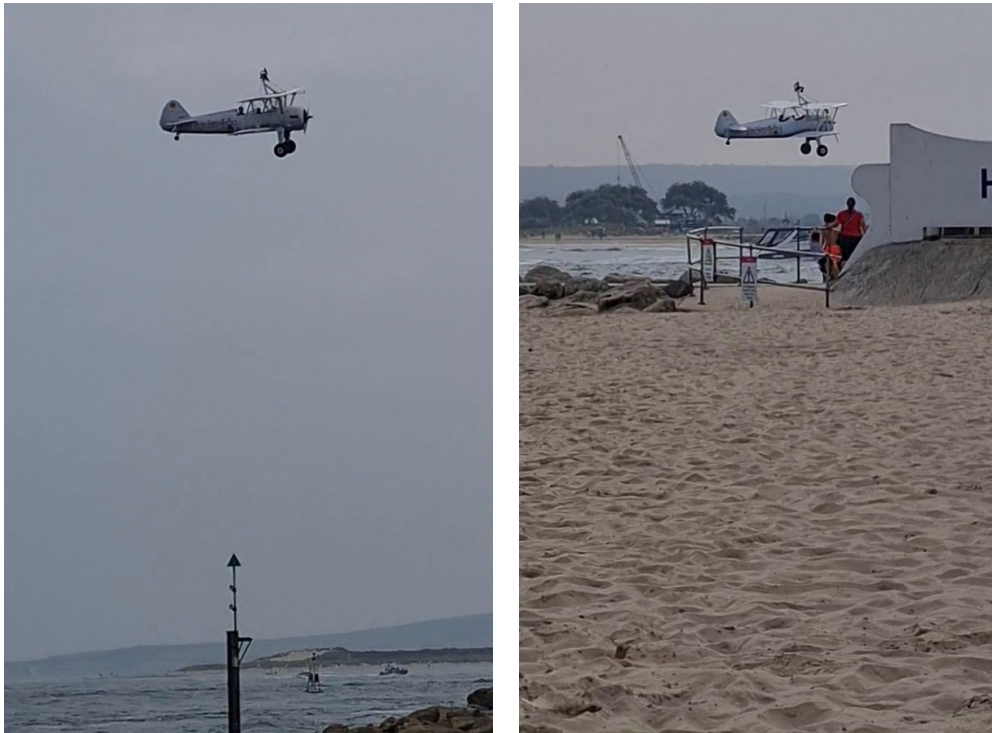
Figure 2

nose-high attitude as it neared the water (Figure 2). On contact with the water the aircraft rapidly flipped over onto its back and came to rest close to the chain ferry slipway on the Sandbanks side of the harbour entrance; the ferry was on the other side of the harbour. The pilot and wing walker exited their cockpits, which were submerged, and were picked up by a small leisure craft.

Stills taken from video just prior to ditching (Used with permission)

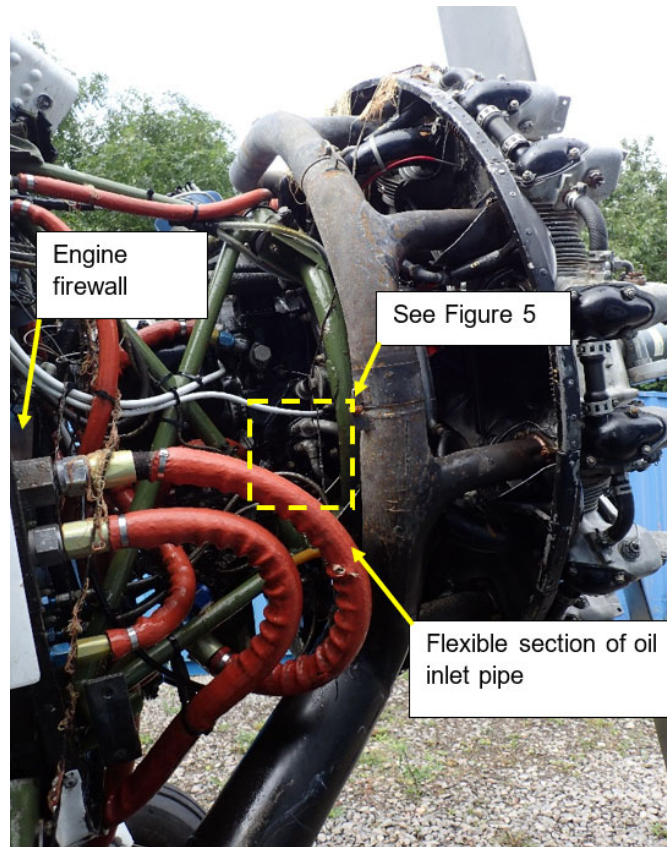
Figure 4

Visual examination of the engine revealed that the oil inlet pipe was broken at the point where it attached to the engine casing (Figures 4 and 5). The rigid section of pipe had fractured at the mounting boss and the support strap had fractured at a fastener hole. An area of damage was evident on the flexible section of pipe, but this was limited to a tear in the fire-retardant sleeve on the pipe and the inner pipe was intact at this location. This damage may have occurred during recovery of the aircraft from the water, as the engine cowlings which would normally protect this part of the engine bay were no longer present.

N707TJ's engine viewed from right side showing oil inlet pipe

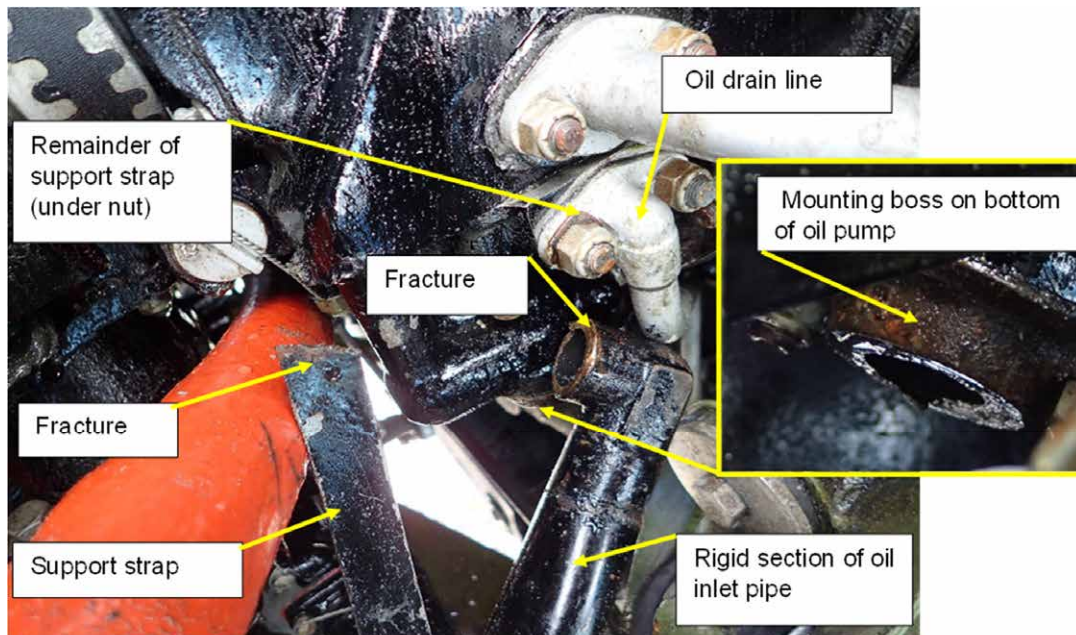
Figure 5

Fractured oil inlet pipe and support strap

The loss of engine power, and subsequent ditching, was the result of a loss of oil supply to the engine. This occurred following a failure of the engine oil inlet pipe.

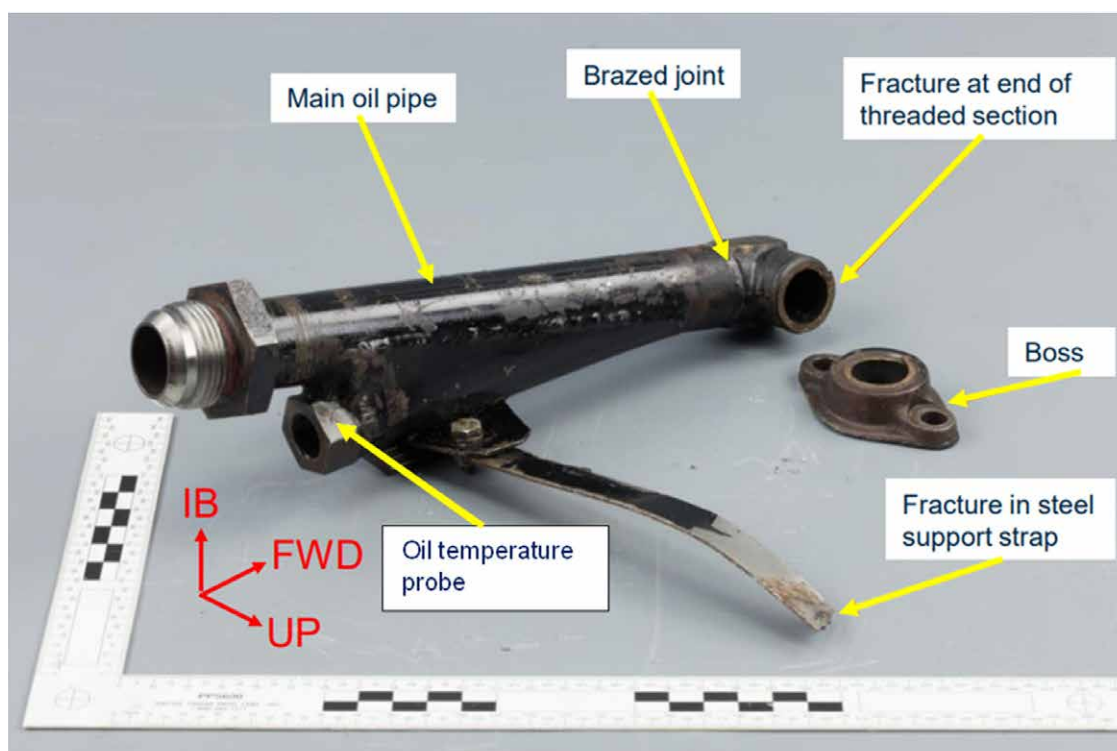
Figure 6

Failure had occurred at a fastener hole in the support strap and on the threaded section of pipe that connected to the mounting boss. Part of the threaded joint remained inside the mounting boss (Figure 6). The support strap and main oil pipe were made from steel. The right-angled threaded end piece of the oil pipe which had fractured was made from a leaded gunmetal casting. It appeared that the gunmetal end fitting had been brazed to the steel pipe.

Rigid section of the oil inlet pipe

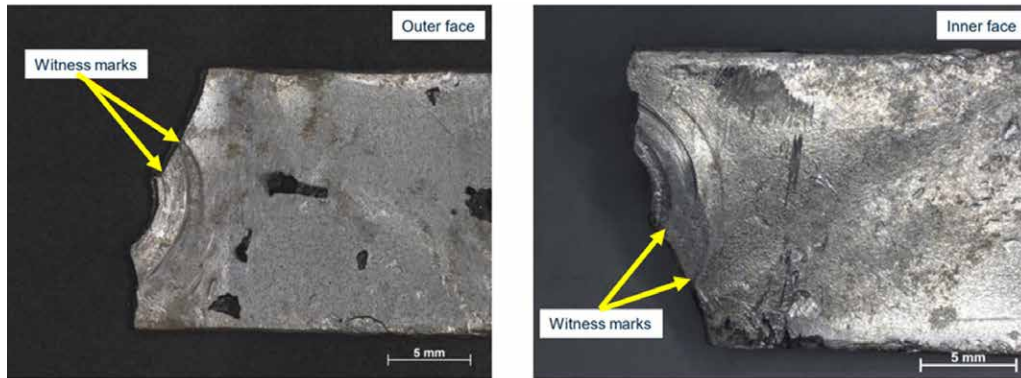
Figure 7

Visual examination of the support strap at the fracture location showed evidence of mechanical damage (witness marks) around the fastener hole on both sides of the strap (Figure 7). The witness marks were circular in shape and consistent with a nut (possibly in combination with a washer) having been over-tightened. No washer was present when the aircraft was examined.

Witness marks around fastener hole on support strap outer face (left image) and inner face (right image)

The size and shape of the witness marks associated with the mechanical damage on the support strap were consistent with its retaining nut having been over-tightened. It was not determined when this occurred, but there was no indication in the aircraft logbook that the oil pipe had been disturbed since the engine was replaced in 2013. It was not determined how long the aircraft may have flown with the support strap fractured, but nothing was noted during the recent annual inspection carried out several months before the accident.

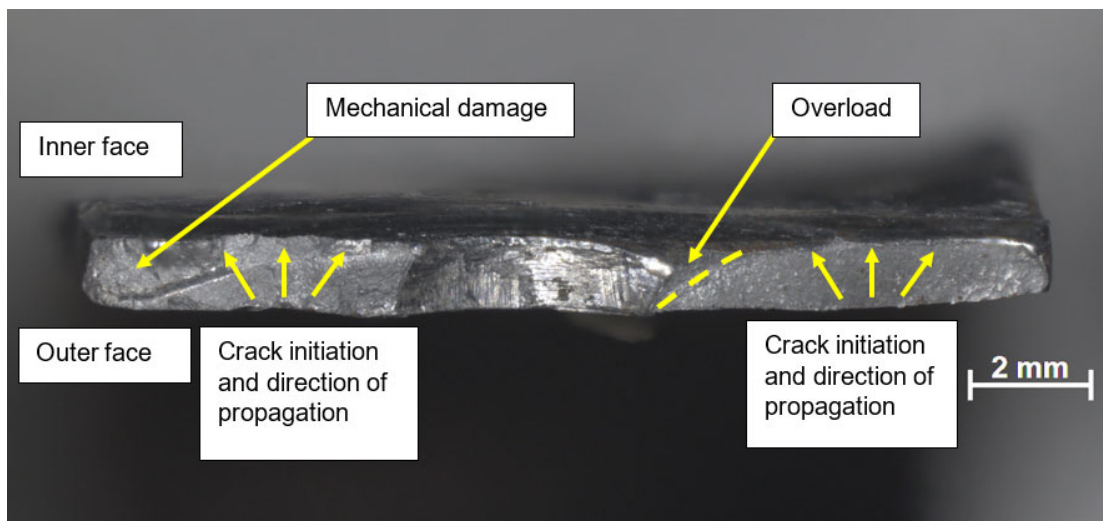
Figure 8

Scanning electron microscope (SEM) examination of the fracture surface showed extensive corrosion. After cleaning to remove the corrosion, fatigue striations were observed across most of the fracture surface on both sides of the fastener hole. The fatigue initiated within the mechanical damage around the fastener hole on the outer face of the support strap and propagated towards the inner face. A small amount of overload was observed at the right edge of the fastener hole on the inner face. The end of the fatigue crack on the left side of the fastener hole had been destroyed by mechanical damage (Figure 8).

Key failure features identified on the fracture surface of the support strap (Fatigue striations not shown in this image)

The steel support strap on the oil inlet pipe failed as a result of fatigue, which initiated at mechanical damage on the outer surface of the strap and propagated towards the inner surface. Normal engine vibration could have provided the cyclic loading mechanism to propagate the crack once formed. The function of the strap was to support the weight of the oil pipe. Once the strap had failed, the load would have transferred to the threaded joint on the pipe.

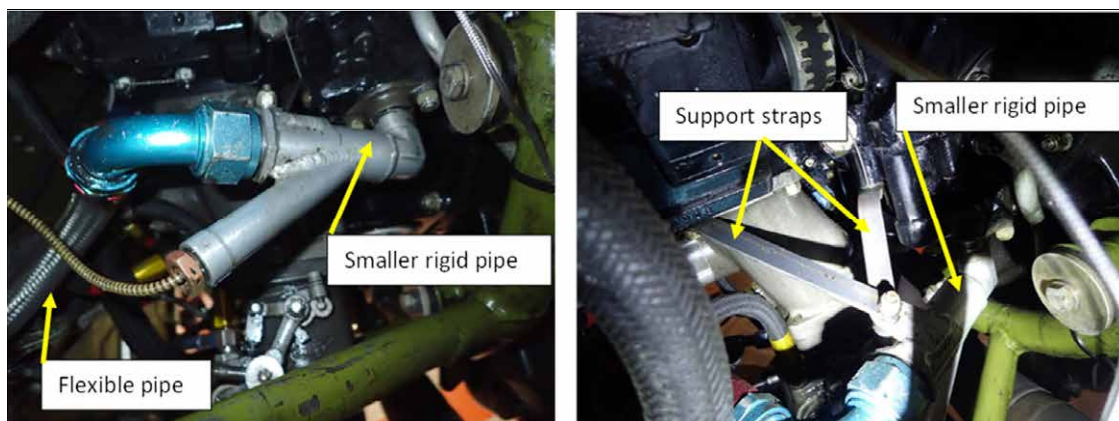
Figure 11

The oil inlet pipe on the first aircraft examined also comprised a flexible and rigid section of pipe. The rigid section, which also accommodated a port for the oil temperature probe and a 90° threaded joint, was similar in shape but much smaller and lighter than that on N707TJ. Two support straps supported the weight of the pipe (Figure 11).

Alternative installation: smaller rigid pipe. Side view (left image), top view (right image)

The operator subsequently modified the installation on this aircraft to consist of a single flexible pipe and relocated the oil temperature probe.

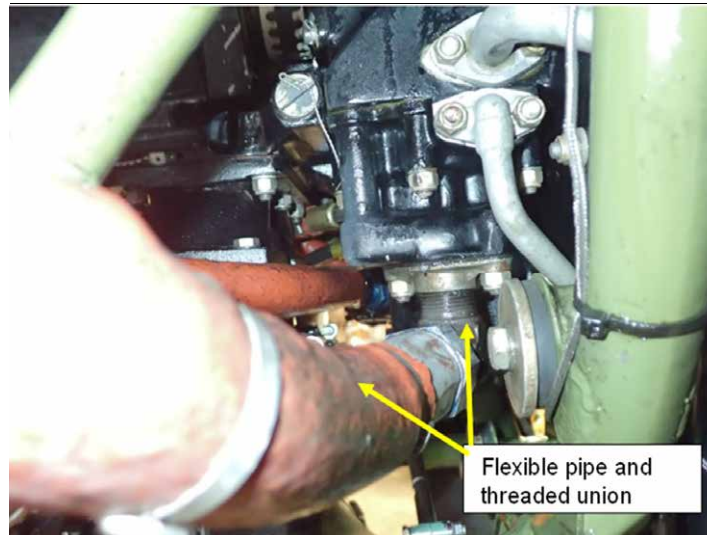
Figure 12

The oil inlet pipe on the second aircraft was comprised only of a flexible pipe, which was shorter than that on N707TJ and a 90° threaded union (Figure 12). There were no supporting straps and the oil temperature probe was mounted separately.

Alternative installation: flexible oil pipe and 90° threaded union, no support strap
