SERIOUS INCIDENT

Aircraft Type and Registration:	Agusta AW169, G-KSST	
No & Type of Engines:	2 Pratt & Whitney Canada PW210A turboshaft engines	
Year of Manufacture:	2016 (Serial no: 69014)	
Date & Time (UTC):	2 July 2022 at 1710 hrs	
Location:	Epsom, Surrey	
Type of Flight:	Emergency Services Operations	
Persons on Board:	Crew - 4	Passengers - None
Injuries:	Crew - None	Passengers - N/A Other - 1 (Minor)
Nature of Damage:	None	
Commander's Licence:	Airline Transport Pilot's Licence	
Commander's Age:	59 years	
Commander's Flying Experience:	7,260 hours (of which 352 were on type) Last 90 days - 5 hours Last 28 days - 3 hours	
Information Source:	Aircraft Accident Report Form submitted by the pilot

Synopsis

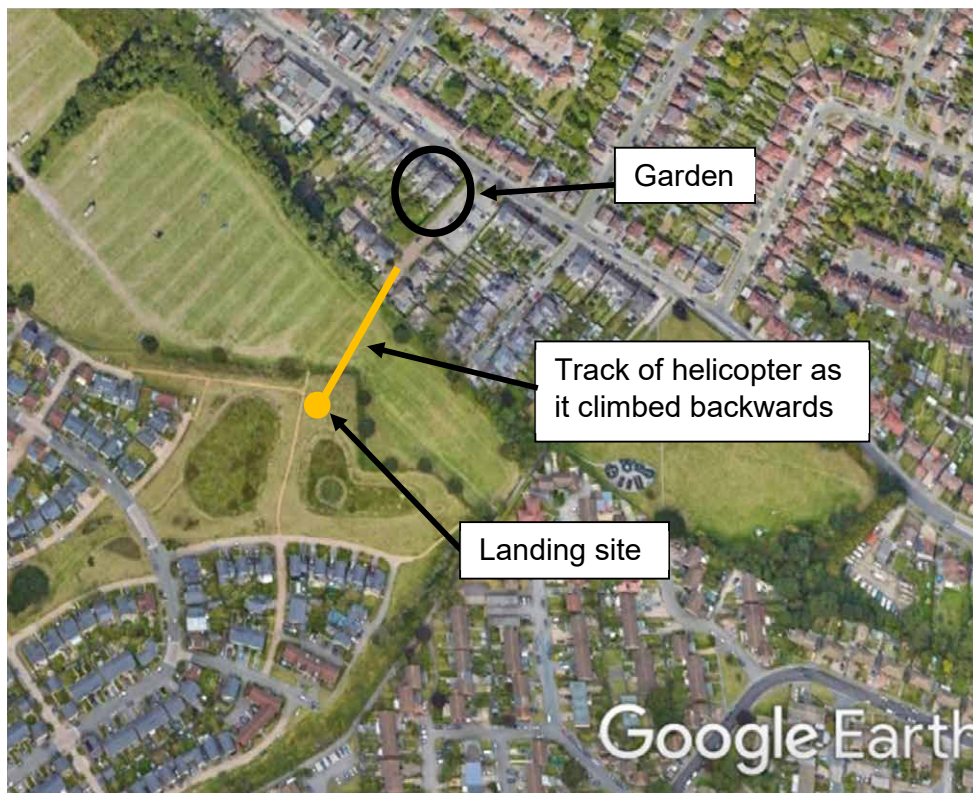
Data was available for the flight of the helicopter. Figure 1 shows the landing site of the helicopter and its track rearwards on its departure. It also shows the garden in which the injury occurred.

The location of the helicopter and garden in which the incident occurred
