ACCIDENT

Aircraft Type and Registration:	Cessna A185F Skywagon, G-SAUO	
No & Type of Engines:	1 Continental Motors Corp IO-520-D piston engine	
Year of Manufacture:	1974 (Serial no: 185-02324)	
Date & Time (UTC):	30 August 2022 at 1008 hrs	
Location:	Luxters Farm Airstrip, Henley-on-Thames, Buckinghamshire	
Type of Flight:	Private	
Persons on Board:	Crew - 1	Passengers - 1
Injuries:	Crew - 1 (Minor)	Passengers - 1 (Minor)
Nature of Damage:	Aircraft destroyed	
Commander's Licence:	Airline Transport Pilot's Licence	
Commander's Age:	69 years	
Commander's Flying Experience:	28,000 hours (of which 350 were on type) Last 90 days - 38 hours Last 28 days - 10 hours	
Information Source:	Aircraft Accident Report Form submitted by the pilot

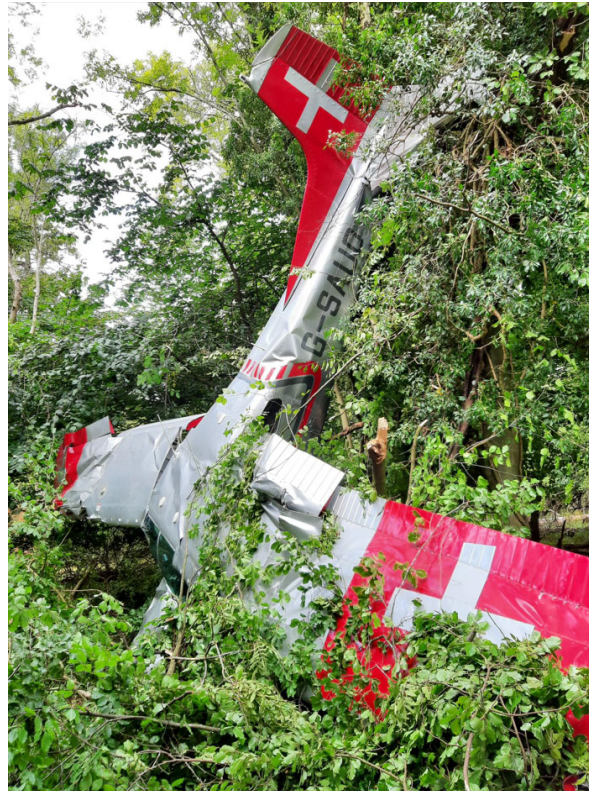
The pilot was on a cross-country flight from Shelsley Beauchamp Airfield, Worcestershire, to Luxters Farm Airstrip, Buckinghamshire. Luxters Farm Airstrip is a private 950 m grass airstrip, oriented 10/28, surrounded by trees. The weather was fine and the pilot reported that after flying an approach to Runway 28, the aircraft bounced on landing and he decided to go-around. The aircraft struck trees at the far end of the runway and came to rest on the ground, partially supported by the tree canopy (Figure 1).

Figure 1
G-SAUO accident site
