ACCIDENT

Aircraft Type and Registration:	DH82A Tiger Moth, G-AXAN	
No & Type of Engines:	1 De Havilland Gipsy Major 1F piston engine	
Year of Manufacture:	1942 (Serial no: 85951)	
Date & Time (UTC):	14 May 2022 at 1515 hrs	
Location:	Private Farm Strip, near Duxford, Cambridgeshire	
Type of Flight:	Private	
Persons on Board:	Crew - 1	Passengers - 1
Injuries:	Crew - None	Passengers - None
Nature of Damage:	Aircraft destroyed	
Commander's Licence:	Commercial Pilot's Licence	
Commander's Age:	49 years	
Commander's Flying Experience:	3,687 hours (of which 533 were on type) Last 90 days - 67 hours Last 28 days - 25 hours	
Information Source:	Aircraft Accident Report Form submitted by the pilot and further AAIB enquiries

Synopsis

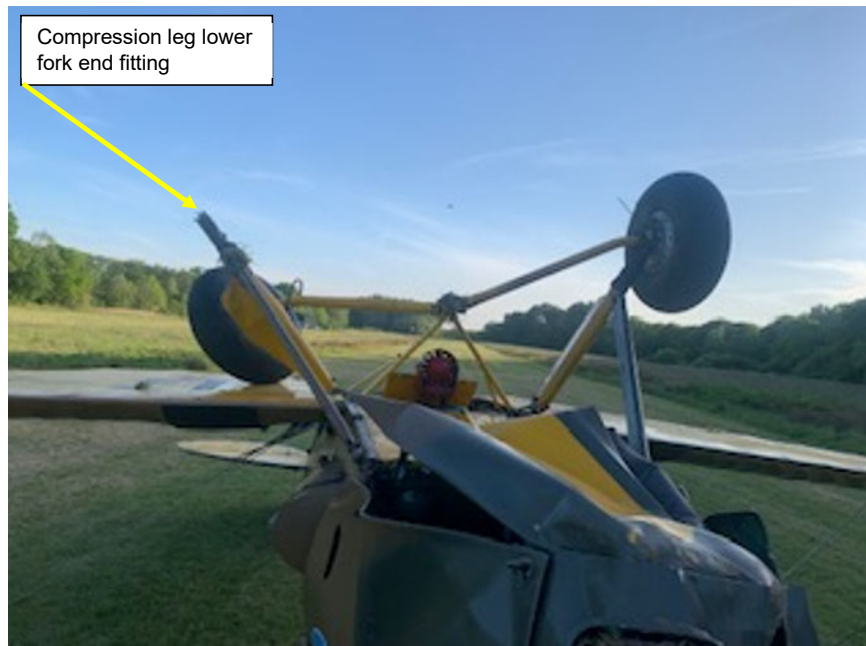
Figure 1

Inspection of the aircraft and runway showed that the left wheel had touched down in soft ground, causing the landing gear to fail at the lower fork end fitting on the compression leg (Figure 1).

G-AXAN after coming to rest inverted

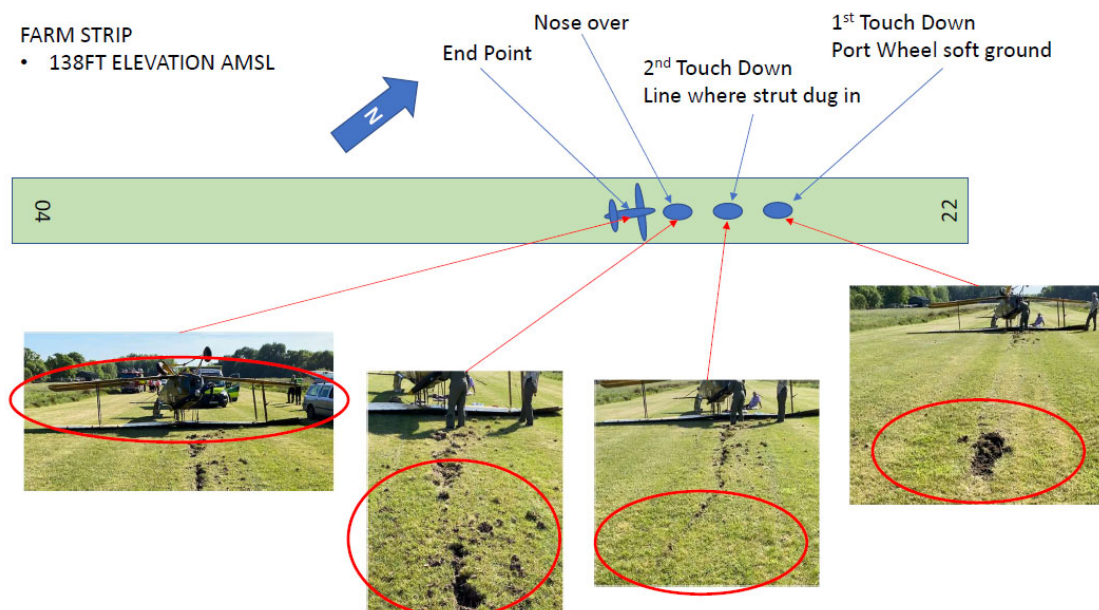
Figure 2

The pilot provided a diagram of the accident site and ground marks (Figure 2) which shows a depression in the grass surface coincident with the left wheel striking the ground, followed by a long narrow ground mark caused by the lower fork end fitting of the compression leg.

Diagram of accident site and ground marks
