ACCIDENT

Aircraft Type and Registration:	Kolb Twinstar Mk III (Modified SS), G-MZZT	
No & Type of Engines:	1 Rotax 582 piston engine	
Year of Manufacture:	1999 (Serial no: PFA 205-12596)	
Date & Time (UTC):	30 January 2022 at 1230 hrs	
Location:	Plaistows Farm, St Albans	
Type of Flight:	Private	
Persons on Board:	Crew - 1	Passengers - None
Injuries:	Crew - 1 (Minor)	Passengers - N/A
Nature of Damage:	Aircraft destroyed	
Commander's Licence:	Light Aircraft Pilot's License (LAPL)	
Commander's Age:	60 years	
Commander's Flying Experience:	Unknown hours (of which Unknown were on type) Last 90 days - Unknown hours Last 28 days - Unknown hours	
Information Source:	Aircraft Accident Report Form submitted by the pilot and further AAIB enquiries

Synopsis

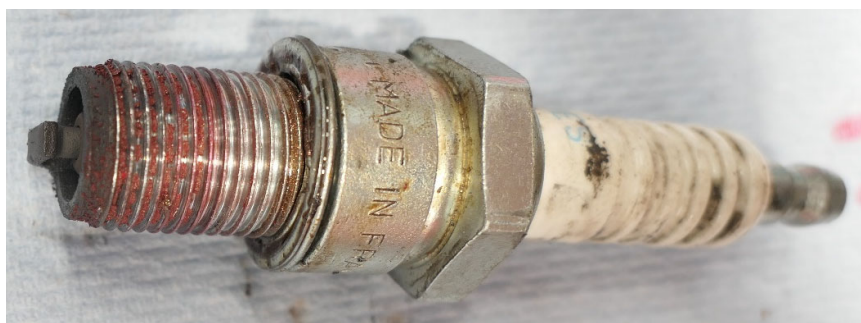
Figure 1

The external inspection of the engine showed no visible damage except for crushing of one of the air filters. The aft left engine mounting bolt was too short with no threads protruding through the nut. Approximately 23 litres of 50:1 two-stroke fuel/oil mix was removed from the two plastic fuel tanks behind the cockpit. The spark plugs were removed from the cylinder head and an unidentified red sealant compound was found on the threads. The colouration of the plugs was considered normal however the electrode gaps were 0.33 to 0.356 mm instead of the recommended gap of 0.5 mm.

Example spark plug showing unidentified red sealant

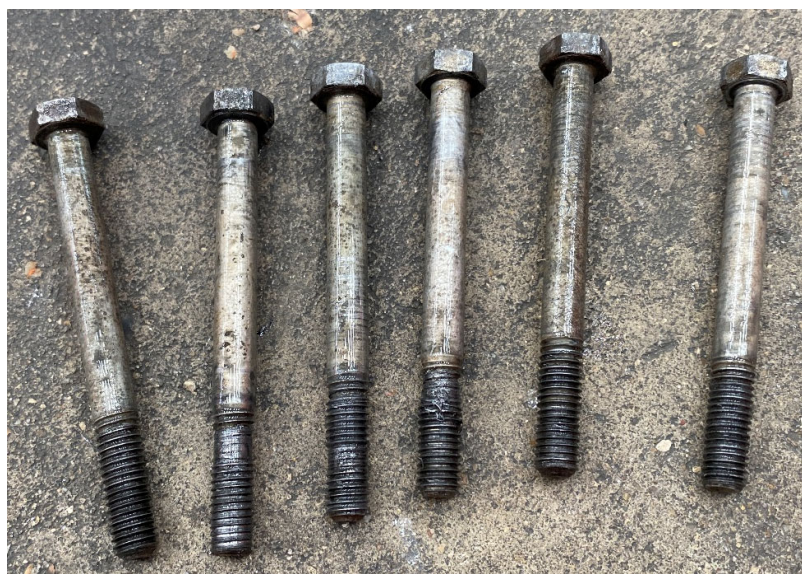
Prior to removal of the propeller, the pitch of the blades was measured using the Warp Drive blade setting tool. The blade pitch was found to be between $5^{\circ} 20'$ and $4^{\circ} 50'$. The condition of the blades was good, however when the propeller was removed from the gearbox hub, the threads of two of the six retaining bolts were found partially stripped (Figure 4).

Figure 4
Propeller attachment bolts
