ACCIDENT

Aircraft Type and Registration:	DA 40 NG, G-CTSR	
No & Type of Engines:	1 Austro E4-A piston engine	
Year of Manufacture:	2015 (Serial no: 40.N304)	
Date & Time (UTC):	3 September 2021 at 1257 hrs	
Location:	Cranfield Airport, Bedfordshire	
Type of Flight:	Training	
Persons on Board:	Crew - 1	Passengers - None
Injuries:	Crew - 1 (Minor)	Passengers - N/A
Nature of Damage:	Damaged beyond economical repair	
Commander's Licence:	Student pilot	
Commander's Age:	42 years	
Commander's Flying Experience:	23 hours (of which 23 were on type) Last 90 days - 23 hours Last 28 days - 14 hours	
Information Source:	Aircraft Accident Report Form submitted by the pilot and further enquiries by the AAIB

Synopsis

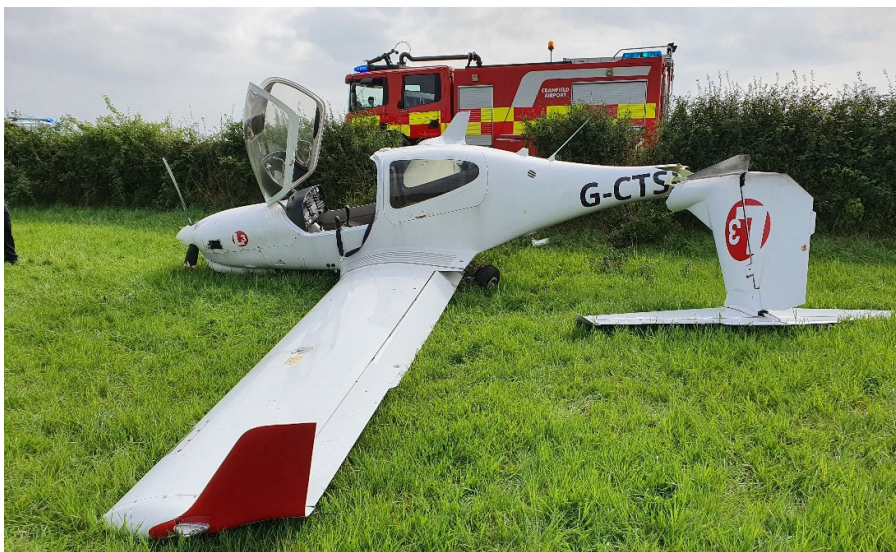
As the aircraft crossed the end of the runway the pilot noted that the IAS was "dangerously low". The flaps were retracted to the takeoff position to try to extend the aircraft's range and clear the approach lights to Runway 21 and the hedge on the airfield boundary. However, the aircraft continued to descend and struck the hedge. As it did so, the stall warning sounded and the pilot noted that the IAS was about 60 kt. The aircraft came to rest in a field on the other side of a road that bounded the airfield (Figure 1).

The aircraft was damaged beyond economical repair.

Figure 1
G-CTSR after the accident

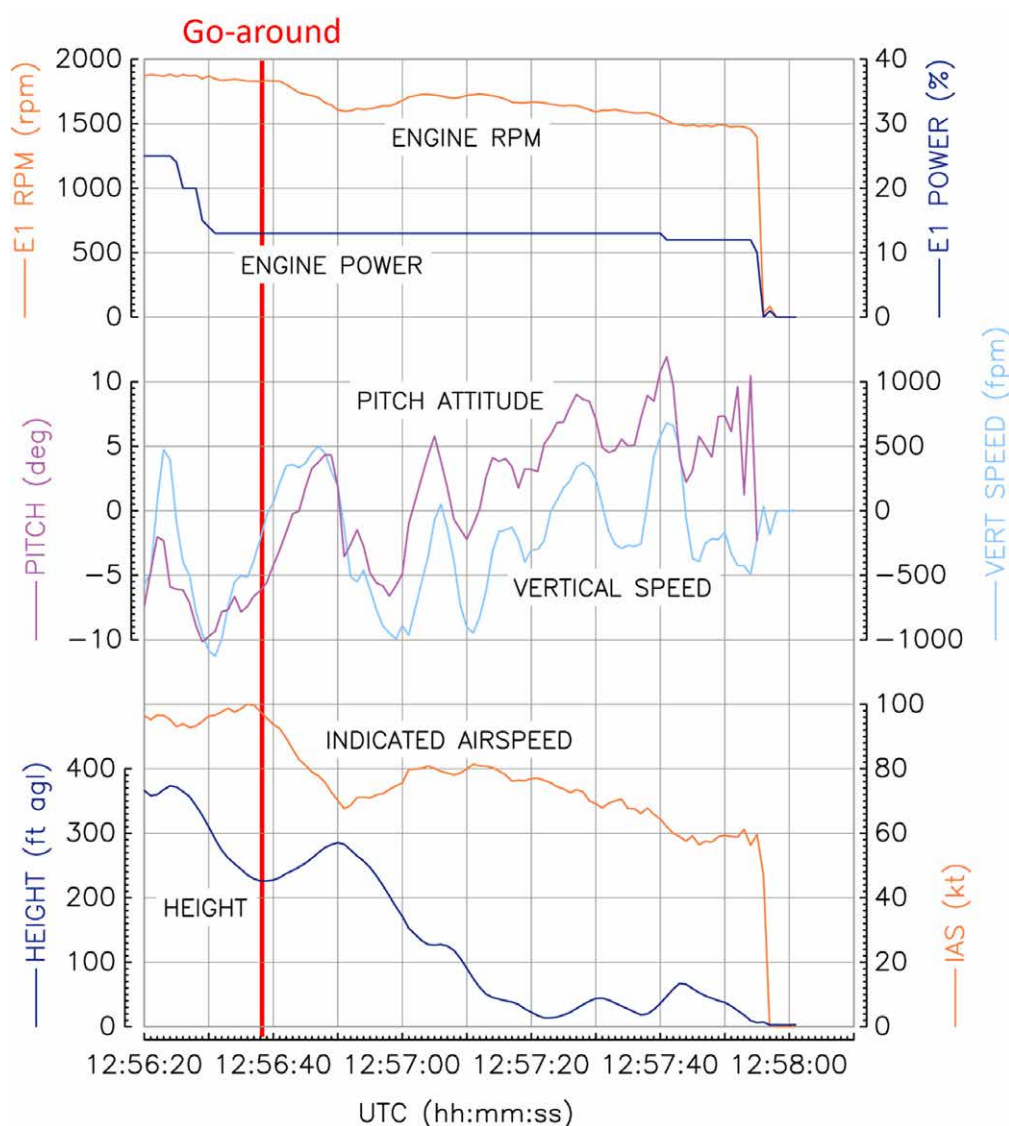
Figure 2

The aircraft was fitted with an integrated electronic flight instrument system (EFIS), and its removable memory card was downloaded. Pertinent data from the flight is shown in Figure 2. The data shows that the GA was initiated at about 215 ft aal, at which point the IAS was 100 kt, and the pitch attitude of the aircraft slowly increased to about 4° nose up. The IAS then decreased to 68 kt as the height increased slightly to about 240 ft aal. The aircraft then began a descent during which the IAS increased to about 80 kt. The aircraft's height then varied slightly, although it stayed predominantly below about 60 ft aal, and the IAS began to reduce again. Finally, the aircraft descended further and struck the hedge. Throughout the GA the engine power remained stable at about 13%.

Graph showing pertinent data from the EFIS

This was the student pilot's second solo flight. Having noticed that the approach was unstable, the pilot's decision to execute a GA was in accordance with CAA guidance¹. However, the evidence from the EFIS was that the power did not increase above 13% during the GA, and the aircraft's subsequent lack of performance indicated that this was insufficient power for the aircraft to climb.
