AAIB Bulletin

11/2022

Special Bulletin S2/2022: Bombardier CL-600-2B16 (604 variant)	D-AAAY	10-Aug-22	3
---	--------	-----------	---

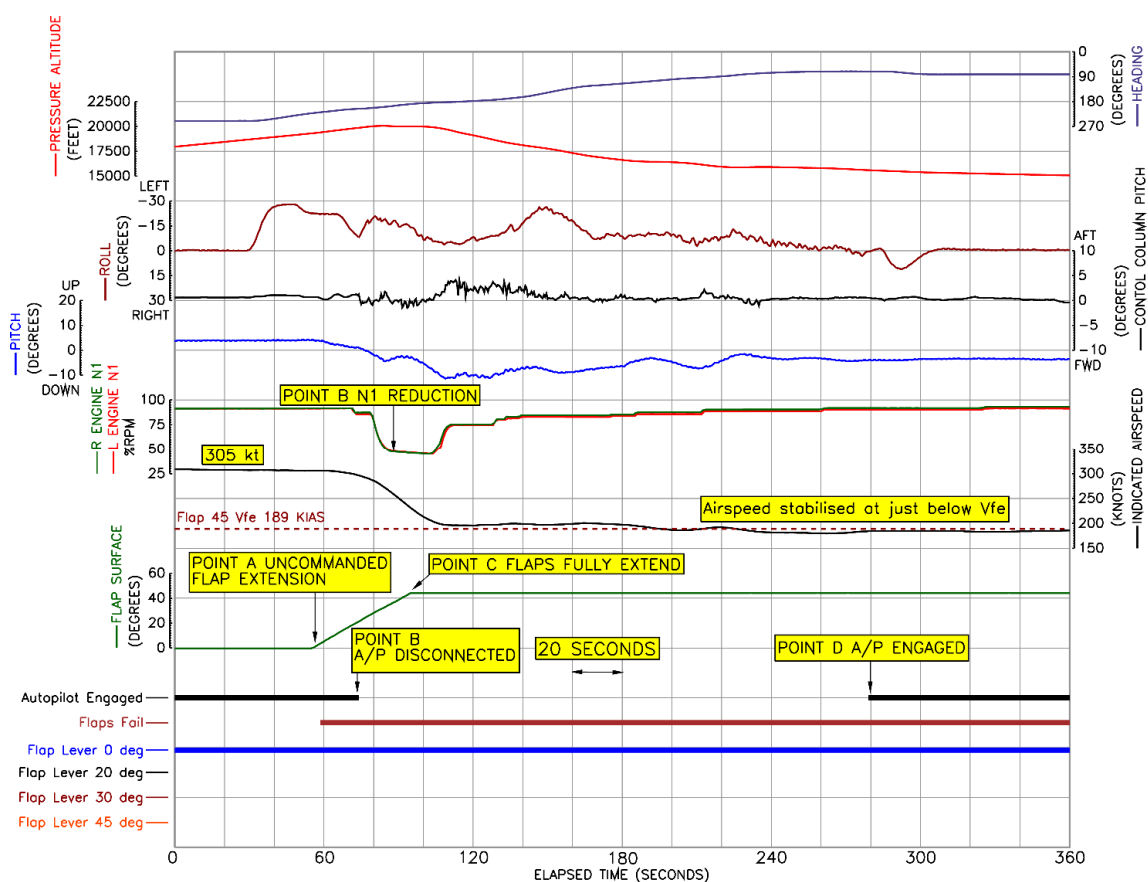
Figure 2

to extend whilst the flap control lever remained in the flap 0 position (Figure 2, Point A). The rate at which the flaps extended was about 1.1°/sec, which was about half the normal extension speed. The autopilot remained engaged, and the aircraft's speed started to progressively reduce whilst also pitching down from 4° nose up. Shortly after, a flap failure message was recorded, which occurred when the flaps had extended by about 3°.

As the flaps reached 20°, the airspeed was 296 KIAS, which was 65 kt above flap 20 VFE. This coincided with the flight crew disconnecting the autopilot and reducing engine thrust from 91% to 47% N1 (Figure 2, Point B). The flaps continued to extend over the next 21 seconds until reaching 45° where they stopped, at which point the airspeed was 234 KIAS, 45 kt above flap 45 VFE (Figure 2, Point C).

FDR data of uncommanded flap extension

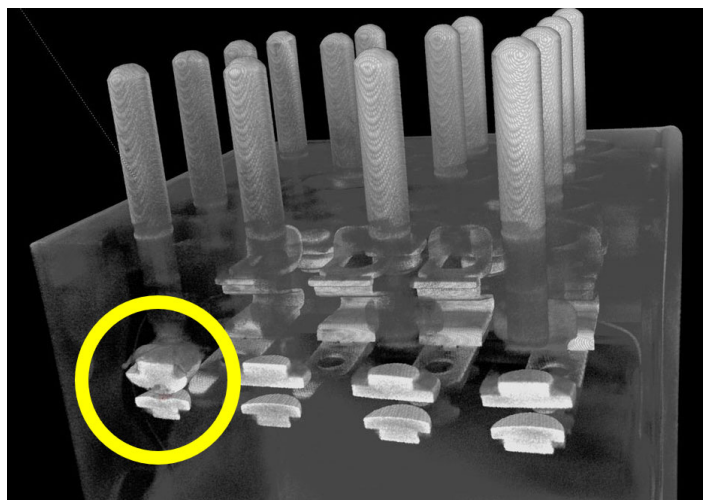
All four of the flap extend / retract relays were taken to a specialist facility and were scanned using a computerised tomography (CT) scanner. Figure 4 is an image of the No 1 motor retract relay from the scan showing a contact anomaly. This anomaly is being investigated further, along with discrepancies in the operation of the relay.

CT scan image of a contact anomaly in No1 motor retract relay

Failure of the No 1 retract relay meant that the uncommanded movement protection system was disabled and only an uncommanded extend signal was required to extend the flaps. The safety case for an uncommanded flap movement was calculated assuming two concurrent failures, but this event shows that it is possible for one failure to exist undetected for some time, thereby increasing the risk of this potentially catastrophic event occurring. The following Safety Action is being taken by Transport Canada and the aircraft manufacturer to review the safety case for the Challenger 600 series of aircraft:

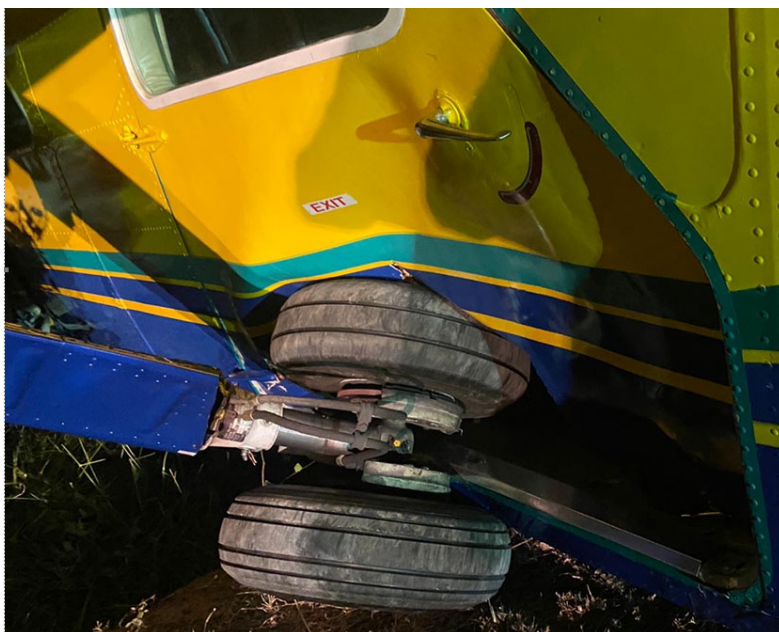
Figure 2

Collapsed left main landing gear blocking left cabin door

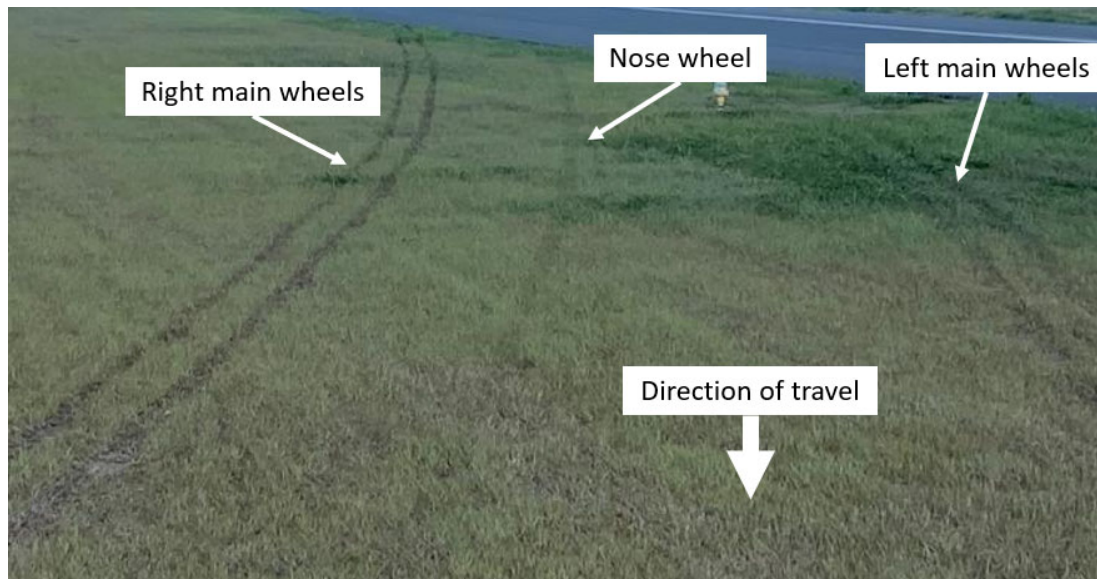
Figure 3

The tyre marks indicated the aircraft continued veering right until it came to rest in a drainage ditch close to the boundary of the airport; this was just over 160 m from the beginning of the skid marks. There was no fire.

Wheel marks in grass beside runway showing evidence of asymmetric braking

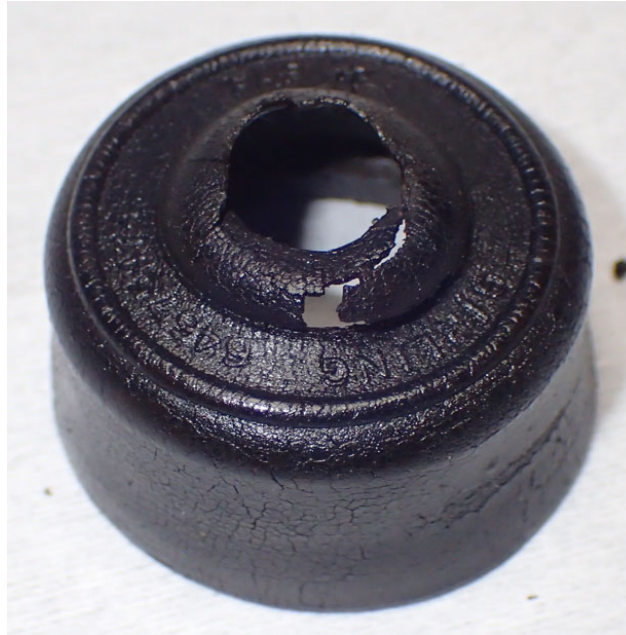
Figure 6

whether it was there before the accident. The main seals and main bores were in satisfactory condition. The dust seals around the input rod from the pilot's pedals were in poor condition (Figure 6).

A dust seal from one master cylinder showing degraded condition

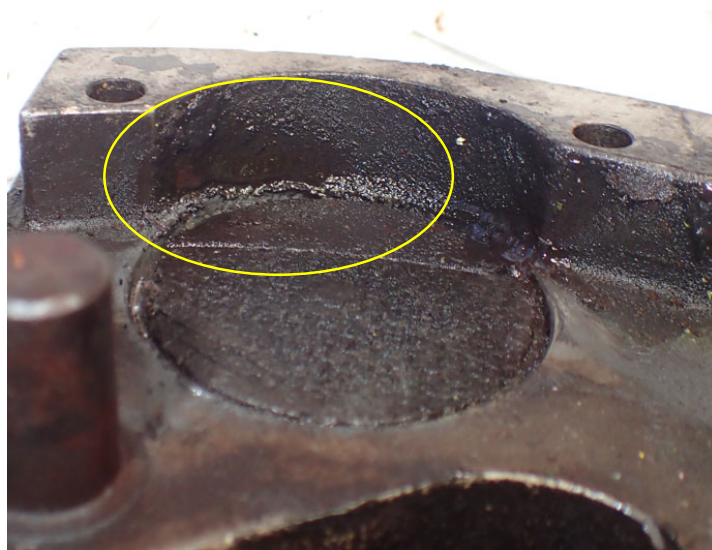
Figure 7

The calliper assembly of the left outboard brake was examined as it appeared to have a slight leak from one of its pistons (Figure 7). When the piston was removed, the piston bore had scoring in the area where the leak was apparent (Figure 8). The piston's 'O' ring seal was found to be flattened rather than the circular cross section of a new seal (Figure 9).

Leak apparent from piston of left outboard calliper

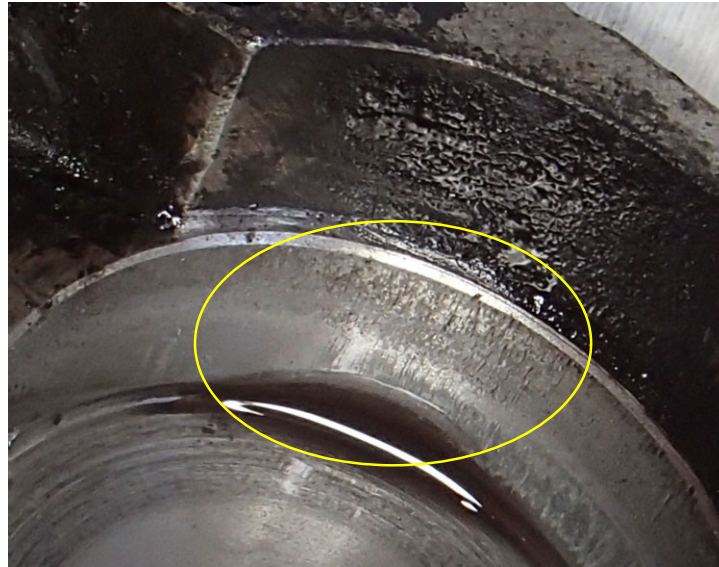
Figure 8

Scoring in piston bore in area of leak

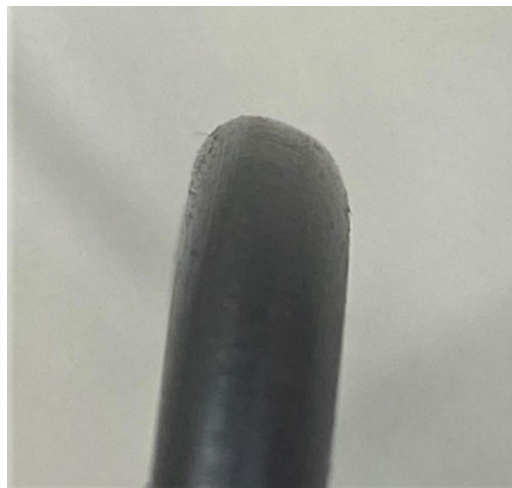
Figure 9

Flattened cross-section of piston 'O' ring seal

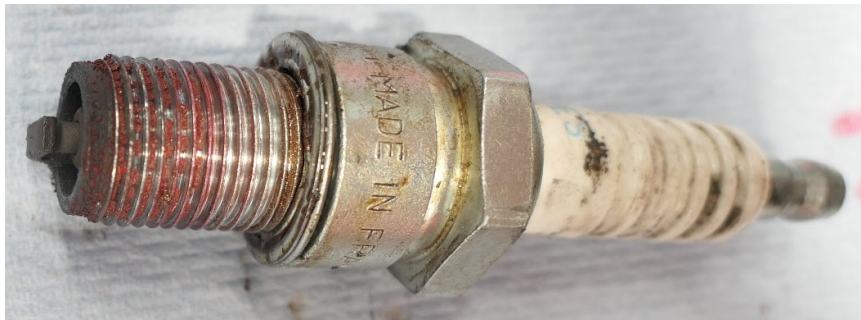
Figure 1

The external inspection of the engine showed no visible damage except for crushing of one of the air filters. The aft left engine mounting bolt was too short with no threads protruding through the nut. Approximately 23 litres of 50:1 two-stroke fuel/oil mix was removed from the two plastic fuel tanks behind the cockpit. The spark plugs were removed from the cylinder head and an unidentified red sealant compound was found on the threads. The colouration of the plugs was considered normal however the electrode gaps were 0.33 to 0.356 mm instead of the recommended gap of 0.5 mm.

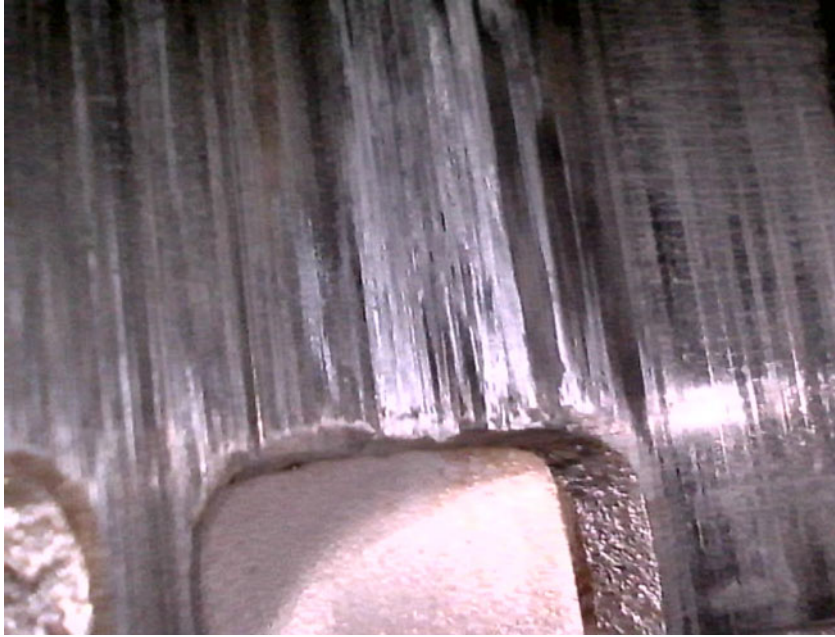
Figure 2
Aft cylinder bore scoring

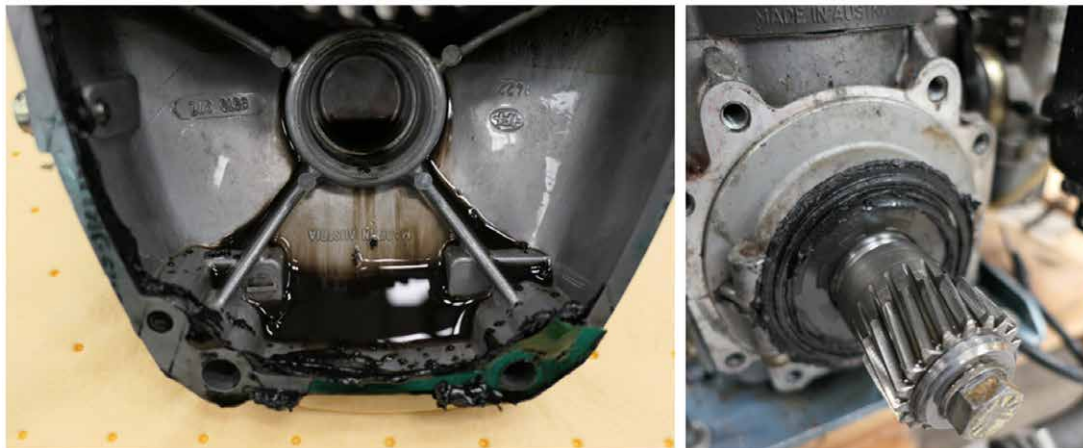
The oil from the reduction gearbox was removed and contained an unidentified black contaminant. The gearbox casing was split and it was found that silicone sealant had been used in addition to the paper gasket between the casing mating faces (Figure 3 left). A significant amount of the sealant was also found at the gearbox to crankcase interface (Figure 3 right). Much of the sealant had exuded into the gearbox where it had been ground between the gears to form the black contaminant seen in the oil. The general condition of the gears was good.

Figure 3
Left – exuded sealant inside casing
Right – sealant on crankcase interface

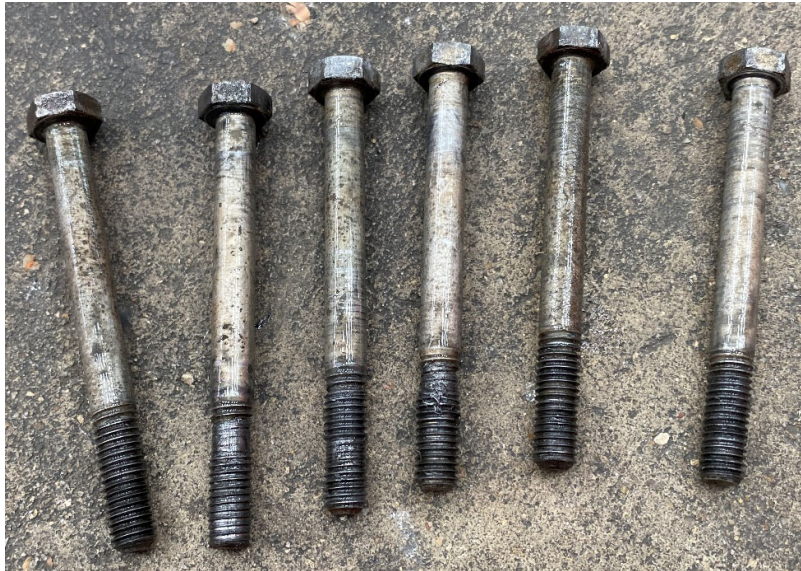
Figure 4

Prior to removal of the propeller, the pitch of the blades was measured using the Warp Drive blade setting tool. The blade pitch was found to be between $5^{\circ} 20'$ and $4^{\circ} 50'$. The condition of the blades was good, however when the propeller was removed from the gearbox hub, the threads of two of the six retaining bolts were found partially stripped (Figure 4).
