**ACCIDENT**

<b>Aircraft Type and Registration:</b>	Boeing 787-8, G-ZBJB	
<b>No &amp; Type of Engines:</b>	2 Rolls-Royce Trent 1000-AE3 turbofan engines	
<b>Year of Manufacture:</b>	2013 (Serial no: 38610)	
<b>Date &amp; Time (UTC):</b>	18 June 2021 at 0651 hrs	
<b>Location:</b>	London Heathrow Airport Stand 583	
<b>Type of Flight:</b>	Commercial Air Transport (Cargo)	
<b>Persons on Board:</b>	Crew - 2	Passengers - None Other - 6
<b>Injuries:</b>	Crew - 1 (Minor)	Passengers - N/A Other - 1 (Minor)
<b>Nature of Damage:</b>	Underside of forward fuselage, door 2L and forward lower engines cowlings damaged	
<b>Commander's Licence:</b>	Airline Transport Pilot's Licence	
<b>Commander's Age:</b>	47 years	
<b>Commander's Flying Experience:</b>	8,364 hours (of which 587 were on type) Last 90 days - 26 hours Last 28 days - 0 hours	
<b>Information Source:</b>	AAIB Field Investigation

**Synopsis**

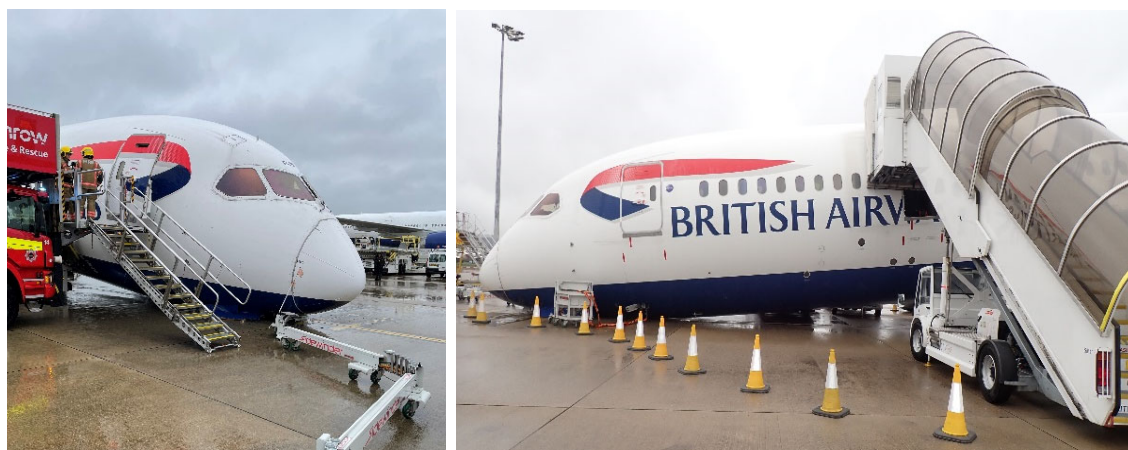
Figure 2

On the stand, the aircraft was resting on its nose with no NLG visible (Figure 2) but with both MLGs down and their down locks in place.

View of right and left side of the aircraft following NLG retraction

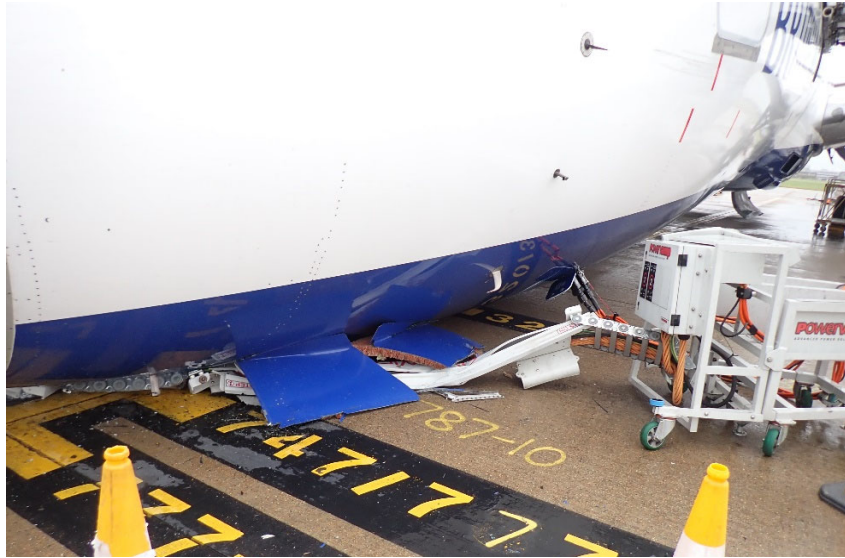
**Figure 3**

The front lower fuselage and both NLG doors were badly damaged, and the doors were partially detached from their hinges. Crushed underneath the nose was a metal articulated conduit containing the ground power supply cables (Figure 3).

View of the damaged NLG doors and crushed ground power supply cables

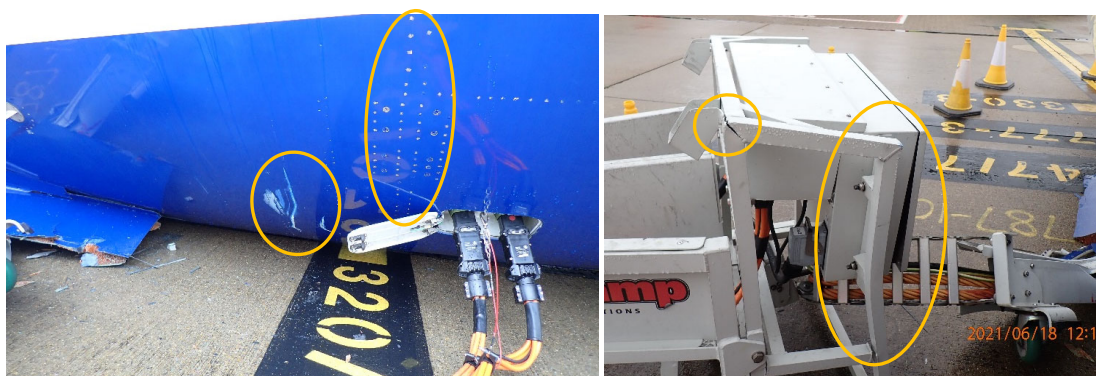
**Figure 4**

On the left side of the aircraft, aft of the NLG bay, deep vertical scratches were scored into the fuselage skin where it had been in contact with the fixed power unit when the nose lowered to the ground. The fixed power unit was also deformed and damaged by the impact with the aircraft (Figure 4). There were signs of distressed rivet heads along the bulkhead rivet lines forward and aft of the NLG bay.

Score marks and distressed rivet heads (left) and damage to fixed power unit (right)

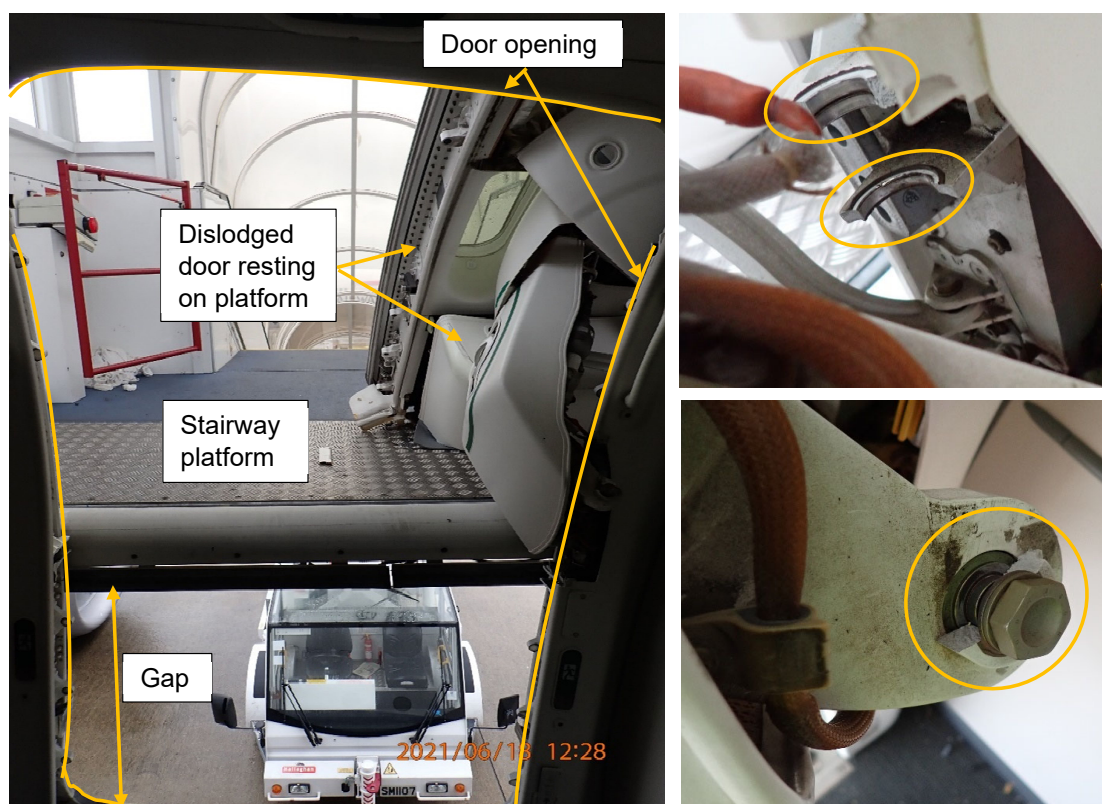
**Figure 5**

At door L2, motorised covered passenger stairs were still in place. The aircraft passenger door hinges had been disrupted during the accident sequence and the door was resting on the horizontal platform at the top of the stairs. The stairway's platform was approximately 2 feet higher than the lower door frame (Figure 5).

View from inside the aircraft showing the door resting on staircase and disrupted door hinges

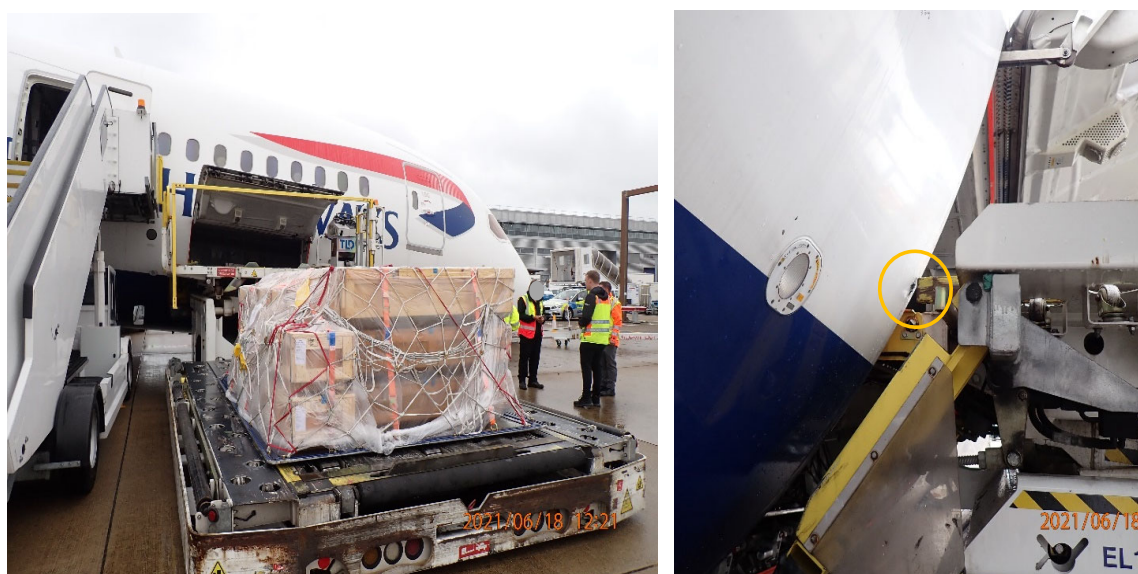
**Figure 6**

On the right side of the aircraft was an access stairway that had been positioned at door R2 to allow safe access to the aircraft after the accident. At the forward cargo door was the ULD Loader for raising cargo pallets to the height of the aircraft cargo hold and transferring them to the aircraft. There was slight damage to the aft vertical cargo door frame caused by

contact with the ULD Loader when the aircraft nose lowered to the ground (Figure 6). The rear cargo door was also open but there was no ground support equipment at that location.

ULD Loader (left) and impact damage to aft side of cargo door frame (right)

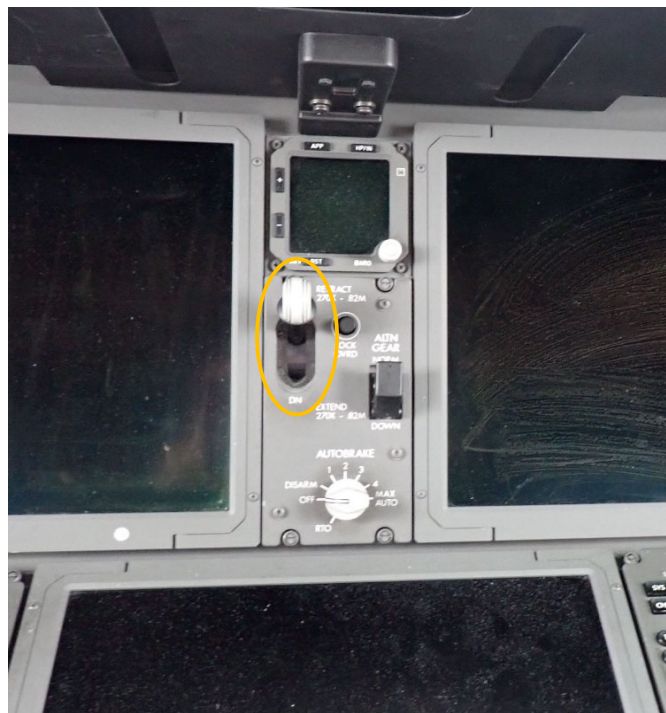
**Figure 7**

On the flight deck, the landing gear selection lever remained in the UP position (Figure 7) but AC power had been lost when the nose of the aircraft crushed the ground power cables.

Landing gear selector lever in the UP position

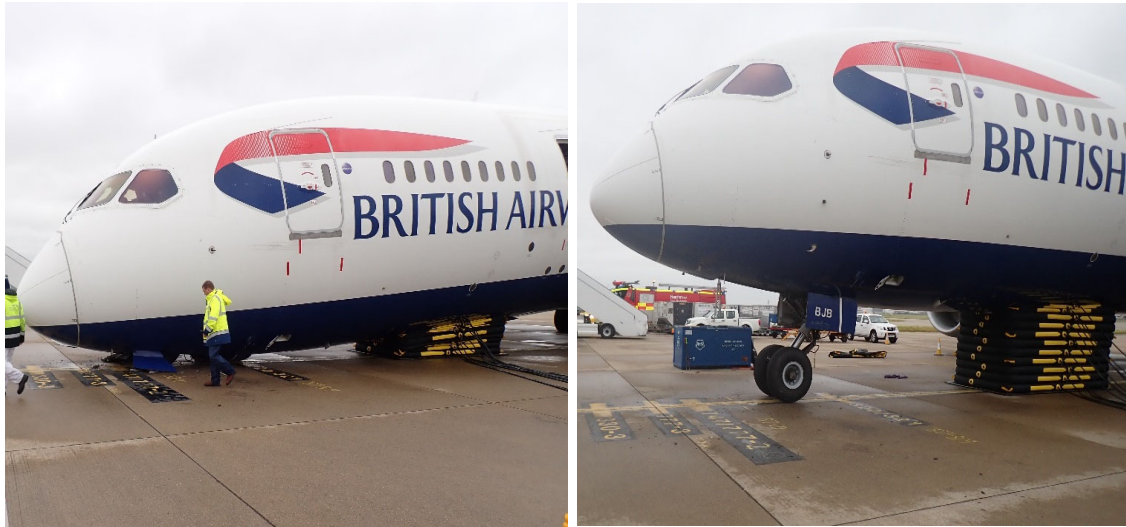
**Figure 8**

Recovery action commenced by raising the aircraft nose using a system of pneumatically inflatable mats. As the nose was raised, the NLG lowered under gravity, (Figure 8), until it was in its down position.

Aircraft nose was lifted using pneumatic inflatable mats

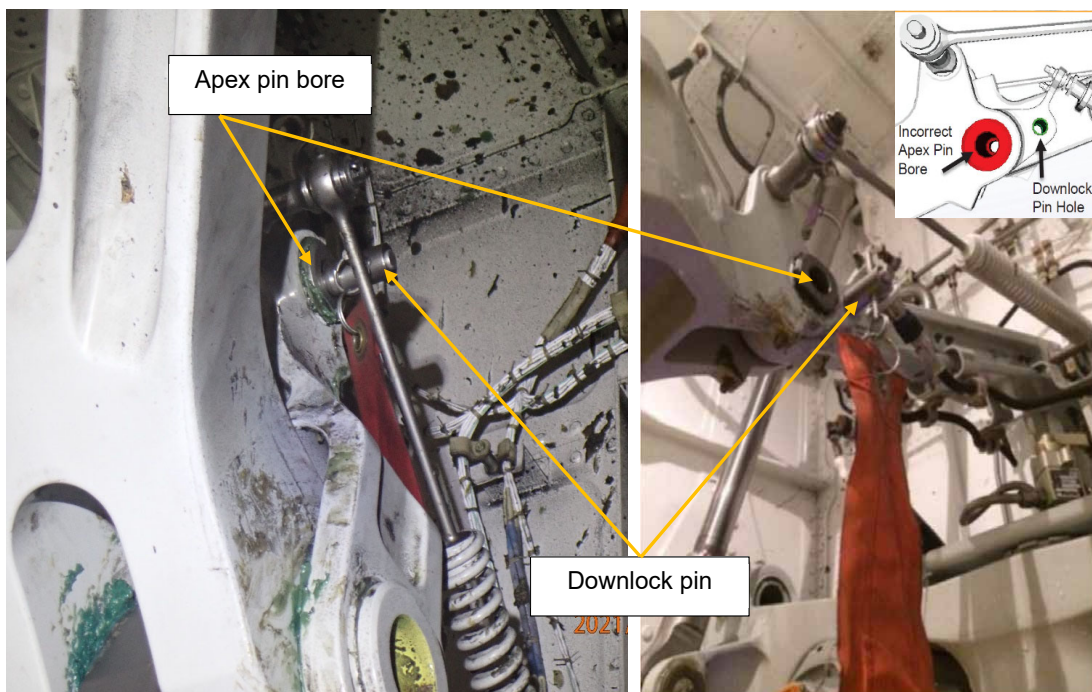
**Figure 9**

The NLG downlock pin had inadvertently been inserted in the downlock link assembly apex pin bore instead of the downlock pin hole. The design of the aircraft nose landing gear downlock assembly created an opportunity for error when inserting the NLG locking pin, with two holes located so close together that the pin could be inadvertently inserted in the incorrect location. A Service Bulletin and Airworthiness Directive was available that would have prevented the accident, but this had not yet been completed on G-ZBJB.

When the NLG bay was accessed, the NLG downlock pin was found to be in the leg's apex bore hole rather than the downlock pin hole (Figure 9). The downlock pin was transferred to the correct position to lock the gear down and to allow the inflatable mats to be removed so the aircraft could be towed to a suitable quarantine hangar.

Downlock pin incorrectly fitted to the apex pin bore (left) and an example of the correct location of the pin for comparison (right)  
Image used with permission

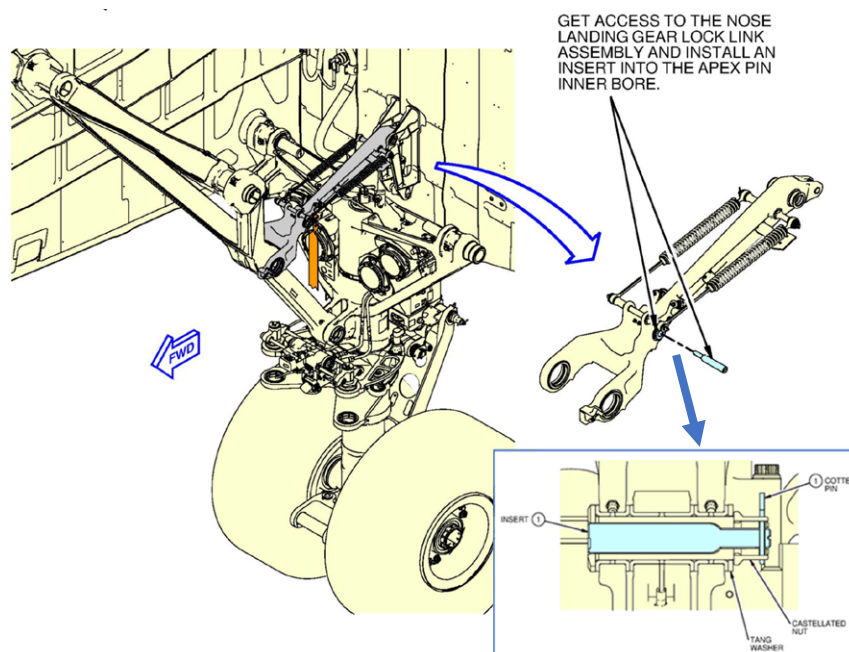
**Figure 17**

SB illustration of NLG lock link assembly and apex inner bore insert

*'If this Service Bulletin is not done, the NLG can be retracted on the ground during maintenance or fault isolation if the NLG pin is accidentally installed in the apex pin inner bore, which can cause damage to the airplane and injuries to personnel.'*

The FAA issued AD 2019-23-07 to address this issue, which could result in the NLG retracting on the ground, possibly causing serious injuries and substantial aircraft damage. The associated SB 320040 installs an insert into the apex pin bore to prevent incorrect installation of the downlock pin. The current 787-8 and -9 fleets will have this SB incorporated before the compliance end date (Jan '23). 787-10 G-ZBLA and all subsequent deliveries will have this change from production.
