Rail Accident Investigation Branch

Rail Accident Report

Collision between a passenger train and a hand trolley at Challow, Oxfordshire 21 October 2021

Report 11/2022
October 2022

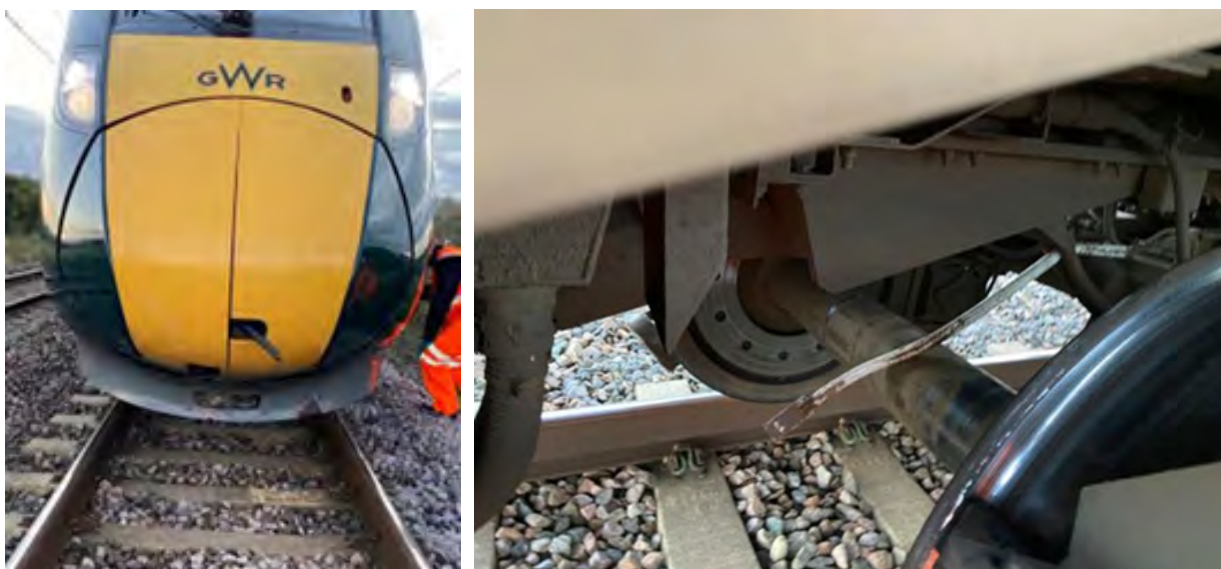
- 4 The train came to a stop about 1.0 mile (1.6 km) beyond the point of collision (figure 2). There were no injuries among the passengers or crew on board and the train did not derail. The hand trolley was destroyed by the impact. Its handle became wedged under the leading bogie of the train (figure 2) and debris from the trolley caused damage to equipment under the train. The collision also resulted in minor damage to the track.
- 5 Staff from Network Rail and Hitachi Rail went to the train to assess the damage to it and to remove the debris from under it. At 08:53 hrs, the train departed and continued westwards as far as Swindon where the service was terminated. The train then ran eastwards empty to North Pole depot in London.

Figure 2: The train once stopped and the handle from the hand trolley wedged under it (courtesy of Network Rail)

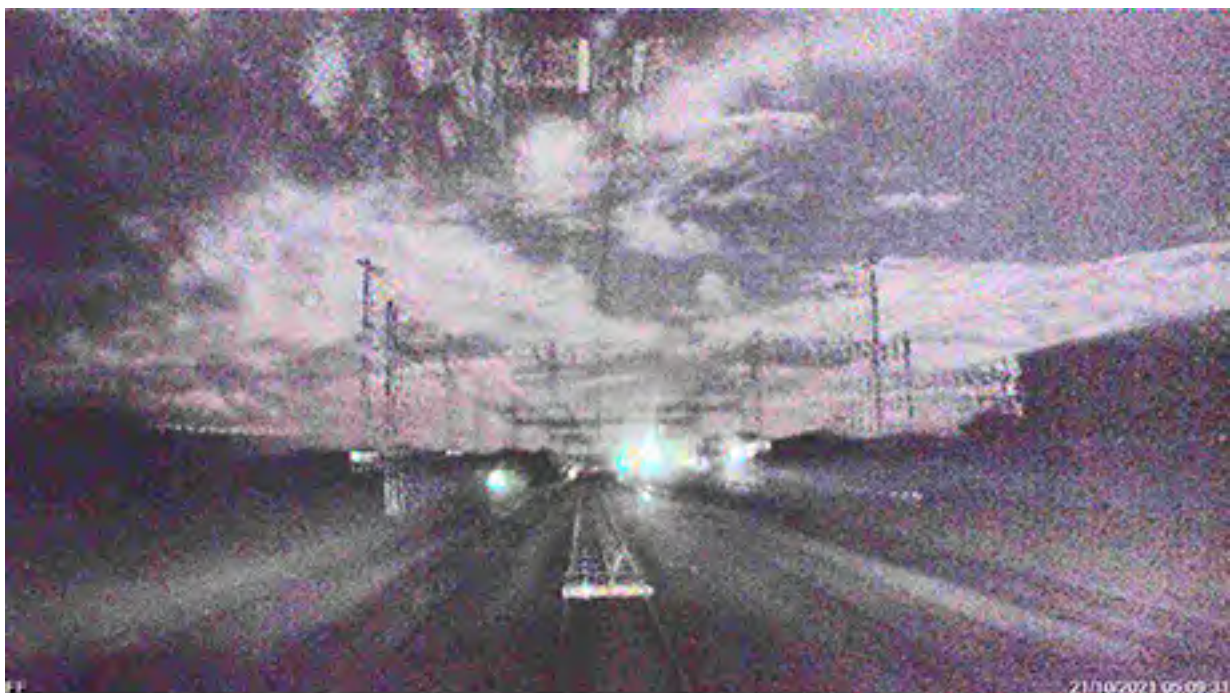
- 33 At 05:23 hrs, train 1C00 departed on time from London Paddington station. It stopped at Reading and Didcot Parkway. After departing from Didcot Parkway at 06:02 hrs, the train accelerated to 123 mph (198 km/h) and was travelling at this speed as it approached Challow. At 06:09 hrs, as the train approached the road-rail access point, the driver noticed the hand trolley on the track ahead of him (figure 8) but had no time to react before the collision. Train 1C00 struck the hand trolley at 123 mph (198 km/h) and the driver immediately made an emergency brake application.

Figure 8: Still image from the forward-facing CCTV footage recorded by train 1C00 (courtesy of Great Western Railway)

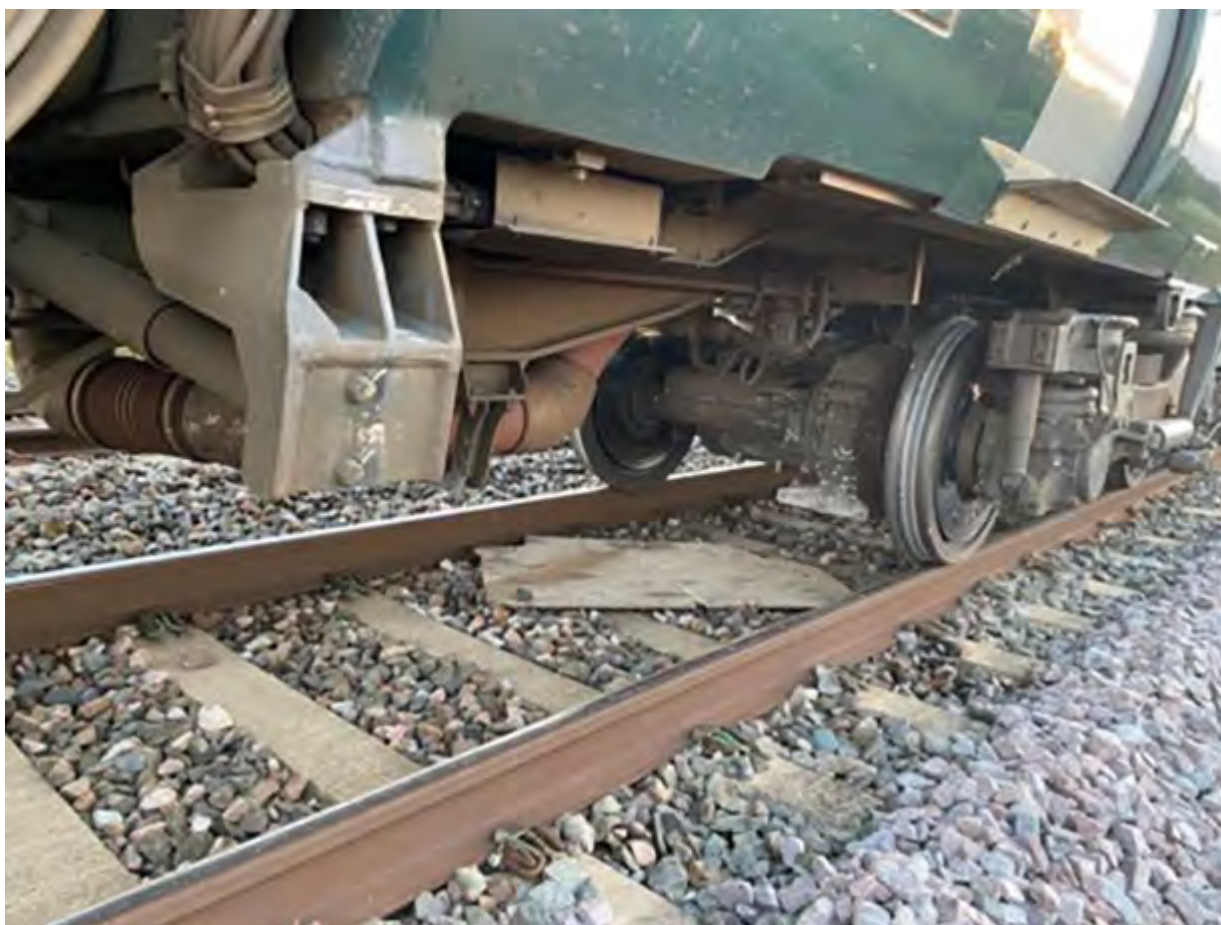
Figure 9: The hand trolley's wooden deck underneath the second vehicle (courtesy of Network Rail).

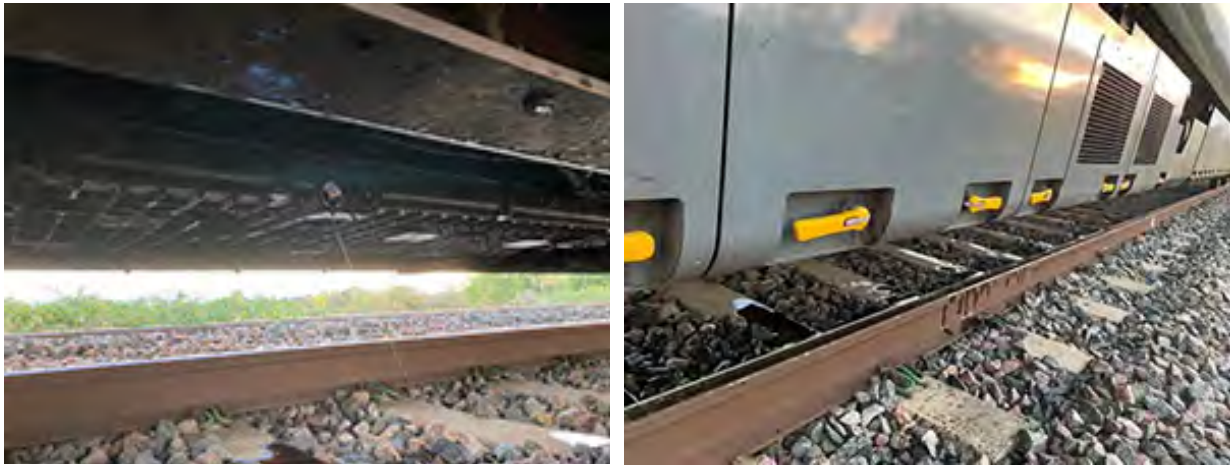
- 37 Shortly after 08:00 hrs, the mobile operations manager at Challow was joined by a track maintenance team. The team's supervisor reported that one of the rails on the down main line was contaminated with oil and would need to be treated. At the train, the technical riding inspector identified that the oil had leaked from a damaged drain plug on a diesel generator unit under the second vehicle (figure 10). He estimated that between 15 and 20 litres of engine oil had leaked out, so he isolated the diesel generator unit concerned. This did not affect the train going forward, as it was in electric mode and drawing power from the overhead line equipment.

Figure 10: The oil leak under the second vehicle and oil contamination on the rail (left image courtesy of Hitachi Rail and right image courtesy of Network Rail)

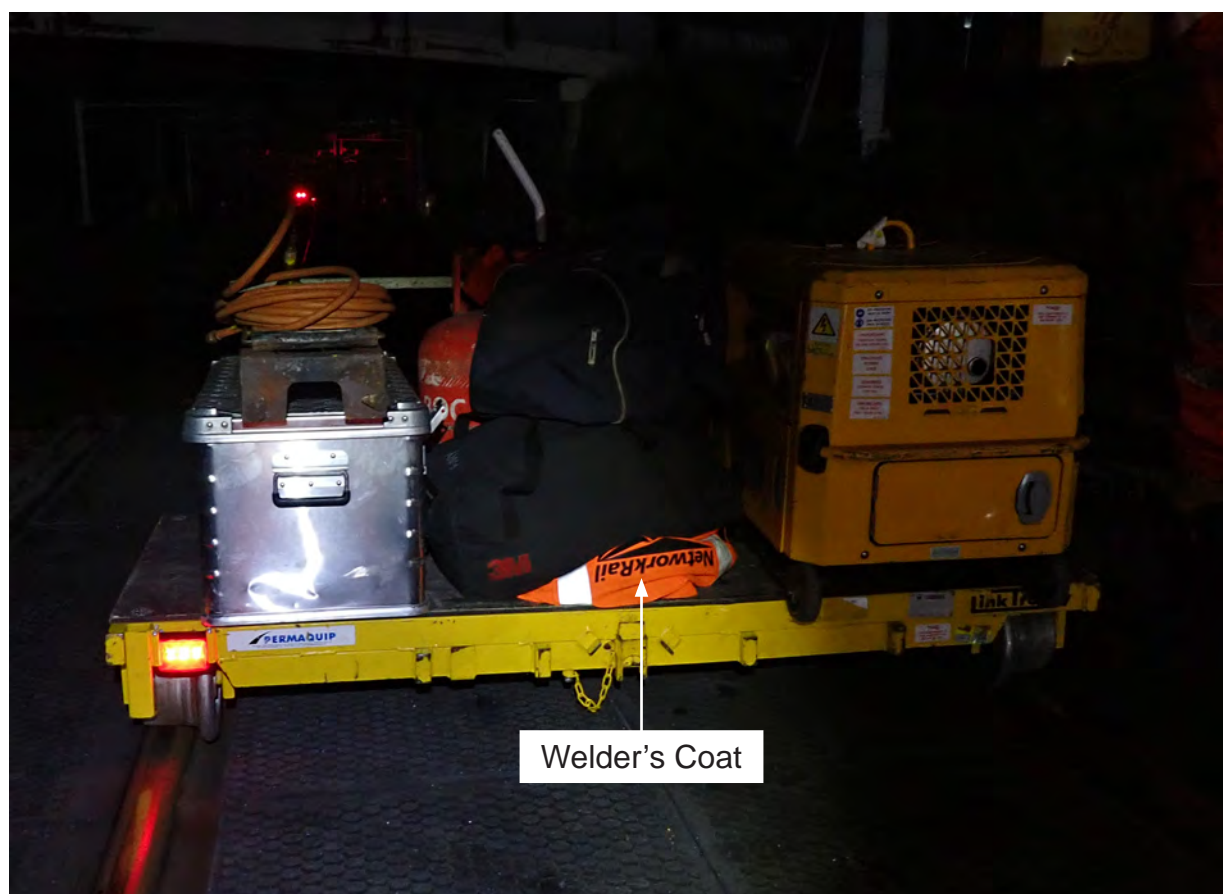
- 51 When the COSS and the welder set off to find the rail defect and repair it, because it had been raining (paragraph 20), they both wore their high visibility coats in addition to their usual high visibility clothing. Later, the welder took his coat off and placed it on the empty hand trolley. This was because it had stopped raining and the welder was getting hot while grinding out the defect. After completing the repair, the COSS and the welder packed up their equipment, loaded it all back on the hand trolley on top of the coat (figure 11), and then pushed the hand trolley back to the road-rail access point.

Figure 11: A reconstruction of how the hand trolley was loaded by the COSS and the welder after completing the repair

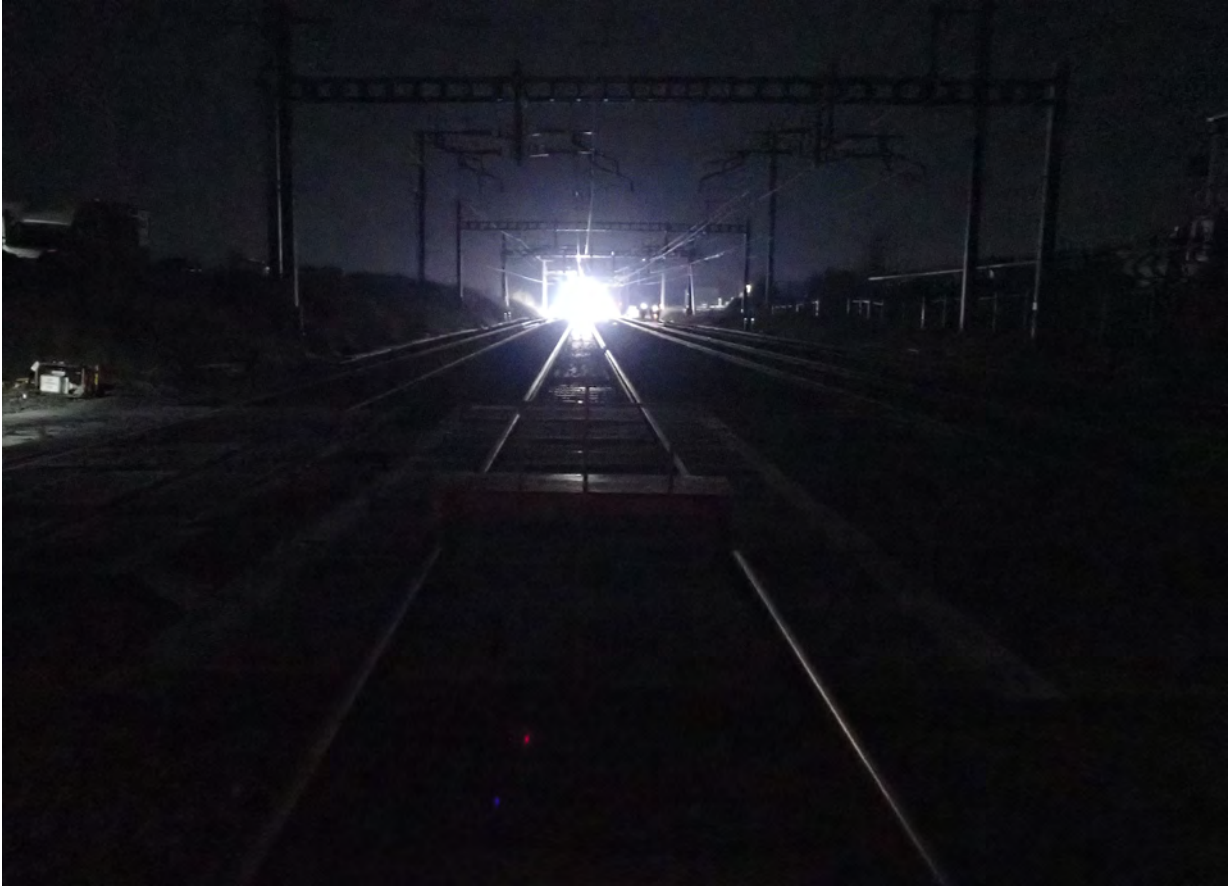
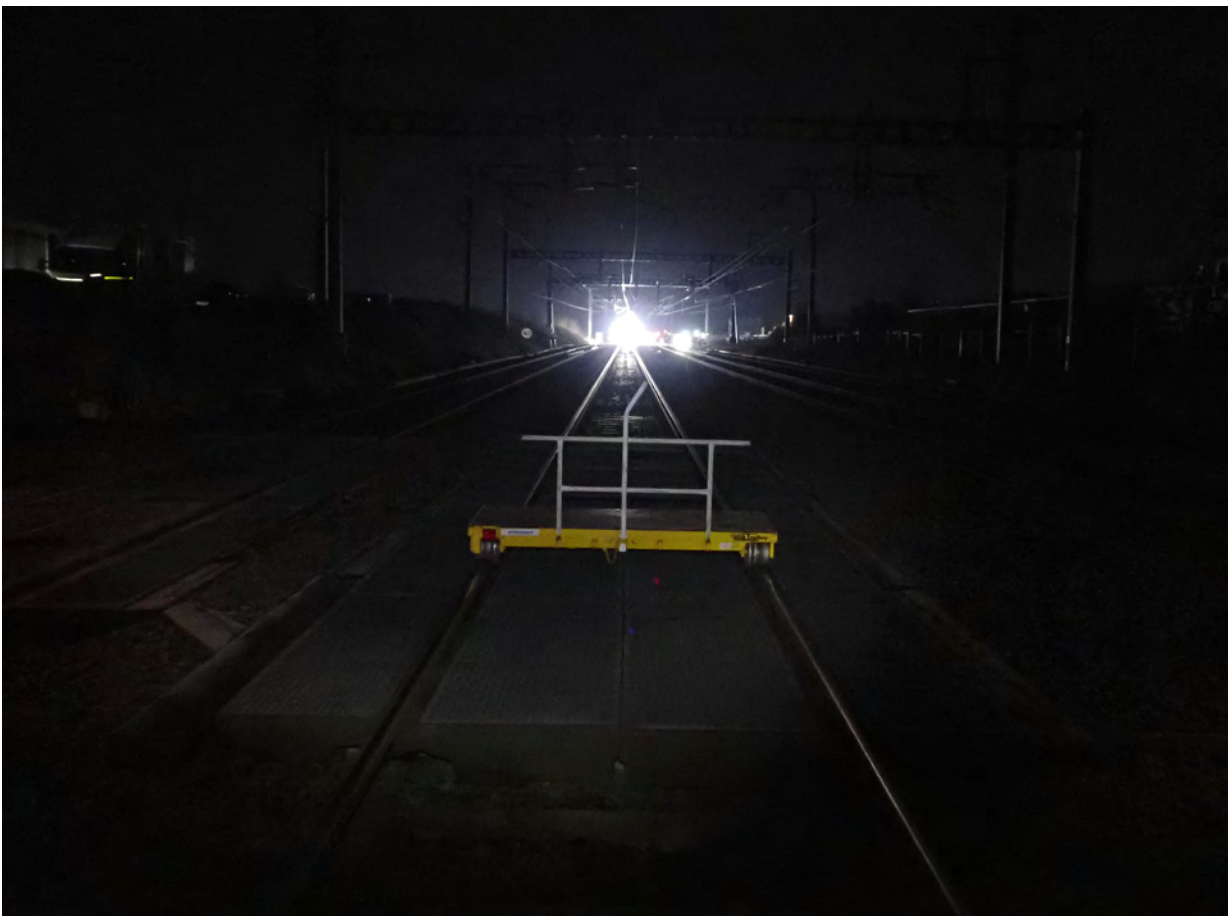
- 68 Without illuminated red lights, the hand trolley would be very difficult to see in the darkness. During a reconstruction of events in more favourable circumstances because of the presence of distant light sources, RAIB observed that the hand trolley was still very difficult to see (figure 13), even when standing only about five metres away from it. The hand trolley was painted yellow to improve its visibility in daylight, but this paint was not reflective or luminescent. It was not fitted with any type of reflective tape or reflective markings to improve its visibility in the dark. The COSS and the welder could have complied with the requirements of GE/RT8000/HB10 by placing a red flag on the hand trolley. However, this would not have prevented this accident as the red flag would not have been visible in darkness.

Figure 13: A hand trolley, with no illuminated red lights, on the road-rail access point in darkness during the reconstruction (top image) and illuminated by torch light for comparison (bottom image)

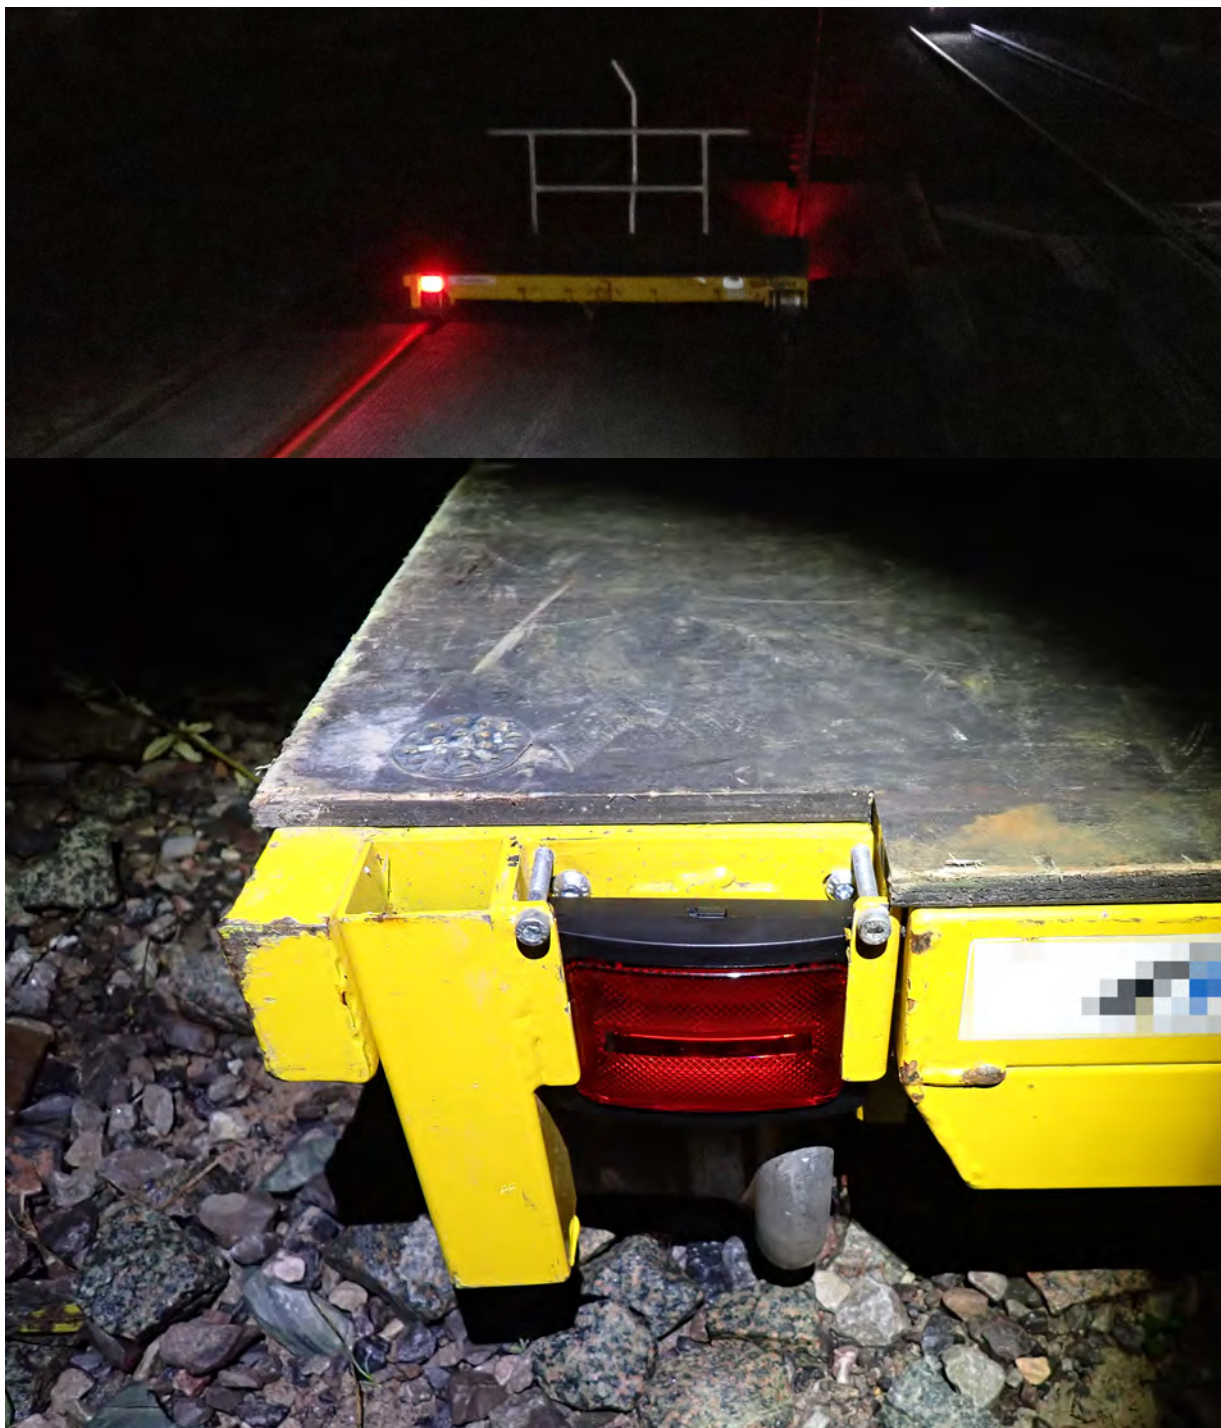
- 69 This type of hand trolley is fitted with a bracket on each long side (the side which crosses between the two rails) to house a red-light unit (figure 14). The provision of these brackets is a requirement in Network Rail's specification for manually propelled trolleys. The brackets were checked at the hand trolley's last maintenance inspection in August 2021 and recorded as serviceable. Although there was no witness evidence which suggested that the red lights units were not fitted in the hand trolley's brackets, RAIB has not been able to confirm this independently. None of the hand trolley debris removed from the track (paragraph 38) was kept afterwards by Network Rail, meaning it could not be examined. The forward-facing CCTV footage from train 1C00 (figure 8) is also too dark and of insufficient quality to determine if non-illuminated red-light units were fitted to the hand trolley.

Figure 14: The red-light units on the same model of hand trolley.

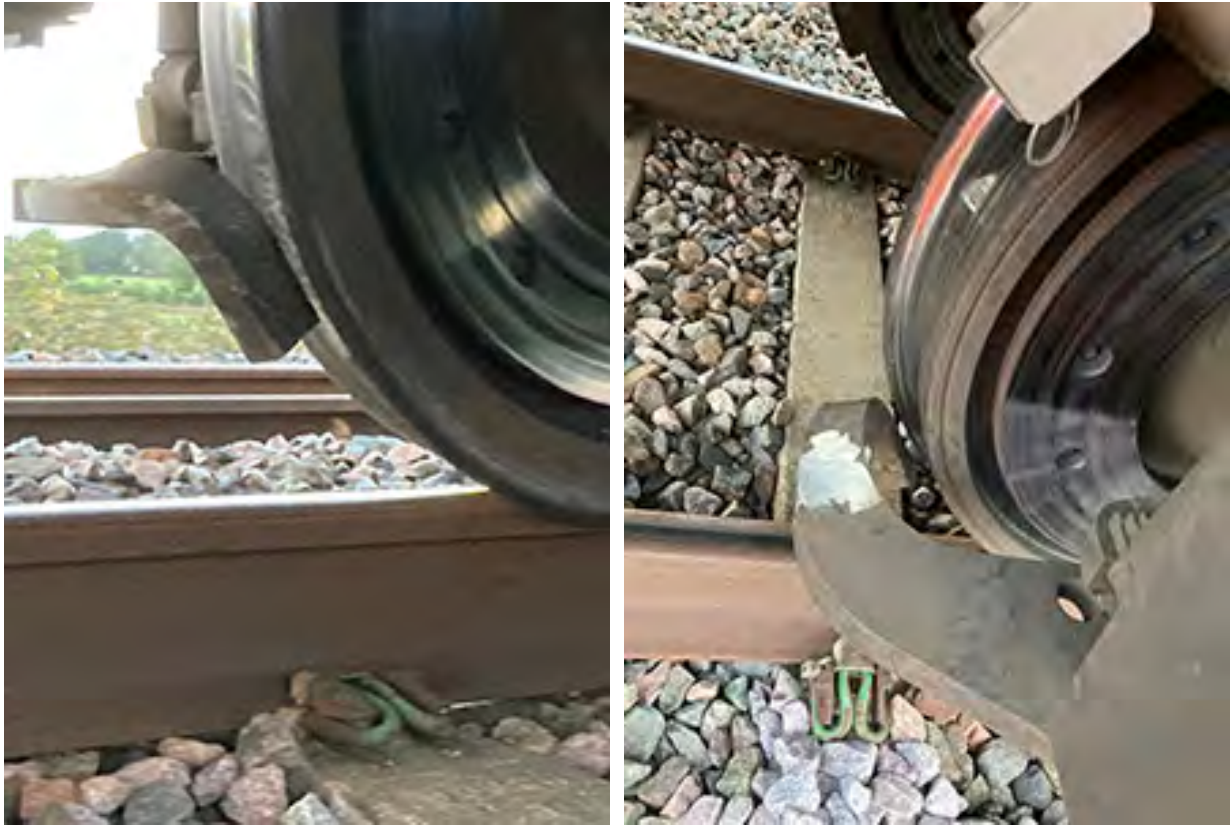
123 The Hitachi maintenance controller was not aware that the lifeguards²⁸ at the leading end of the train were also damaged after striking the hand trolley (figure 16). According to the defective on-train equipment plan, this level of damage to the lifeguards required a 40 mph (64 km/h) speed restriction to be imposed on the train when this end of the train was leading to Swindon. As the damaged lifeguards still had all their fixing bolts in place, the defective on-train equipment plan did not require any restrictions to be imposed when the train travelled in the opposite direction back to North Pole depot.

Figure 16: The damaged lifeguards on the leading vehicle (courtesy of Hitachi Rail)

124 As the 40 mph (64 km/h) speed restriction required by the defective on-train equipment plan was not applied to the train, with the vehicle with the damaged lifeguards leading from Challow to Swindon, the train reached a speed of 85 mph (137 km/h) with passengers on board. The restriction was not applied due to the maintenance controller and the staff at the train not coming to a clear understanding about what damage had been sustained by the train. Rule Book Module M3,²⁹ which covers managing incidents, provides some guidance on what to check after a train has collided with an obstruction on the track. Lifeguards are listed as an item that could possibly be damaged in these circumstances.

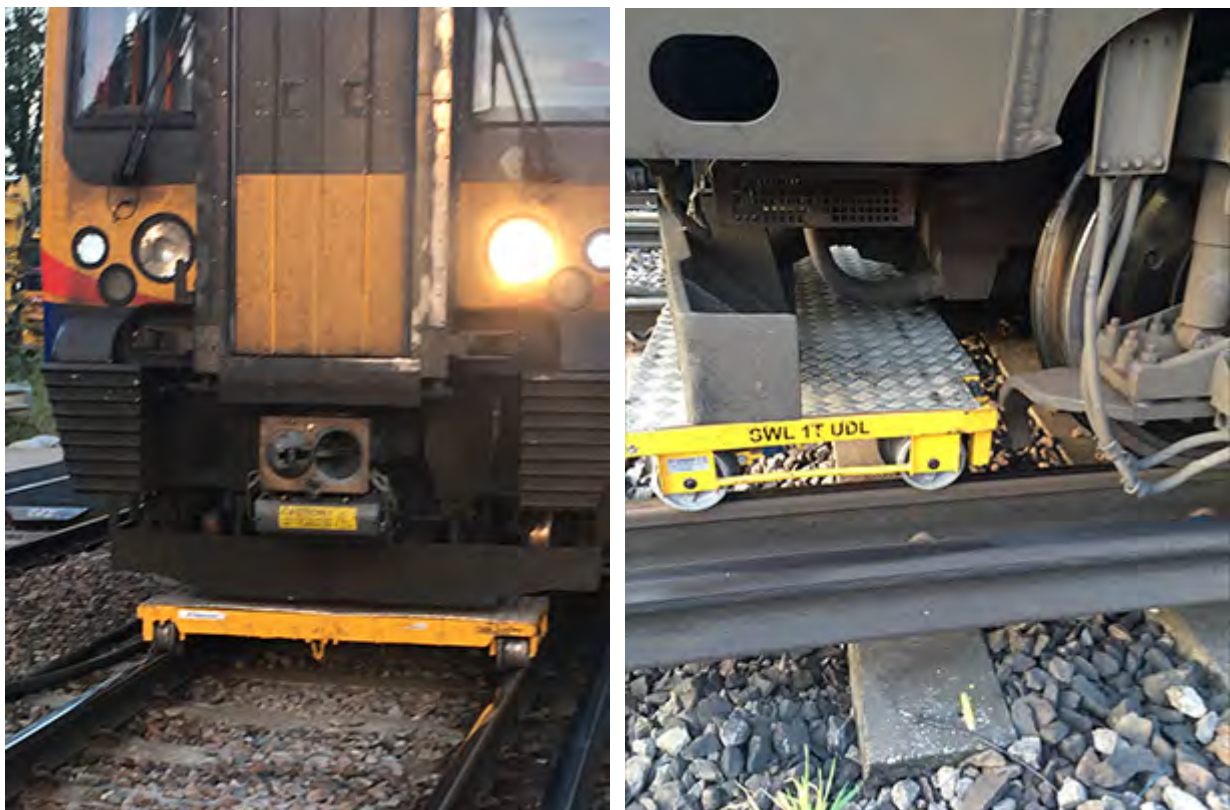
138 On 8 September 2021, about six weeks before the accident at Challow, a similar accident happened near to Twickenham station. At 05:55 hrs, an empty passenger train travelling from Staines to London Waterloo struck a hand trolley on the up main line on the approach to Twickenham station (figure 18). The train was travelling at about 25 mph (40 km/h) at the time. It was the first train to pass through this area after the railway had been handed back for normal operation following track renewal work by the Southern Rail Systems Alliance (SRSA) in an overnight possession. No injuries were reported and there was minor damage to the train and hand trolley.

Figure 18: The train and hand trolley after the collision at Twickenham (courtesy of Network Rail)
