**ACCIDENT**

| <b>Aircraft Type and Registration:</b> | Piper PA-28R-200-2, G-EGVA | |

**Synopsis**

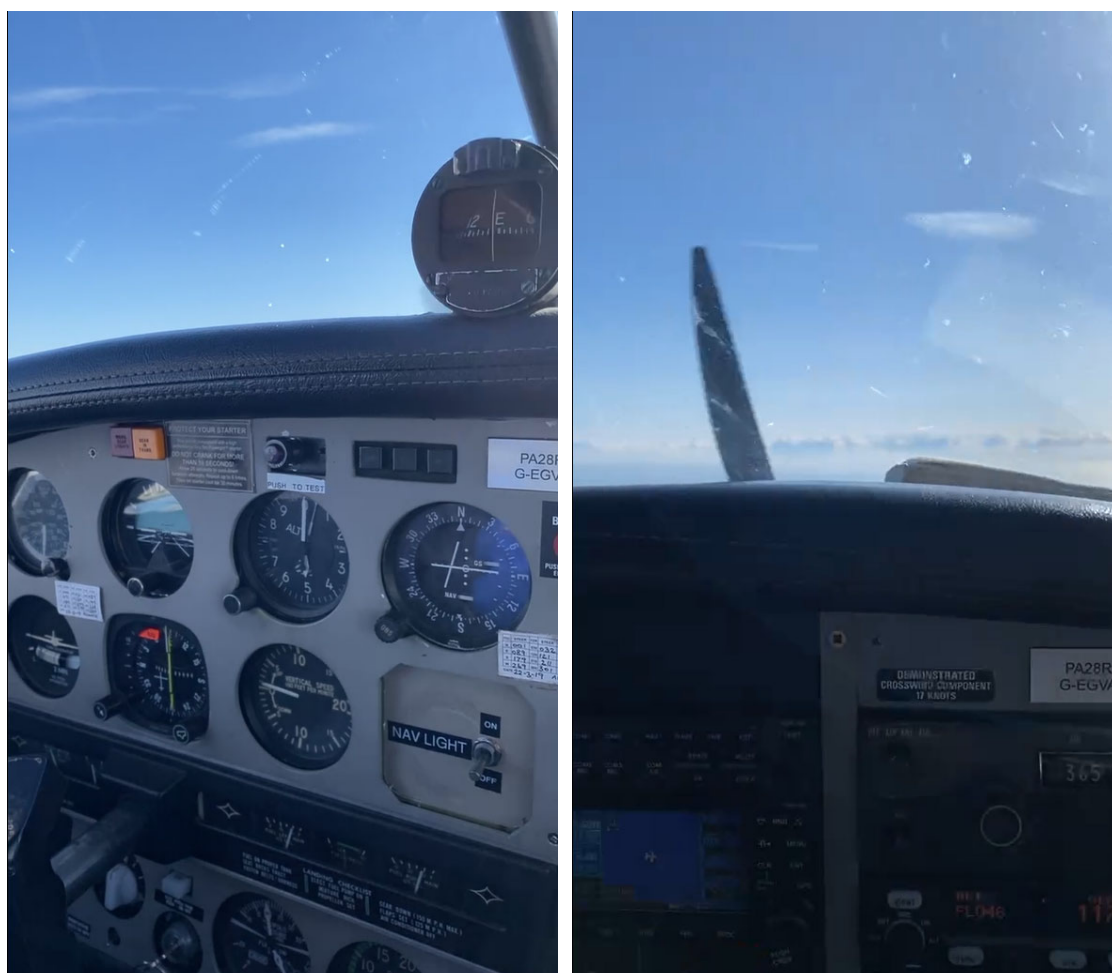
**Figure 2**

At 0846 hrs a video was posted online by the right seat pilot of G-EGVA. Extracts from the video are shown in Figure 2. The video showed the aircraft in flight passing abeam Shoreham with the flight appearing to proceed normally. The aircraft's altimeter showed 5,000 ft, the heading was approximately 090° and the airspeed indicator showed approximately 115 kt. The autopilot did not appear to be engaged and the engine and fuel indications, which were visible, appeared normal. Cumulus cloud could be seen in the distance ahead of the aircraft. Both occupants were wearing lifejackets with their shoulder harnesses worn under their lifejackets.

Extract from the video posted at 0846 hrs showing the instrument panel and the cloud ahead of G-EGVA

The video posted on social media by the right seat pilot of G-EGVA showed the aircraft at 5,000 ft with cumulus cloud visible ahead. Radar recordings show that after this time the aircraft descended to approximately 3,000 ft then climbed to above 7,000 ft whilst continuing on a constant heading towards the cloud. It is not possible to know the pilots' intentions but these changes in altitude might have been an attempt to avoid cloud vertically. Climb above 7,000 ft was restricted due to the controlled airspace above.

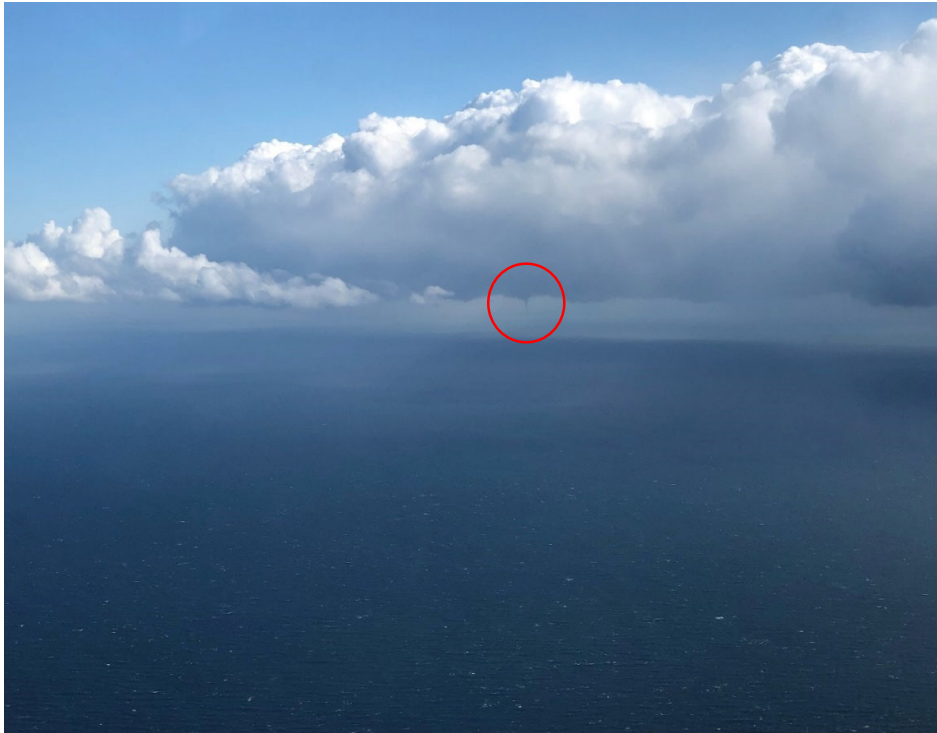
**Figure 3**

Photograph taken at 0918 hrs showing the cloud mid Channel (waterspout circled in red)

Met Office weather radar data from the time of the accident showed heavy precipitation in the Channel, suggesting a highly active convective area. Photographs taken by other aircraft in the area at the time showed waterspouts descending from the cloud, and cloud down to the surface, also indicating a highly active convective area.

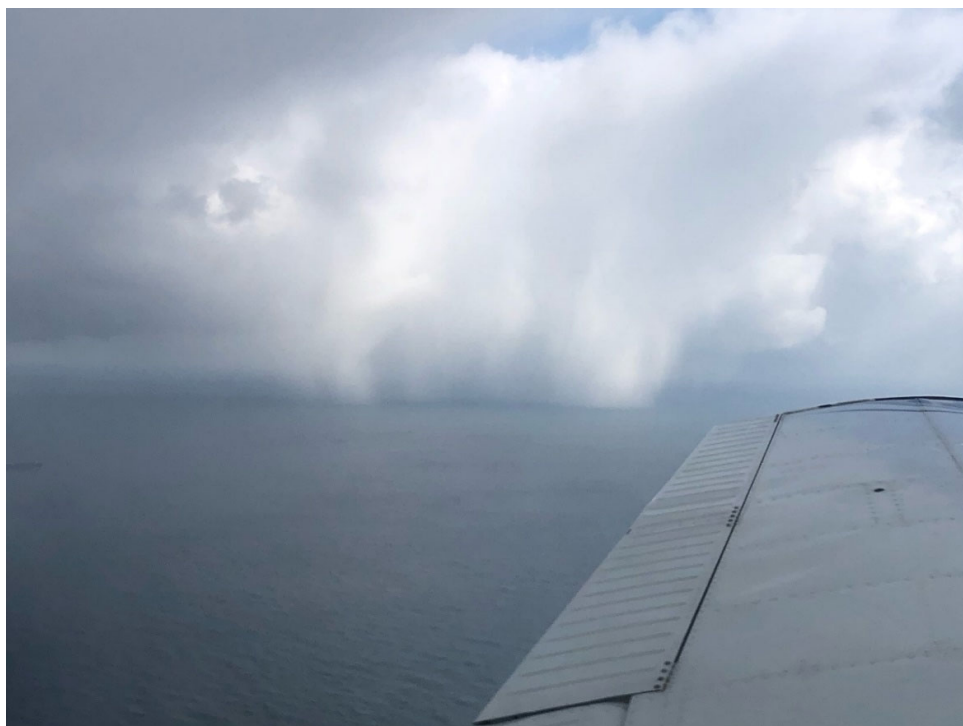
**Figure 4**

Photograph taken at 0924 hrs showing cloud to the surface

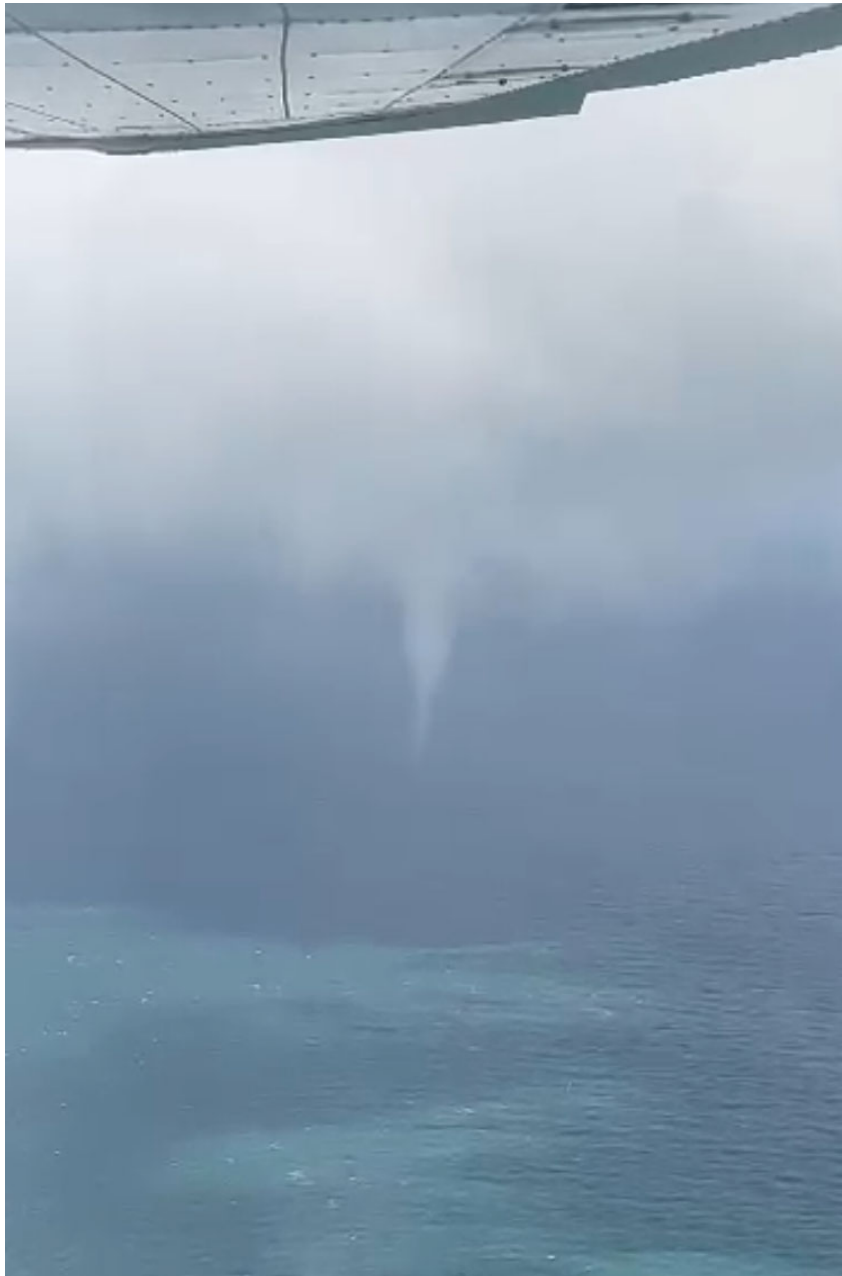
**Figure 5**

A passenger flying in another aircraft, unconnected to the Wellesbourne fly-out, which was flying from Elstree to Le Touquet took a video of the mid-channel weather. The image in Figure 5 is an extract from that video and shows one of the waterspouts.

Image from a video filmed from an aircraft which was also flying to Le Touquet

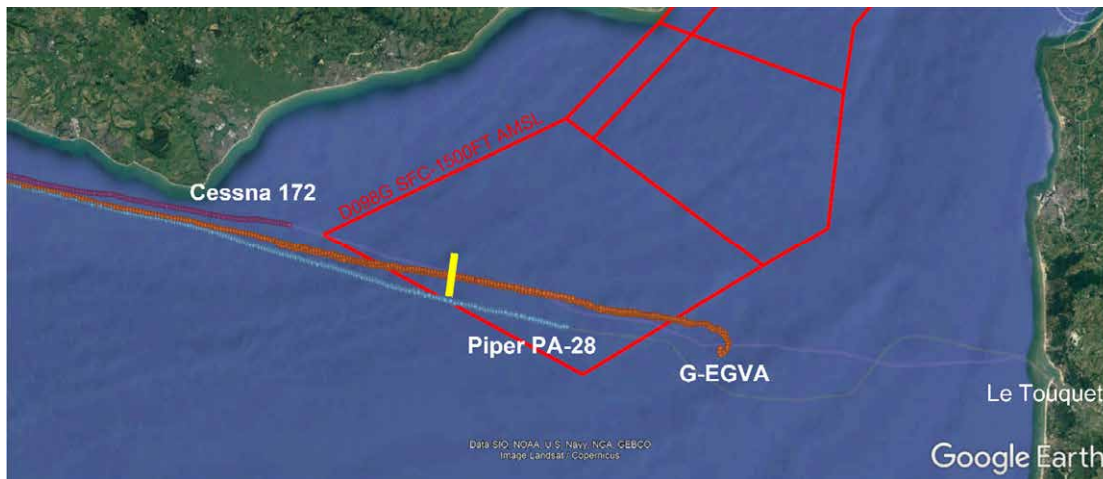
**Figure 7**

Secondary surveillance radar data for G-EGVA and the nearest two aircraft of the fly-out is shown in Figures 7 and 8. Figure 7 shows part of the ground track of these aircraft to the point when radar contact was lost with G-EGVA at 0916:31 hrs. Figure 8 shows the reported altitudes for these aircraft, corrected for the QNH of 1022 hPa. Indicated on both these figures is the point at which G-EGVA descended from its cruise altitude of about 5,000 ft amsl, and on Figure 8 the corresponding time when the two following aircraft were abeam this point.

Radar track of G-EGVA up to the last known position at 0916 hrs with the location of two of the following aircraft shown. The yellow line on G-EGVA's track is the point at which G-EGVA descended from its cruise altitude.

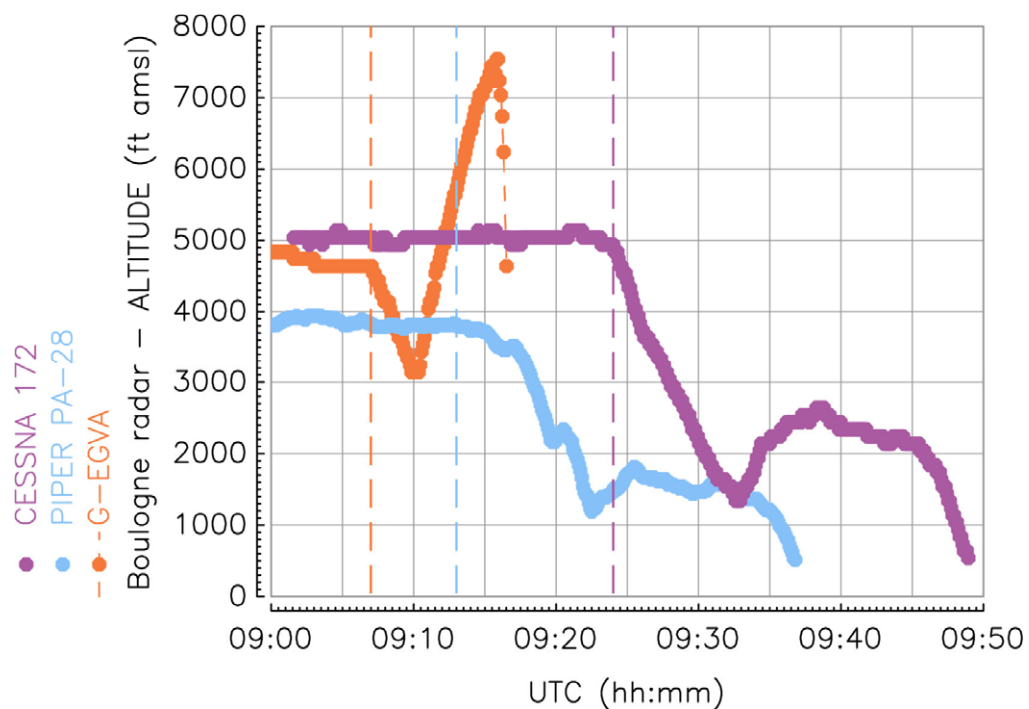
**Figure 8**

Altitude trace of G-EGVA and the following aircraft from 0900 hrs. The orange dashed line shows when G-EGVA descended from its cruise altitude – the corresponding dashed lines for the other aircraft show when they were abeam this point

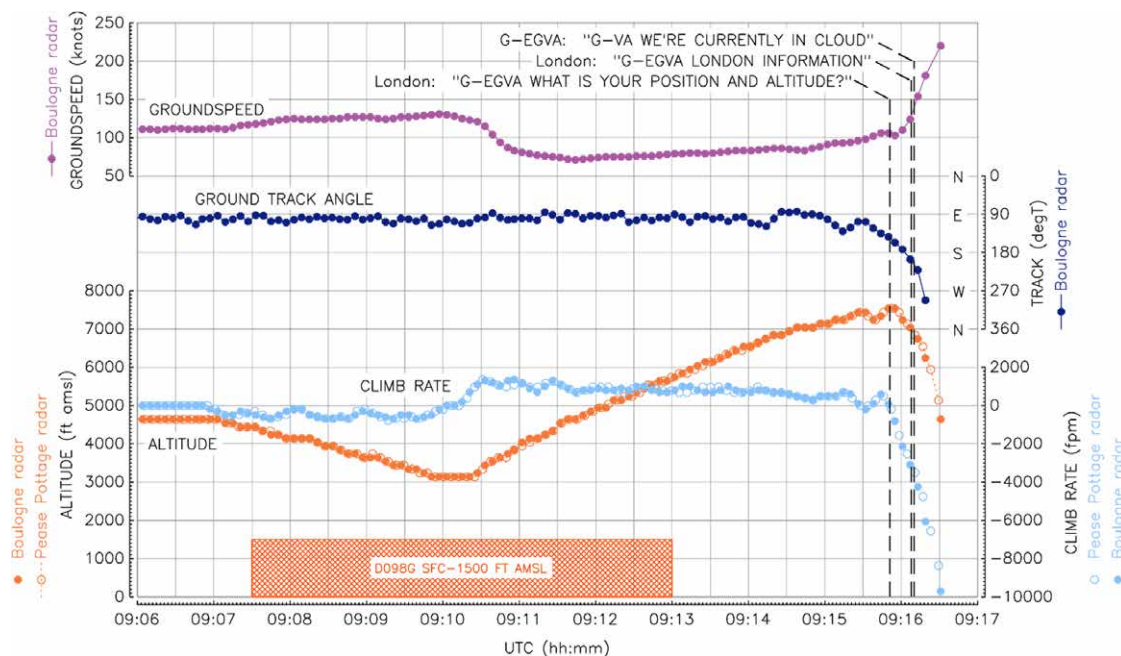
**Figure 9**

Figure 9 is a plot of the altitude and radar-derived data for G-EGVA starting just before the descent from the cruise altitude. The plot shows that the aircraft descended to about 3,000 ft at approximately 500 fpm, where it remained for 30 seconds before climbing to over 7,000 ft at about 1,000 fpm, while maintaining an easterly track. Over the next 50 seconds the aircraft climbed 400 ft, descended 200 ft, and then climbed 300 ft, and at the same time turned right, left, and right again through a total of 50°. The aircraft then continued to turn to the right in a descent. Radar contact was lost 40 seconds later as the aircraft descended through 4,600 ft with a calculated descent rate of just under 10,000 fpm. The last recorded position was 50°34'23.49" N 001°04'11.23" E at 0916:31 hrs.

Figure 9 also shows when the last radio transmissions between London Information and G-EGVA were made. G-EGVA was descending through 7,000 ft at about 3,000 fpm and accelerating during its final transmission.

Altitude and radar-derived data for G-EGVA

It is not known exactly when the aircraft entered cloud. However, in the minutes before the aircraft was lost from radar its heading and altitude varied before it descended in a steepening right turn. The forecast severe turbulence and icing in cloud may have exacerbated the challenge of maintaining controlled flight. When the last radio transmission was made, the aircraft was descending through 7,000 ft at approximately 3,000 fpm. At the last radar point the aircraft was passing 4,600 ft and descending at just under 10,000 fpm. Basic PPL training is unlikely to have prepared the pilots for flight through a turbulent cumulus cloud. Once no longer in stable flight it is unlikely they would have had the experience to recover control of the aircraft.

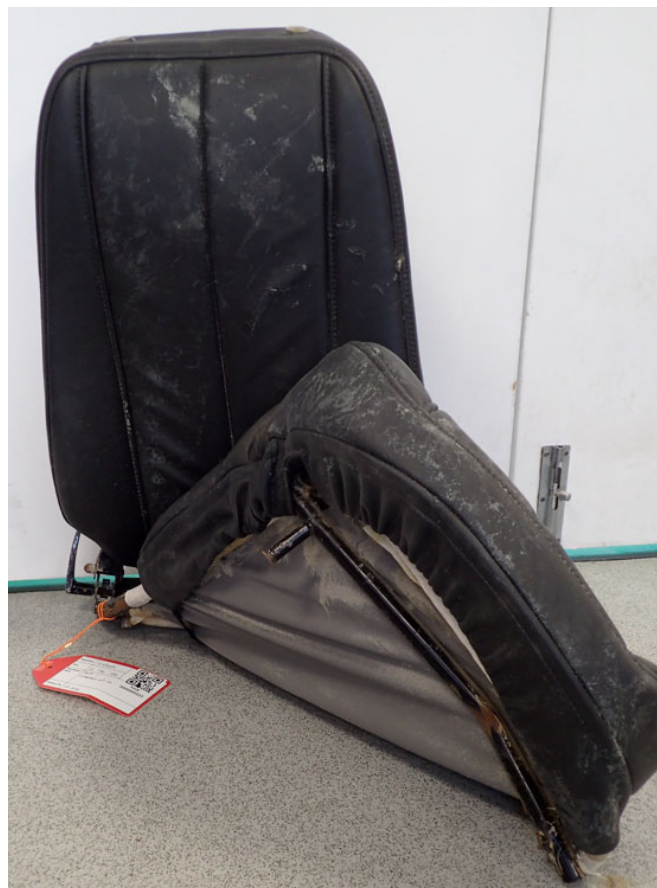
**Figure 10**  
Seat recovered from G-EGVA

The seat recovered from the French Coast (Figure 10) was examined at the AAIB. No part number or serial numbers were evident on the seat, but the style and branding of the seat covers matched those of the new leather seat covers that had recently been fitted to G-EGVA. It was identified as being one of the rear seats.

The seat cover exhibited minor scuffing and several small tears but was otherwise in good condition. The lower seat frame was severely distorted, and the forward left mounting point had separated from the frame.

The radar evidence suggests the aircraft struck the water with a high rate of descent. The damage to the retrieved seat suggests the aircraft was subjected to considerable forces and substantial disruption. It is therefore unlikely that the occupants had any opportunity to escape from the aircraft.

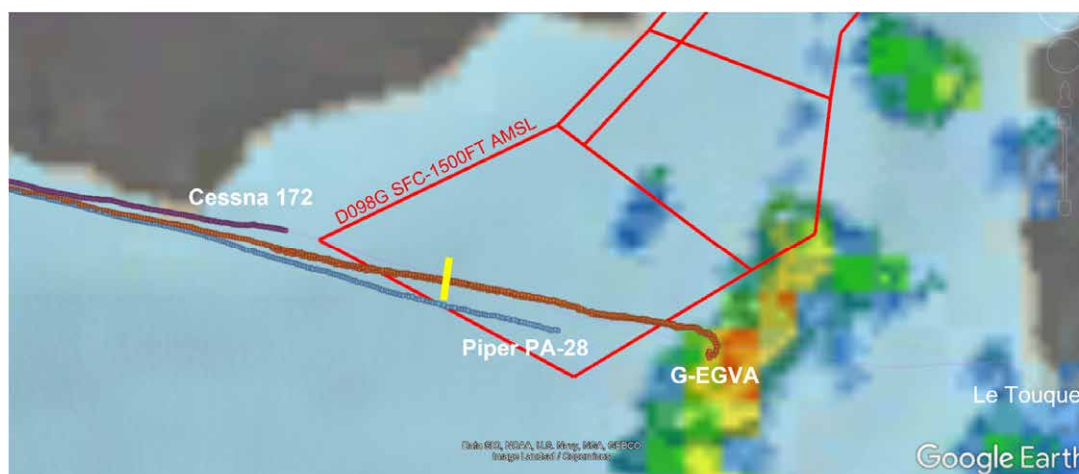
**Figure 15**

Figure 15 shows the radar track of G-EGVA and the two following aircraft overlaid on the 0900 hrs weather radar image.

Aircraft tracks at 0916 hrs overlaid on the 0900 hrs weather radar image (the Danger Area described in the NOTAM is shown in red outline).  
The yellow line on G-EGVA's track is the point at which G-EGVA descended from its cruise altitude
