Near miss with track workers at Paddington, London, 18 July 2022

Summary of the incident

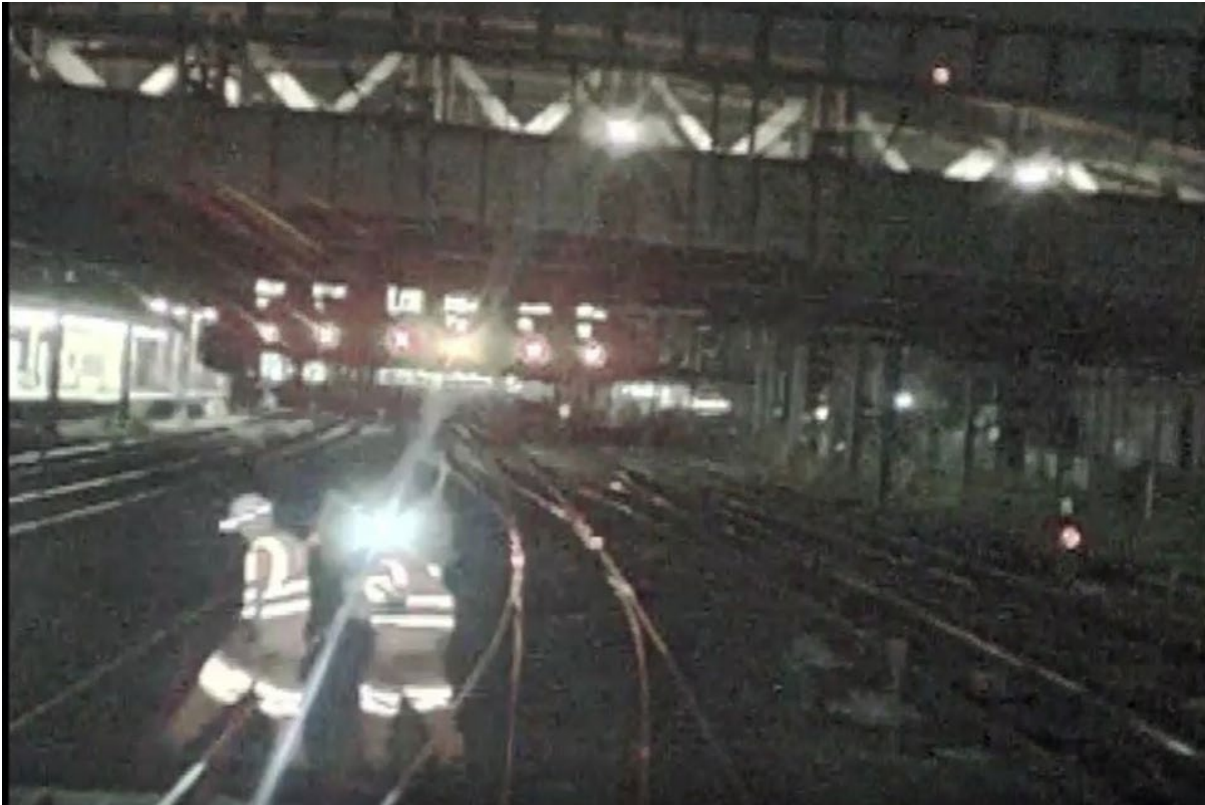
At around 01:17 hrs on 18 July 2022, a passenger train entering London Paddington station while travelling at 24 mph (39 km/h) narrowly missed two track workers. The two track workers were walking very close to the line that the train was travelling on and with their backs to the approaching train. In response to the train's second audible warning, they acknowledged its approach and moved clear of the train's path between one and two seconds before it reached their location.

Forward-facing CCTV showing the two track workers moving clear of the train (courtesy of Great Western Railway).

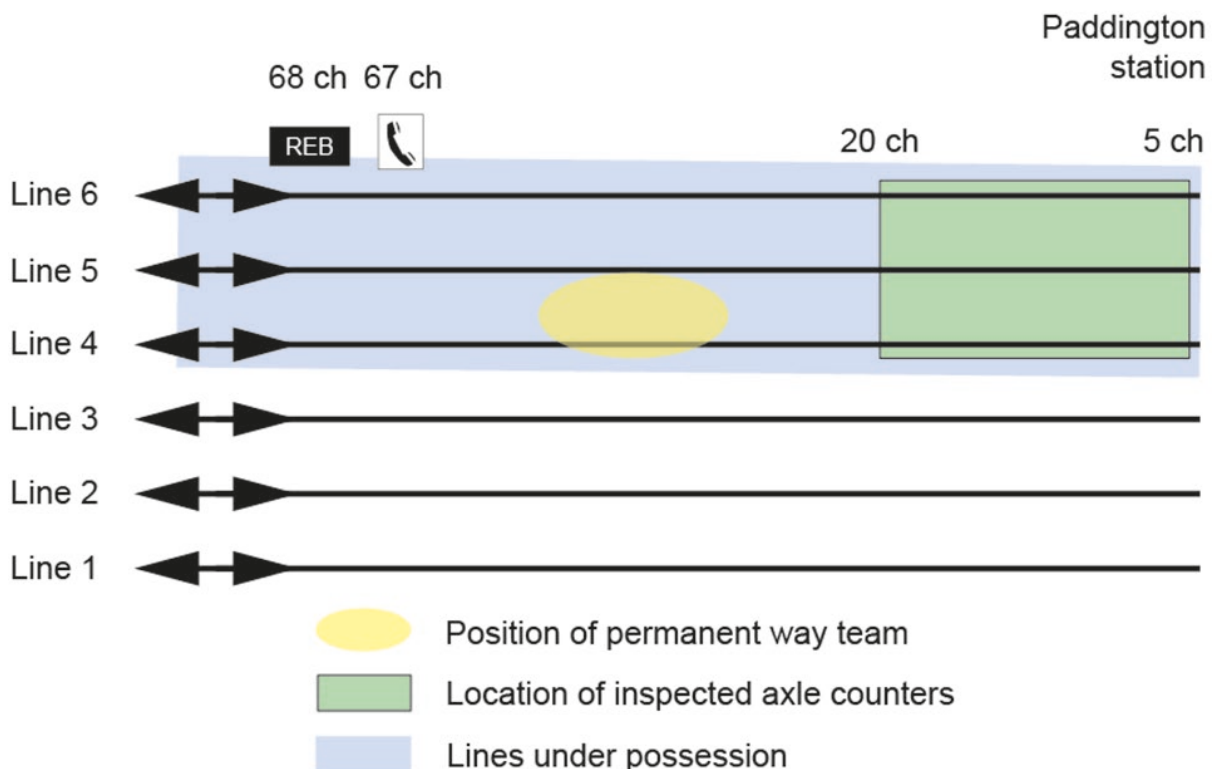
At around 00:35 hrs on 18 July, the S&T team entered the track from platform 10 at Paddington station and inspected axle counters on lines 4, 5 and 6, up to 15 chains (0.2 miles or 0.3 km) west of the station. This was the maintenance work originally assigned to the first of the two S&T teams. The work was undertaken within a separated safe system of work. This was arranged with the lines the team were working on (lines 4, 5 and 6) blocked under the possession but with the adjacent lines (1, 2 and 3) open to traffic.

Track layout and features of interest (not to scale and not all features shown).

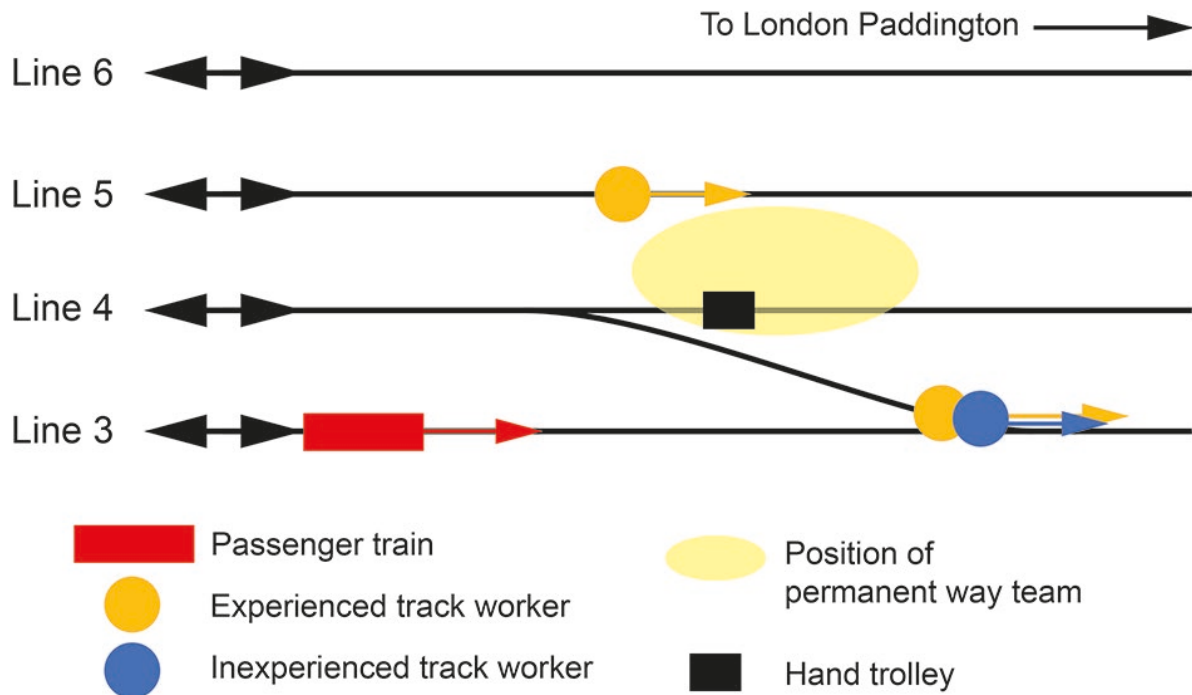
After the PIC/COSS had left them, the three members of the group completed the maintenance of the signal post telephone and began walking back towards Paddington station. One track worker walked in the four-foot (the space between the rails) of line 5, while the other two walked in the four-foot of line 4, as they found that underfoot conditions were better there. Around 47 chains (0.6 miles or 1.0 km) from Paddington station, the group encountered a six-person permanent way team who were also working in the possession and who had placed a hand trolley on line 4. At this point, the inexperienced track worker (wearing a blue helmet) was walking in front of the more experienced members of the team. One of these team members was close behind him on line 4 and the other was around 20 metres behind, on line 5.

Track layout (not to scale and not all features shown).

As the two track workers on line 4 approached the trolley, they stepped out into the crossover between lines 4 and 3. The inexperienced track worker stated that he was aware that line 3 was open to approaching traffic but had decided to walk between the lines because it was an easier route. The experienced track worker reported that he had inadvertently followed the inexperienced worker due to a loss of concentration. Both workers continued to walk in the crossover for around 10 metres unaware that 2P97 was now approaching on line 3. It is unclear why the track workers continued to walk in the crossover after passing the trolley, rather than returning to the lines which had been blocked.
