## ACCIDENT

<b>Aircraft Type and Registration:</b>	Luscombe 8E, G-BSYF	
<b>No &amp; Type of Engines:</b>	1 Continental Motors Corp C85-12 piston engine	
<b>Year of Manufacture:</b>	1946 (Serial no: 3455)	
<b>Date &amp; Time (UTC):</b>	23 July 2022 at 1200 hrs	
<b>Location:</b>	Near East Winch, Kings Lynn, Norfolk	
<b>Type of Flight:</b>	Private	
<b>Persons on Board:</b>	Crew - 1	Passengers - None
<b>Injuries:</b>	Crew - None	Passengers - N/A
<b>Nature of Damage:</b>	Extensive damage to the airframe and shock loading to the engine	
<b>Commander's Licence:</b>	Light Aircraft Pilot's Licence	
<b>Commander's Age:</b>	59 years	
<b>Commander's Flying Experience:</b>	1,051 hours (of which 142 were on type) Last 90 days - 2 hours Last 28 days - 2 hours	
<b>Information Source:</b>	Aircraft Accident Report Form submitted by the pilot

## Synopsis

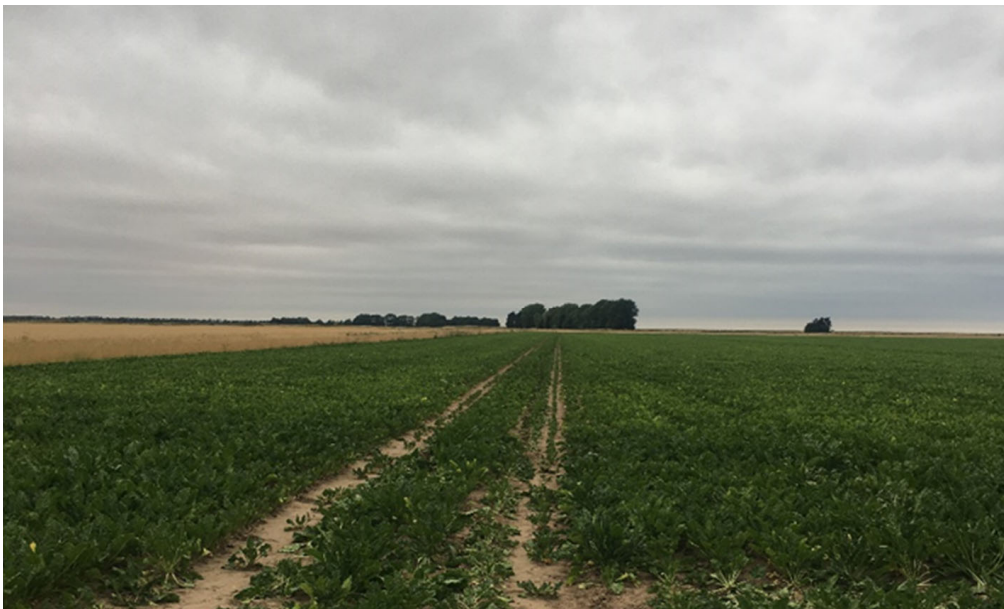
**Figure 1**

Accident field showing the tracks used by the pilot and the sugar beet crop  
(used with permission)

Whilst there are no regulations on the minimum width of a strip to be used for takeoff, the guidance suggested a minimum width of 18 m to allow for the pilot to make directional control adjustments during the takeoff or landing without leaving the designated runway. The two tracks used by the pilot in the field were each less than one metre wide with almost no margin for error or correction.

The CAA also provide Safety Sense Leaflet 12: ‘Strip Flying’<sup>2</sup>, which is intended to assist pilots in thinking about safety in flying to and from strips. It states that grass height should be not more than 30% of the diameter of the aircraft’s main wheels and ideally shorter. The height of the sugar beet crop was not measured by the pilot, but pictures of the accident site showed that parts of the crop were probably around the same diameter as the main wheels.

The area used by the pilot in attempting to take off was significantly narrower than the recommended 18 m runway width from CAP793. The wheel tracks were less than one metre wide and did not allow for any margin in directional control. The pilot was unable to remain within the very narrow takeoff tracks in the field during the aborted takeoff. A combination of braking and leaving those tracks resulted in the aircraft nosing over and coming to rest inverted.
