## Accident

<b>Aircraft Type and Registration:</b>	Jabiru UL-430, G-RUFS
<b>No &amp; Type of Engines:</b>	1 Jabiru 2200A piston engine
<b>Year of Manufacture:</b>	1999 (Serial no: PFA 274A-13359)
<b>Date &amp; Time (UTC):</b>	13 August 2022 at 1350 hrs
<b>Location:</b>	Lower Upham Airfield, Wiltshire <sup>1</sup>
<b>Type of Flight:</b>	Private
<b>Persons on Board:</b>	Crew – 1                      Passengers - 1
<b>Injuries:</b>	Crew - 1 (Serious)      Passengers - 1 (Serious)
<b>Nature of Damage:</b>	Aircraft substantially damaged
<b>Commander's Licence:</b>	National Private Pilot's Licence
<b>Commander's Age:</b>	55 years
<b>Commander's Flying Experience:</b>	1,449 hours (of which 824 were on type) Last 90 days - 21 hours Last 28 days - 9 hours
<b>Information Source:</b>	Aircraft Accident Report Form submitted by the pilot and further enquiries by the AAIB

## Synopsis

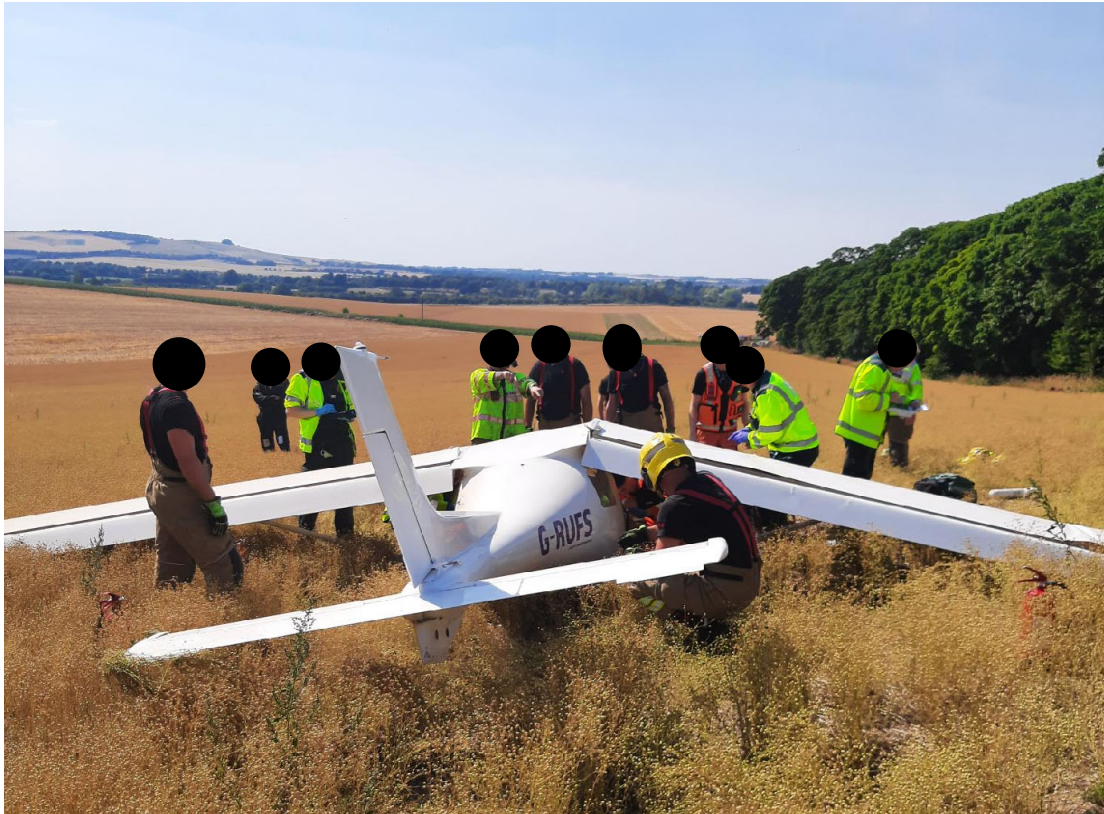
**Figure 1**

G-RUFS after the accident with the runway in the distance ahead of the aircraft. The aircraft is facing in the opposite direction to its flightpath before impact

Figure 1 shows the aircraft after the accident, facing in the opposite direction to its flightpath before impact. The runway can be seen in the distance with the trees the aircraft collided with shown in the right of the image.

The police who attended the scene reported there were ground impact marks approximately 10 m from where the aircraft came to rest.

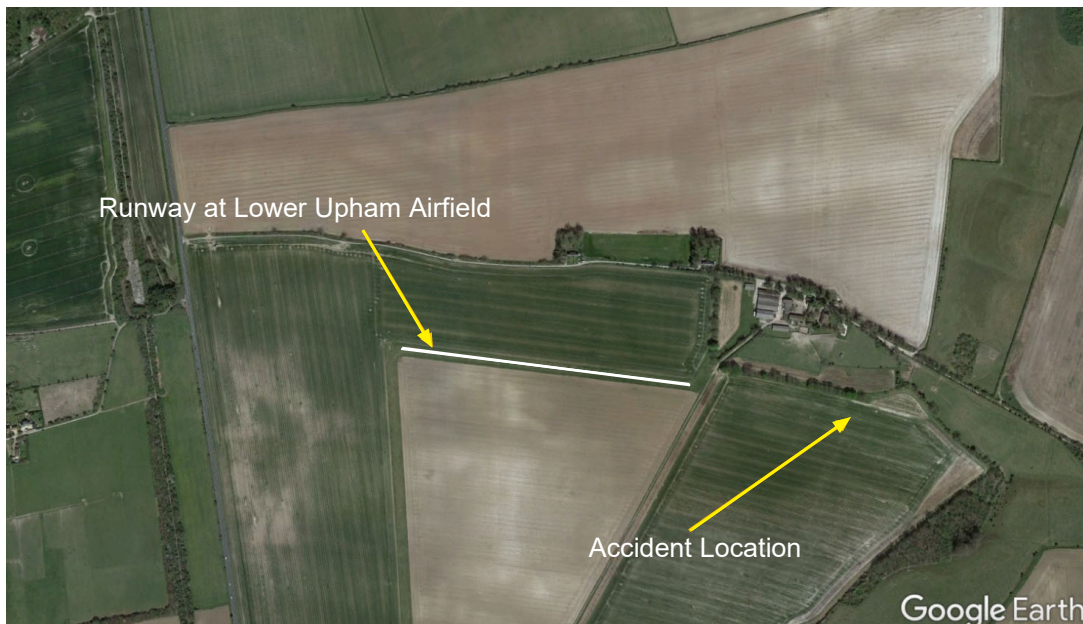
**Figure 2**

Aerial View of Lower Upham Airfield (runway highlighted with a white line)

The grass runway at Lower Upham is approximately 550 m long and is 560 ft above mean sea level (Figure 2). The runway is orientated roughly east west and slopes up from the west to the east. The accident location elevation is 80 ft higher than the threshold of the easterly runway.
