ACCIDENT

Aircraft Type and Registration:	Zenair CH 601UL, G-CDAL	
No & Type of Engines:	1 Rotax 912-S piston engine	
Year of Manufacture:	2004 (Serial no: PFA 162A-14195)	
Date & Time (UTC):	1 August 2022 at 1050 hrs	
Location:	Field northwest of Kinglassie, near Fife Airport	
Type of Flight:	Private	
Persons on Board:	Crew - 1	Passengers - None
Injuries:	Crew - 1 (Minor)	Passengers - N/A
Nature of Damage:	Significant damage to fuselage, wings, propeller, canopy, and undercarriage	
Commander's Licence:	National Private Pilot's Licence	
Commander's Age:	70 years	
Commander's Flying Experience:	828 hours (of which 45 were on type) Last 90 days - 18 hours Last 28 days - 5 hours	
Information Source:	Aircraft Accident Report Form submitted by the pilot

Synopsis

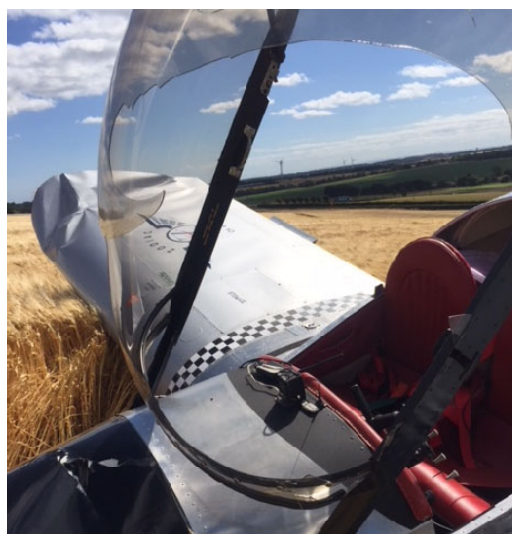
Figure 2

While the right side of the canopy transparency was largely intact, the left side was broken and a large section of it was missing (Figure 2).

G-CDAL's broken canopy

Given the damage to the left cockpit sill, the pilot considered it possible that the loud bang and inrush of air could have resulted from the canopy fragmenting due to torsion as the right side of its frame lifted while the left latch remained engaged.

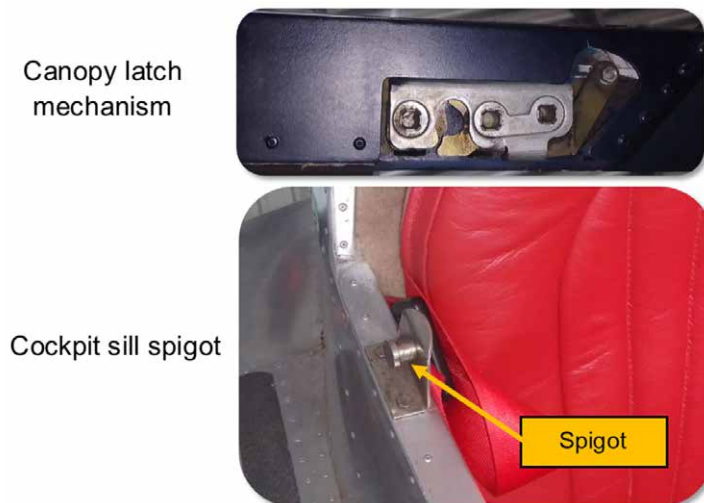
Figure 3

G-CDAL has a one-piece canopy, hinged at the front of the canopy frame. Independent latching mechanisms to secure the canopy for flight are located toward the rear of the canopy frame on each side of the cockpit. These latches engage automatically in corresponding spigots on the cockpit sills when the canopy is closed (Figure 3).

Latch components on canopy frame and cockpit sill

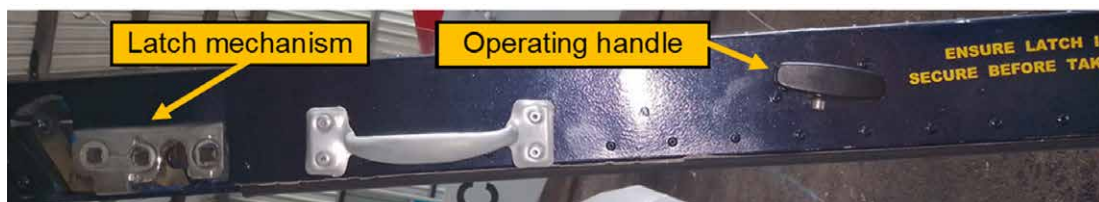
Figure 4

Handles located on each side of the canopy frame are connected to their respective latch mechanism and are used when exiting the aircraft to release the latches, thereby allowing the canopy to be opened (Figure 4).

Left side of canopy frame showing latch mechanism and operating handle

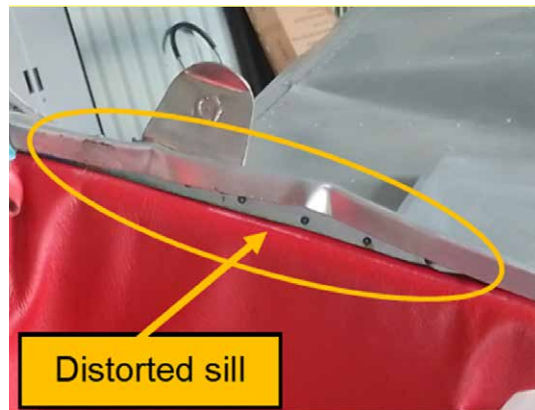
Figure 5
Left cockpit sill

A post-accident examination did not reveal faults with either latch mechanism but the left cockpit sill was distorted near the latch spigot bracket, as highlighted in Figure 5.

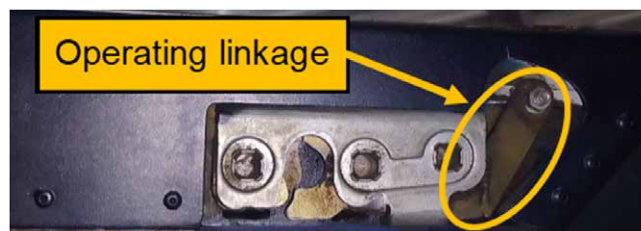
Figure 6
Latch operating linkage

During his post-accident inspection of the canopy mechanism, the pilot found that pushing up on the latch operating linkage (Figure 6) would release the catch independent of the canopy latch operating handle. He also determined that if the linkage was fouled while the canopy was being closed it could prevent the latch jaws from closing correctly around the spigot.

Having found no fault with the canopy latching mechanisms, the pilot concluded that the most likely cause of the accident was the right canopy latch not being fully engaged around its corresponding spigot thereby allowing the canopy to lift up as air loads increased. He surmised that the latch operating linkage had probably been fouled when the canopy was initially lowered, thus preventing the latch's jaws from closing correctly around the spigot.

The pilot reflected that, if one had been available, a secondary canopy locking mechanism might have prevented the uncommanded canopy opening and subsequent accident.
