ACCIDENT

Aircraft Type and Registration:	Avy Aera 1.5	
No & Type of Engines:	5 Electric motors	
Year of Manufacture:	2021 (Serial no: 007)	
Date & Time (UTC):	6 May 2022 at 1225 hrs	
Location:	Lamlash, Isle of Arran	
Type of Flight:	Private	
Persons on Board:	Crew - N/A	Passengers - N/A
Injuries:	Crew - N/A	Passengers - N/A
Nature of Damage:	Damage to lift motor boom, fuselage and landing gear	
Commander's Licence:	Other	
Commander's Age:	34 years	
Commander's Flying Experience:	1,784 hours (of which 75 were on type) Last 90 days - 12 hours Last 28 days - 5 hours	
Information Source:	Aircraft Accident Report Form submitted by the pilot and further enquiries made by the AAIB

Synopsis

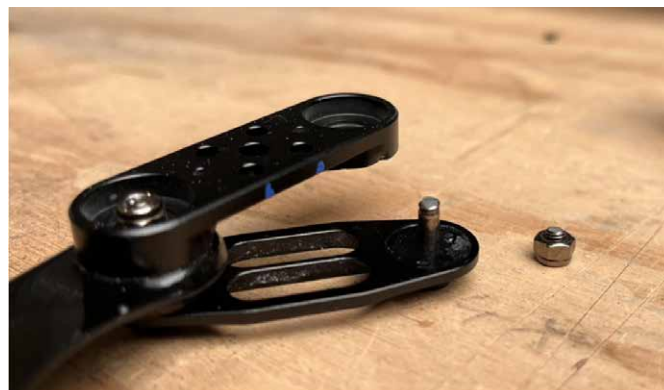
Examination of the UA after the accident found that a blade of one of the lift propellers had detached from its hub in flight. The nut and bolt which held the blade in position had failed near the interface of the plain shank and threaded portion of the bolt. The threaded portion had remained within the stiff nut. The failure of the bolt had allowed the upper and bottom hub plates to separate and open out releasing the blade. Figure 4 shows the failed bolt with its nut and separated hub plates.

Separated hub plates and failed bolt. (The hub is shown inverted)
(image courtesy of the manufacturer)

The manufacturer carried out a metallurgical examination of the M3 bolt and concluded that it had failed due to fatigue within the threaded portion under the nut. Further investigation, which included test running of example propellers, identified the probable causes of the fatigue failure of the bolt to lie with the design of the propeller and the loads they encounter in flight.

It was found that design features of the hub plates and blades could lead to a backlash between the blade boss and the bolt. This in turn can result in vibrations when the propeller is rotating. Results of the testing suggested that these vibrations lead to cyclical loads which manifest themselves as shear and bending loads in the bolt. In addition, it was also found that the failed propeller hub assembly stop pin groove was damaged and showed evidence of fretting on the underside of the blade boss (Figure 5).

The manufacturer has introduced a 10-hour replacement schedule for the propellers and immediate propeller replacement if a Quadchute¹ event occurs.

The manufacturer is carrying out a review of propeller designs for UAs under its development.

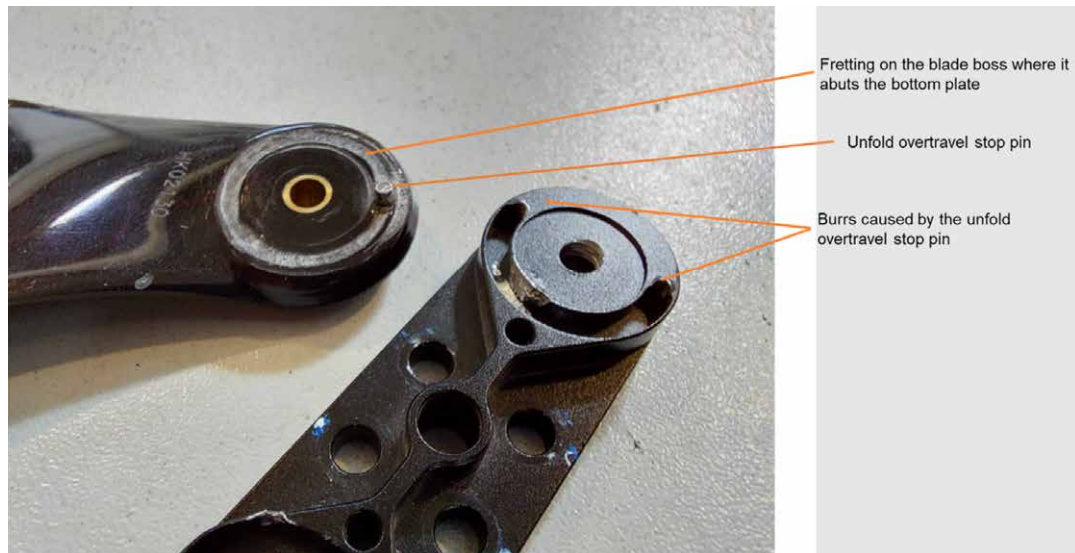
Figure 5

Fretting on the blade boss and damage to the ends of the stop pin groove
(image courtesy of the manufacturer)

It is possible that the damage to the stop pin and groove increased the risk of backlash within the assembly, thereby exacerbating the cyclical loads on the bolt.
