CONTENTS**SPECIAL BULLETINS / INTERIM REPORTS**

Boeing 787-8	G-ZBJB	18-Jun-21	3
--------------	--------	-----------	---

Boeing A75N1(PT17) Stearman	N707TJ	4-Sept-21	37
Piper PA-28R-200-2	G-EGVA	2-Apr-22	56

Aircraft Type and Registration:	Boeing 787-8, G-ZBJB	
No & Type of Engines:	2 Rolls-Royce Trent 1000-AE3 turbofan engines	
Year of Manufacture:	2013 (Serial no: 38610)	
Date & Time (UTC):	18 June 2021 at 0651 hrs	
Location:	London Heathrow Airport Stand 583	
Type of Flight:	Commercial Air Transport (Cargo)	
Persons on Board:	Crew - 2	Passengers - None Other - 6
Injuries:	Crew - 1 (Minor)	Passengers - N/A Other - 1 (Minor)
Nature of Damage:	Underside of forward fuselage, door 2L and forward lower engines cowlings damaged	
Commander's Licence:	Airline Transport Pilot's Licence	
Commander's Age:	47 years	
Commander's Flying Experience:	8,364 hours (of which 587 were on type) Last 90 days - 26 hours Last 28 days - 0 hours	
Information Source:	AAIB Field Investigation

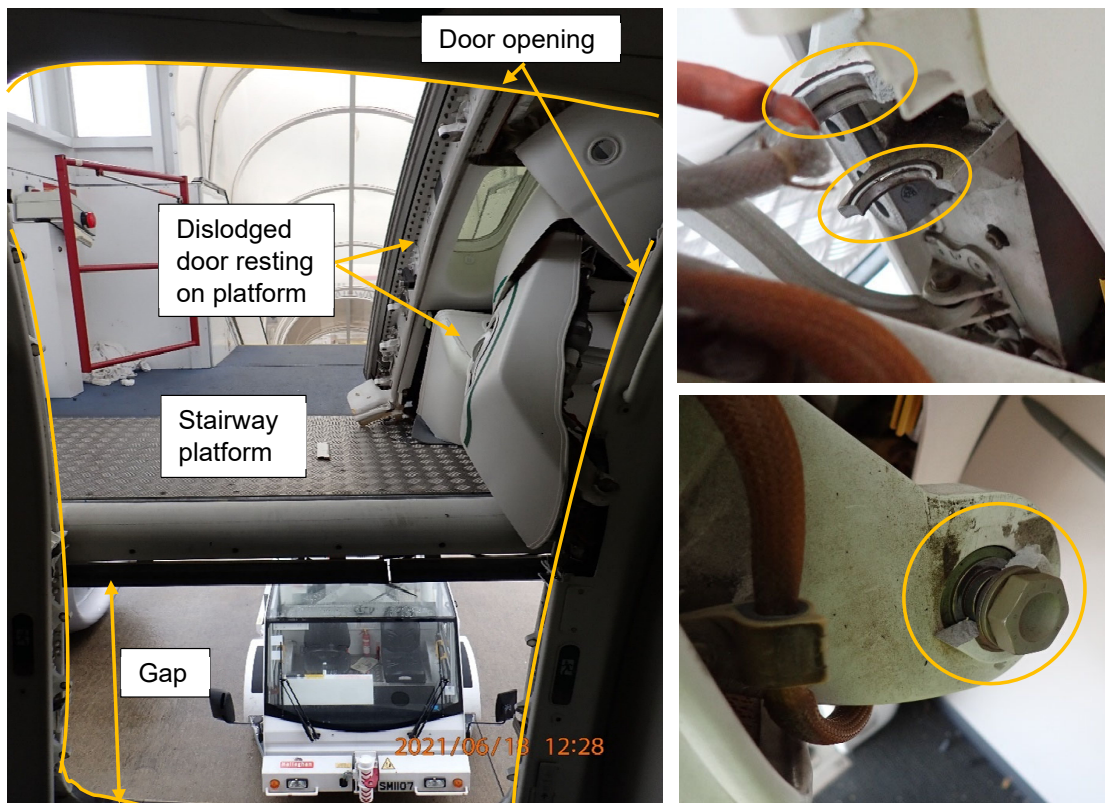
Figure 5

The airport RFFS arrived and entered the aircraft through the L2 door which had been extensively damaged by contact with the access stairs when the NLG retracted. The RFFS suggested that all on board should vacate through the L2 door but due to safety concerns related to the escape slide in the damaged door, the commander suggested that R1 was used when additional steps arrived.

View from inside the aircraft showing the door resting on staircase and disrupted door hinges

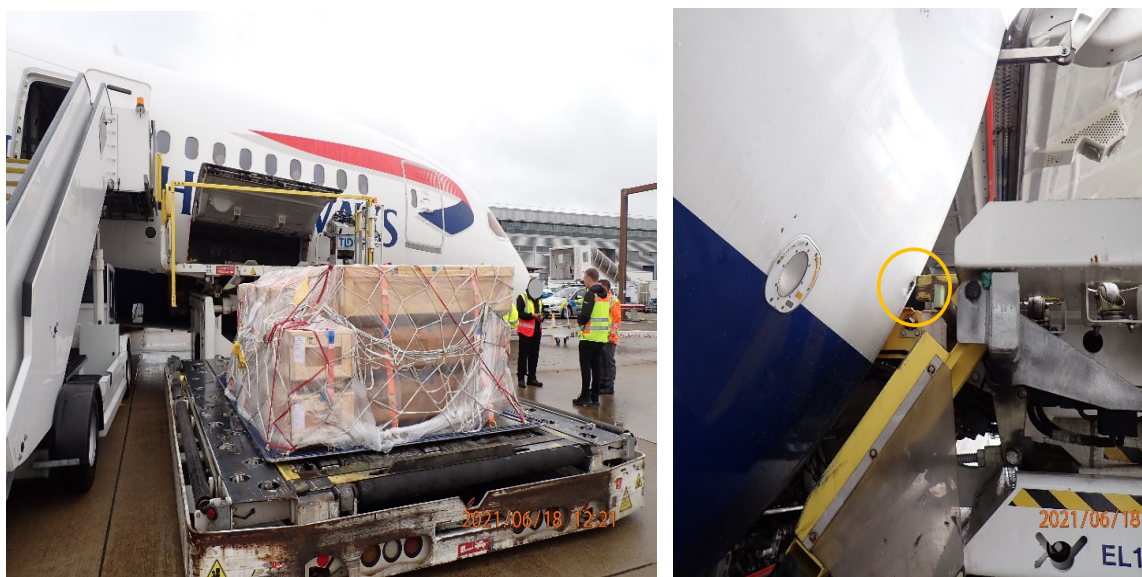
Figure 6

On the right side of the aircraft was an access stairway that had been positioned at door R2 to allow safe access to the aircraft after the accident. At the forward cargo door was the ULD Loader for raising cargo pallets to the height of the aircraft cargo hold and transferring them to the aircraft. There was slight damage to the aft vertical cargo door frame caused by

contact with the ULD Loader when the aircraft nose lowered to the ground (Figure 6). The rear cargo door was also open but there was no ground support equipment at that location.

ULD Loader (left) and impact damage to aft side of cargo door frame (right)

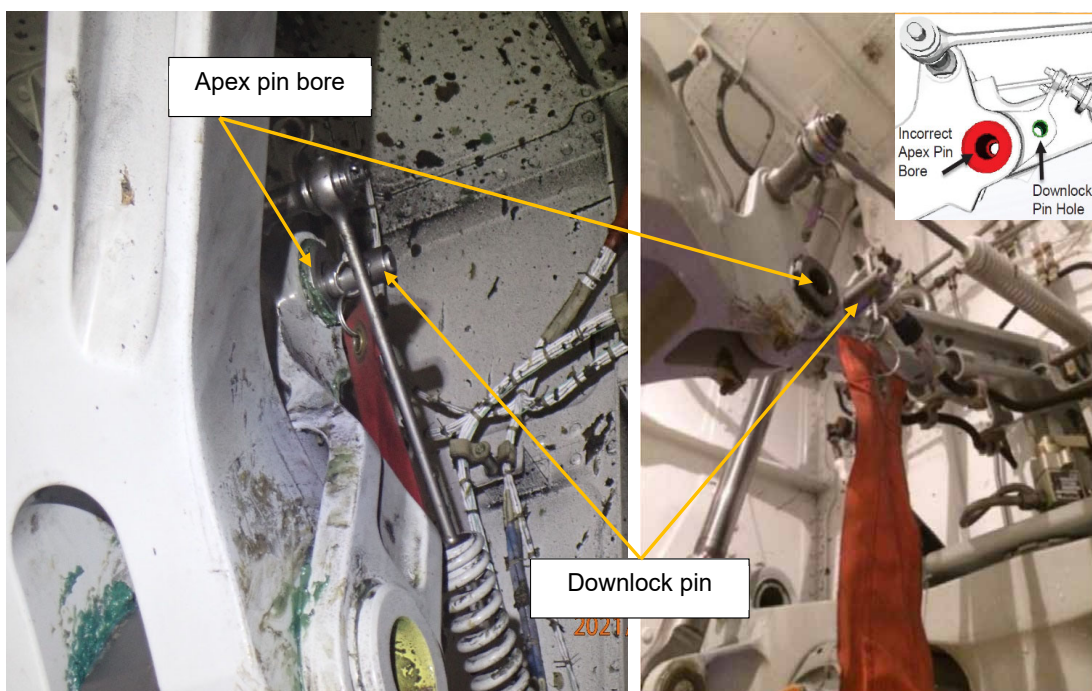
Figure 9

When the NLG bay was accessed, the NLG downlock pin was found to be in the leg's apex bore hole rather than the downlock pin hole (Figure 9). The downlock pin was transferred to the correct position to lock the gear down and to allow the inflatable mats to be removed so the aircraft could be towed to a suitable quarantine hangar.

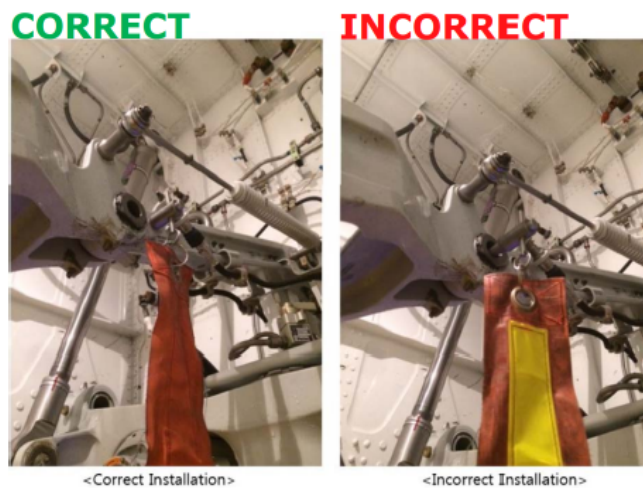
Please ensure that the NLG downlock pins are always installed in the correct location IAW the AMM. The correct and incorrect locations are shown below for reference.

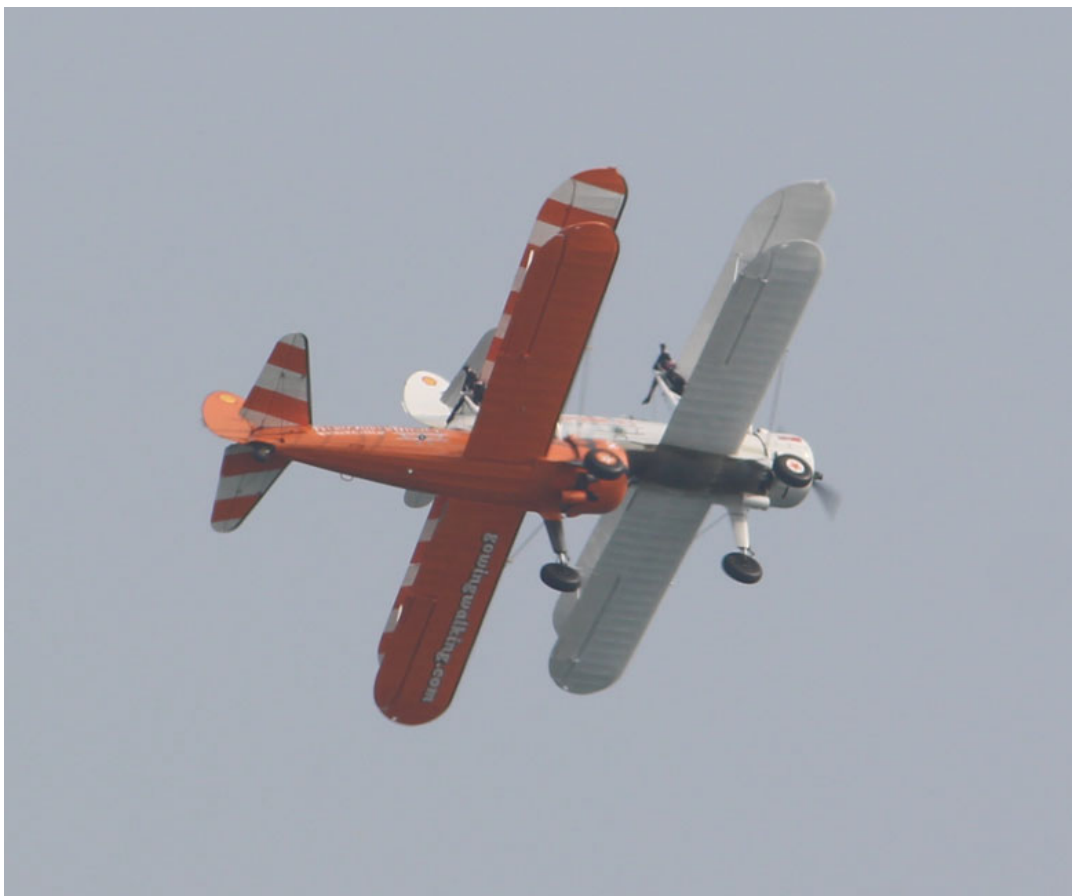
Figure 3

Photographs and videos taken during the accident flight on 4 September 2021 show heavy oil staining on the underside of N707TJ's fuselage aft of the engine cowling (Figure 3) and lighter oil staining on the upper fuselage, aft of the rear cockpit. Photographs taken the previous day during and at the end of the display showed no oil staining present.

Oil staining on underside of N707TJ (white aircraft) fuselage during accident flight

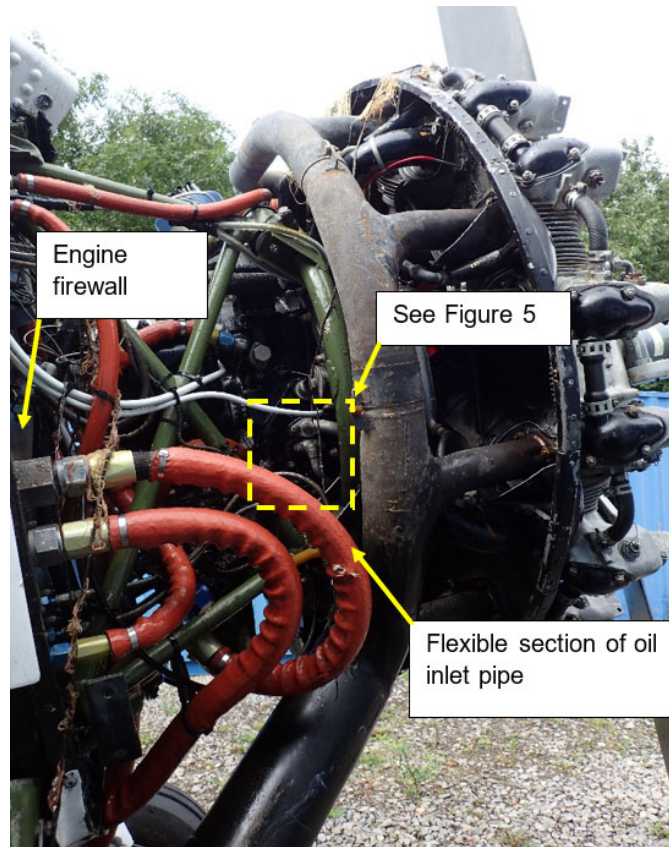
Figure 4

Visual examination of the engine revealed that the oil inlet pipe was broken at the point where it attached to the engine casing (Figures 4 and 5). The rigid section of pipe had fractured at the mounting boss and the support strap had fractured at a fastener hole. An area of damage was evident on the flexible section of pipe, but this was limited to a tear in the fire-retardant sleeve on the pipe and the inner pipe was intact at this location. This damage may have occurred during recovery of the aircraft from the water, as the engine cowlings which would normally protect this part of the engine bay were no longer present.

N707TJ's engine viewed from right side showing oil inlet pipe

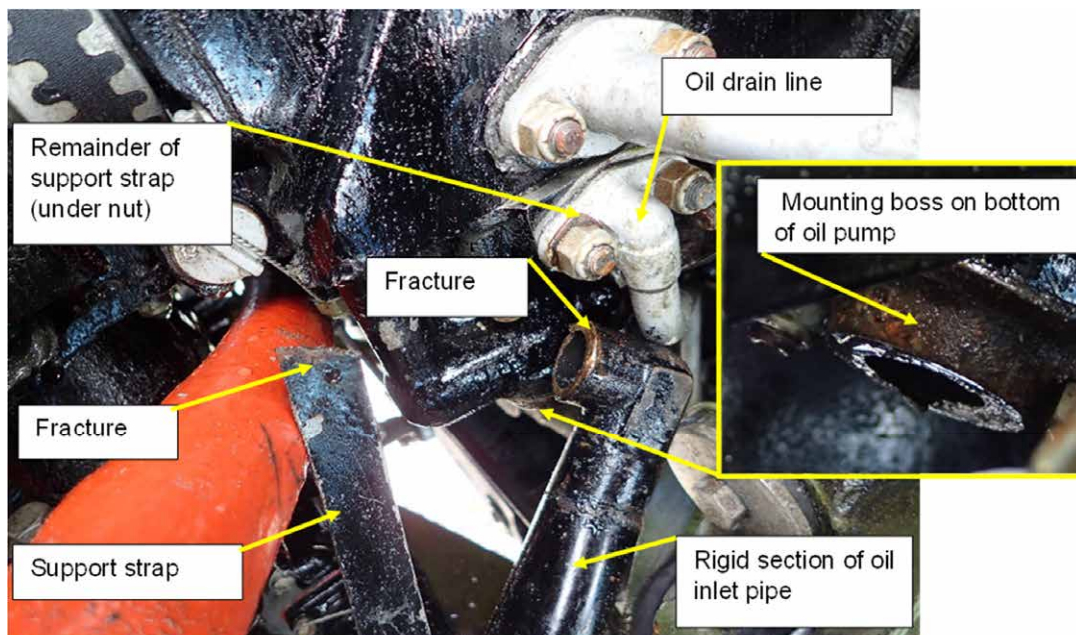
Figure 5

Fractured oil inlet pipe and support strap

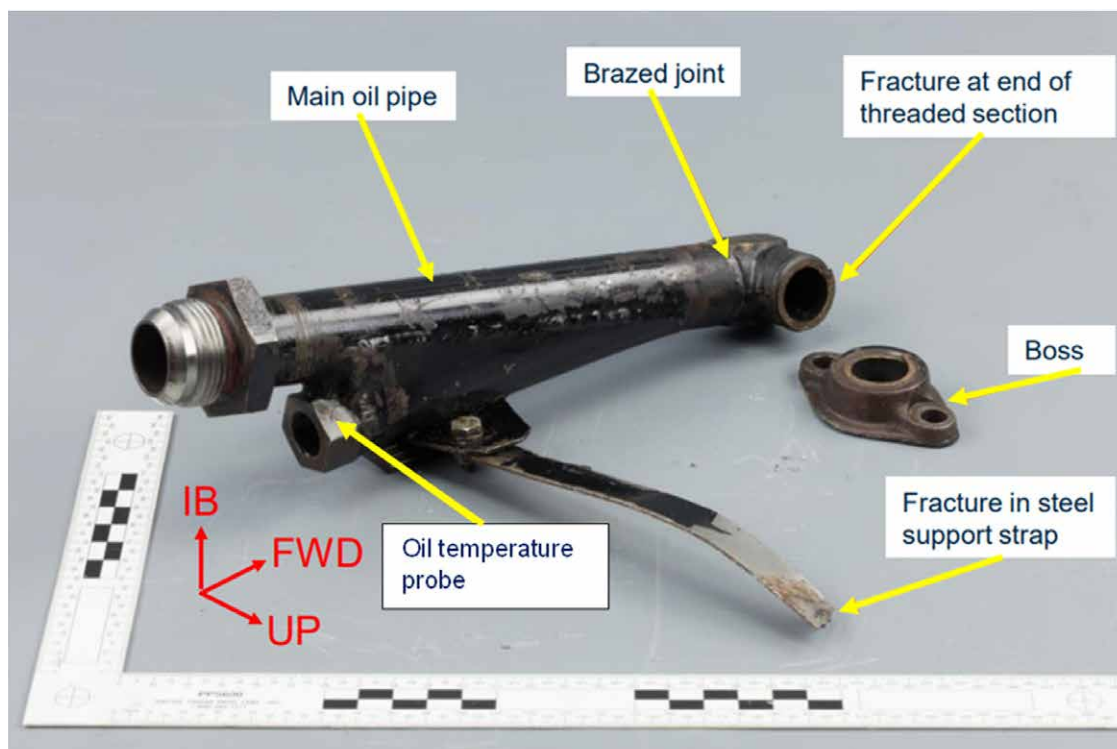
Figure 6

Failure had occurred at a fastener hole in the support strap and on the threaded section of pipe that connected to the mounting boss. Part of the threaded joint remained inside the mounting boss (Figure 6). The support strap and main oil pipe were made from steel. The right-angled threaded end piece of the oil pipe which had fractured was made from a leaded gunmetal casting. It appeared that the gunmetal end fitting had been brazed to the steel pipe.

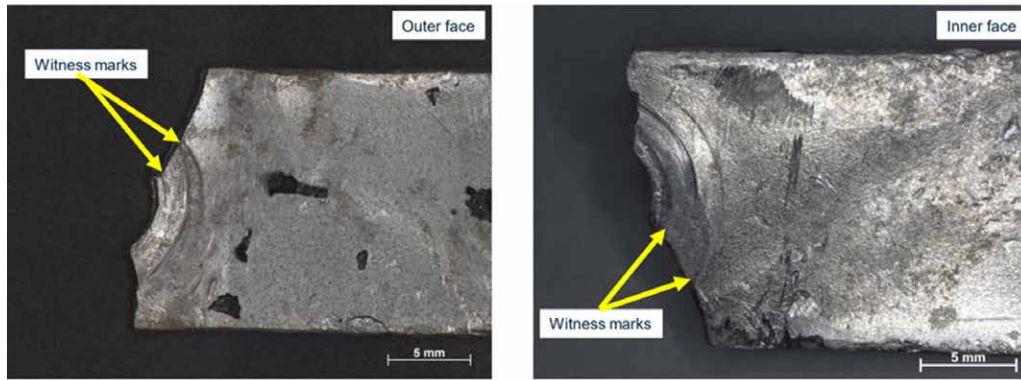
Figure 7

Visual examination of the support strap at the fracture location showed evidence of mechanical damage (witness marks) around the fastener hole on both sides of the strap (Figure 7). The witness marks were circular in shape and consistent with a nut (possibly in combination with a washer) having been over-tightened. No washer was present when the aircraft was examined.

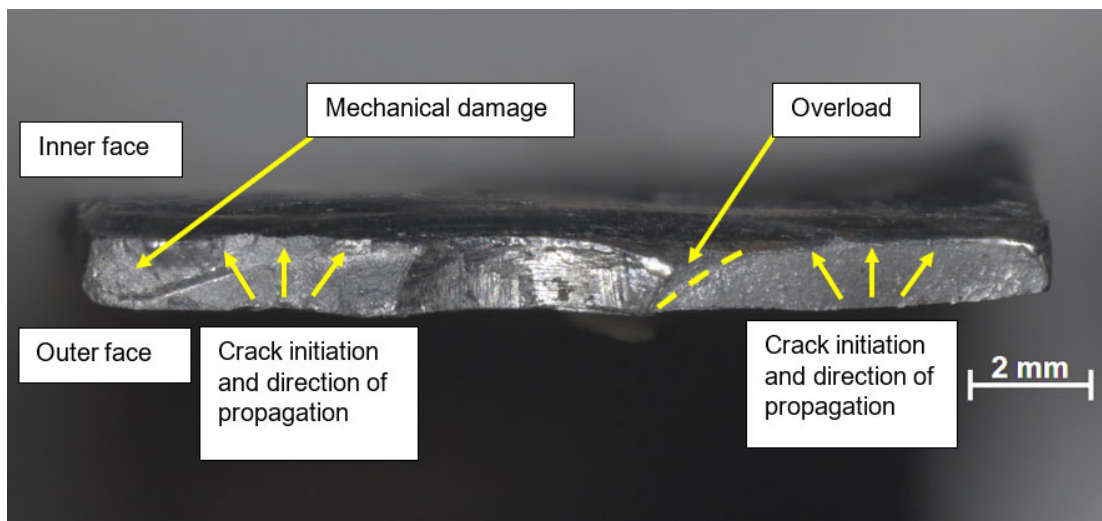
Figure 8

Scanning electron microscope (SEM) examination of the fracture surface showed extensive corrosion. After cleaning to remove the corrosion, fatigue striations were observed across most of the fracture surface on both sides of the fastener hole. The fatigue initiated within the mechanical damage around the fastener hole on the outer face of the support strap and propagated towards the inner face. A small amount of overload was observed at the right edge of the fastener hole on the inner face. The end of the fatigue crack on the left side of the fastener hole had been destroyed by mechanical damage (Figure 8).

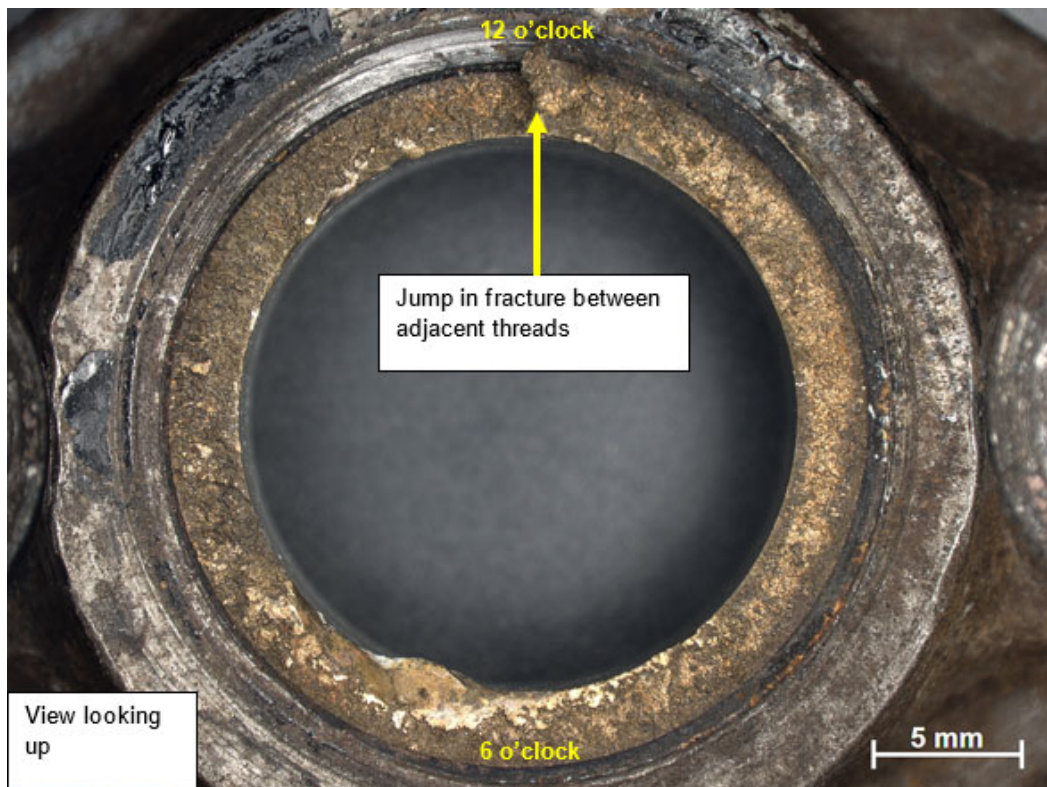
Figure 9

A step was evident in the fracture surface at the 12 o'clock position (Figure 9). In threaded components, this usually occurs at the last part to fracture. This suggests that crack initiation is likely to have occurred opposite to this (around the 6 o'clock position), with the crack propagating clockwise and anticlockwise around the helical thread. At the 12 o'clock position the crack jumped between adjacent threads to form a continuous crack. An area of mechanical damage/smearing was also evident on the fracture surface. A corresponding area of damage on the opposing fracture face indicated that this likely occurred as a result of relative movement between the two fracture faces during or after the final failure.

Fracture surface of the oil pipe at root of thread

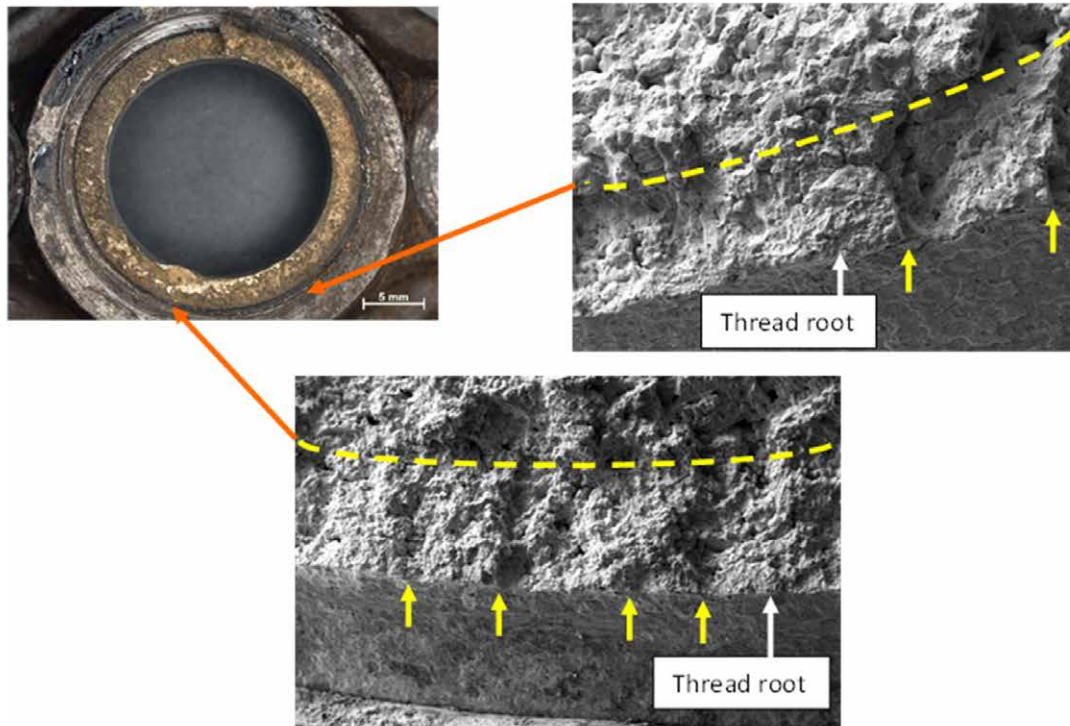
Figure 10

Between the 4 o'clock and 7 o'clock positions on the fracture surface, a band approximately 0.3 mm deep that contained ratchet marks was observed at the edge of the thread root. This band is identified by yellow dashed lines in Figure 10, and the ratchet marks as yellow arrows.

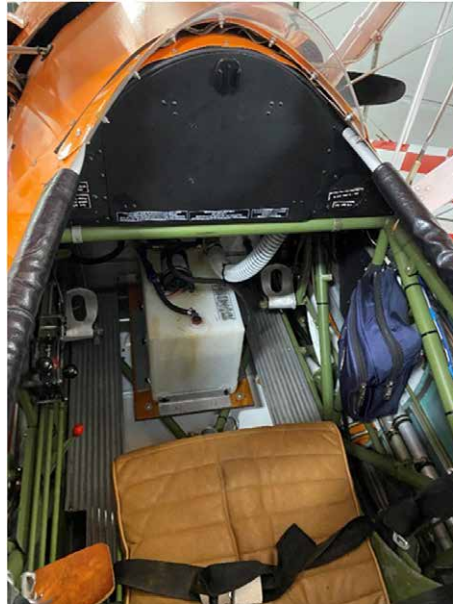
Figure 13

While there was padding around the sides of the cockpit, there was no padding on the coaming to provide head protection for the occupant (Figure 13). The operator explained that with the seat harnesses correctly tightened, it is not possible for the head to hit the coming or instrument panel.

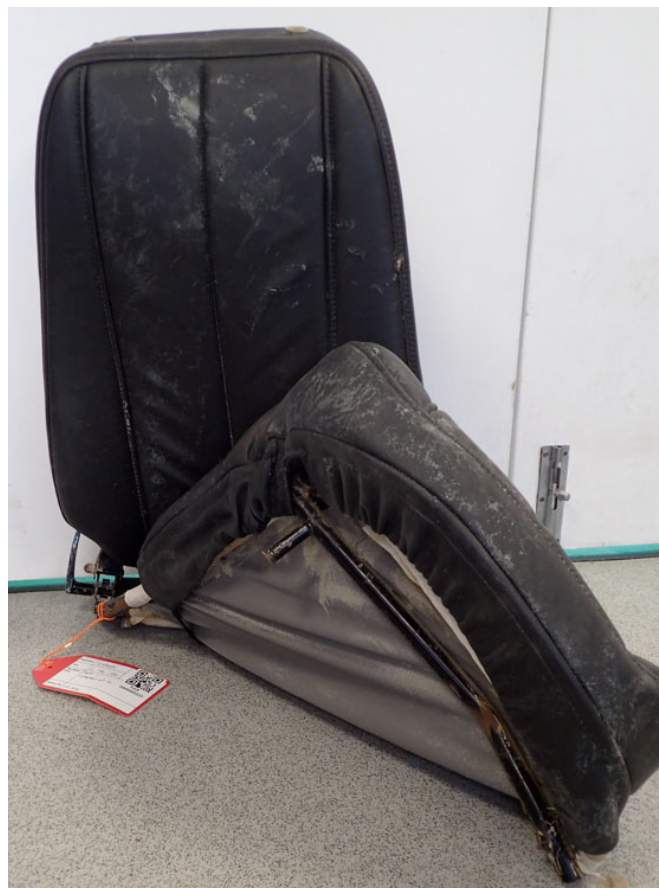
The seat cover exhibited minor scuffing and several small tears but was otherwise in good condition. The lower seat frame was severely distorted, and the forward left mounting point had separated from the frame.

Figure 10
Seat recovered from G-EGVA

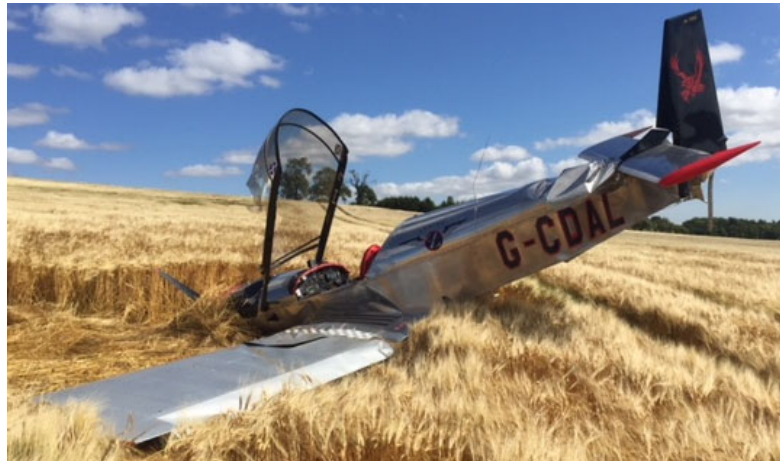
Figure 1

attributed the noise and increased airflow to the canopy having subsequently lifted on his side of the cockpit. The insecure canopy generated a significant amount of extra drag and the pilot had difficulty controlling the aircraft. He reduced power and landed ahead in a field of barley. The fully-grown crop caught the wings and undercarriage, causing a rapid deceleration and loss of directional control which resulted in significant damage to the aircraft (Figure 1).

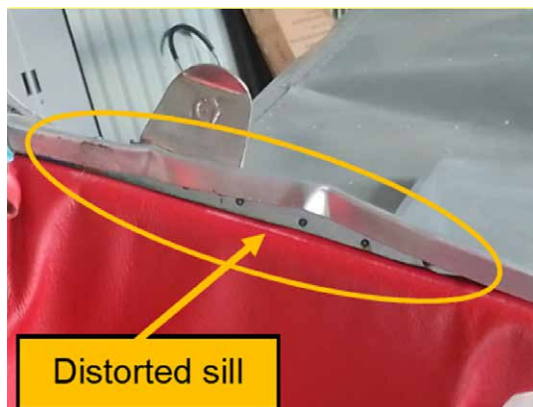
A post-accident examination did not reveal faults with either latch mechanism but the left cockpit sill was distorted near the latch spigot bracket, as highlighted in Figure 5.

Figure 5
Left cockpit sill

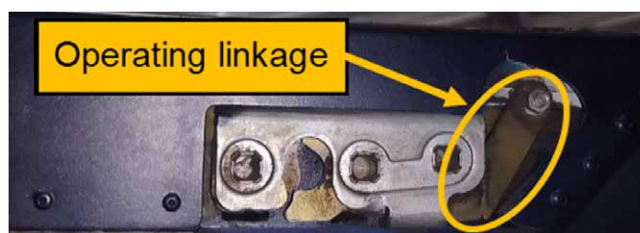
During his post-accident inspection of the canopy mechanism, the pilot found that pushing up on the latch operating linkage (Figure 6) would release the catch independent of the canopy latch operating handle. He also determined that if the linkage was fouled while the canopy was being closed it could prevent the latch jaws from closing correctly around the spigot.

Figure 6
Latch operating linkage
