ACCIDENT

Aircraft Type and Registration:	Evolve Dynamics Sky Mantis	
No & Type of Engines:	4 electric motors	
Year of Manufacture:	2020 (Serial no: ED-SKM-2020-08-030)	
Date & Time (UTC):	25 July 2022 at 1300 hrs	
Location:	St Albans, Hertfordshire	
Type of Flight:	Commercial Operations (UAS)	
Persons on Board:	Crew - N/A	Passengers - N/A
Injuries:	Crew - N/A	Passengers - N/A
Nature of Damage:	Aircraft destroyed	
Commander's Licence:	Other	
Commander's Age:	52 years	
Commander's Flying Experience:	20 hours (of which 8 were on type) Last 90 days - 3 hours Last 28 days - 0 hours	
Information Source:	Aircraft Accident Report Form submitted by the pilot

Synopsis

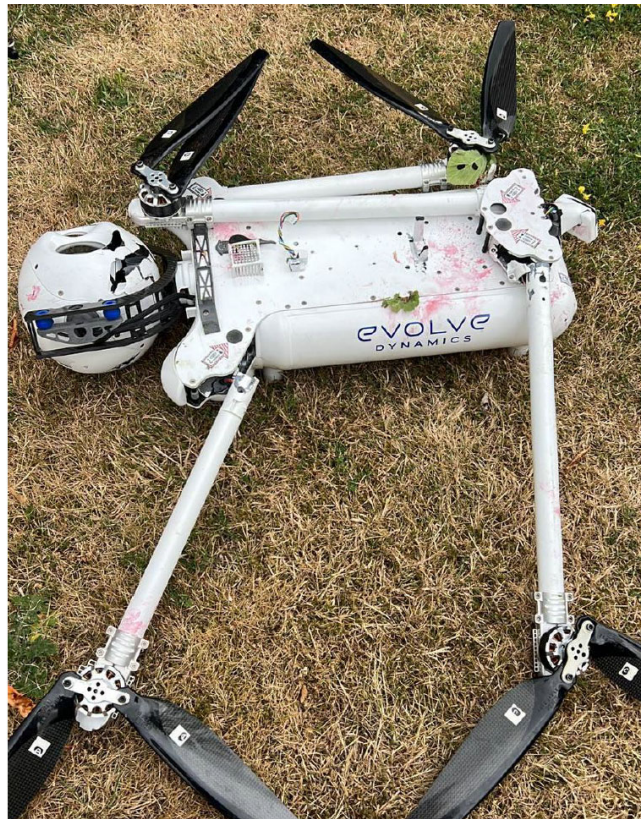
Figure 1

The Evolve Dynamics Sky Mantis UAS was being operated in support of emergency services that were tackling a building fire in St Albans. The UA had successfully completed two flights at the site and was about 13 minutes into its third flight when, from a height of about 20 m, it suddenly fell to the ground. The aircraft was destroyed (Figure 1). The operator had a 200 m cordon in place and was operating the aircraft overhead waste land. No persons were injured.

Sky Mantis after the accident

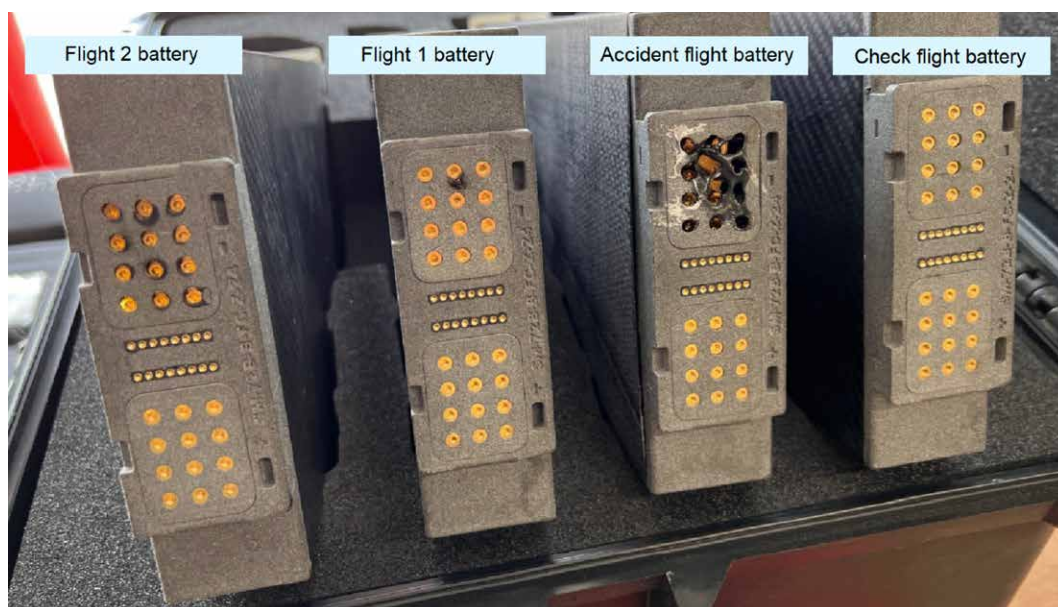
Figure 4
Damage to battery connectors

The aircraft and its five batteries were examined by the manufacturer. This showed that the aircraft's battery connector had been extensively damaged by heat, which had caused 12 of its pins to collapse within the connector. The corresponding electrical connector pads on the flight 2 and accident flight batteries also showed varying levels of thermal damage (Figure 4). The flight 2 battery connector pads had receded slightly into the battery, and there were adjacent scorch marks. The accident flight battery was much more significantly damaged, with the pads having collapsed within the battery.

The contacts on the check flight and the unused fifth battery appeared undamaged, but the flight 1 battery showed evidence of scorching near one of its contacts.

The manufacturer stated that the damage to the connectors was a result of the number of pins in contact within the connector having been progressively reduced, which led to the electrical current through the remaining connections causing sufficient heat to distort the plastic of the connector. This led to the further loss of electrical load sharing between connections and additional heat, until the point where a complete loss of electrical power occurred. The recorded flight logs were also consistent with this, showing that at 13 minutes 27 seconds into the accident flight, there was a complete loss of electrical power. In the final minute of the flight preceding the loss of power, there were also several rapid fluctuations in the battery supply voltage and current flow to the aircraft. These were considered to be related to the connector starting to fail. A check of the battery charge indicator after the accident showed that it was at 75% charge remaining.

The aircraft lost electrical power in flight and fell to the ground because of separation of electrical contacts between the aircraft and battery connections. The separation was a result of a loss of structural integrity due to thermal damage to the connectors.

The small scorch mark on the flight 1 battery indicates that the battery connector on the aircraft had been damaged at some point prior to, or during, flight 1. It was not determined as to how this occurred, but it is possible that foreign object debris could have entered the open battery compartment prior to fitting the battery, or that the battery was not fully locked into place during this flight. Either possibility could have resulted in an increase in inter-contact resistances, causing temperature increases of the connector material that allowed pins to recede or be damaged. This damage eventually culminated in an electrical thermal run-away during the accident flight until pin separation occurred.

The scorch mark on the flight 1 battery, and more extensive thermal damage evident on the flight 2 battery went unnoticed by the pilot during his checks between each flight.

The manufacturer has updated the Sky Mantis Operations Manual to include an instruction during pre-flight to check that the aircraft and battery connections are clean and undamaged.
