ACCIDENT

Aircraft Type and Registration:	Piper PA-46-350P, G-LAMI	
No & Type of Engines:	1 Lycoming TIO-540-AE2A piston engine	
Year of Manufacture:	2022 (Serial no: 4636798)	
Date & Time (UTC):	9 July 2022 at 1000 hrs	
Location:	Wycombe Airpark, Buckinghamshire	
Type of Flight:	Private	
Persons on Board:	Crew - 2	Passengers - 4
Injuries:	Crew - None	Passengers - None
Nature of Damage:	Left wing, both landing gear and fuselage damaged	
Commander's Licence:	Airline Transport Pilot's Licence	
Commander's Age:	65 years	
Commander's Flying Experience:	31,500 hours (of which 131 were on type) Last 90 days - 91 hours Last 28 days - 26 hours	
Information Source:	Aircraft Accident Report Form submitted by the pilot and further enquiries by the AAIB

Synopsis

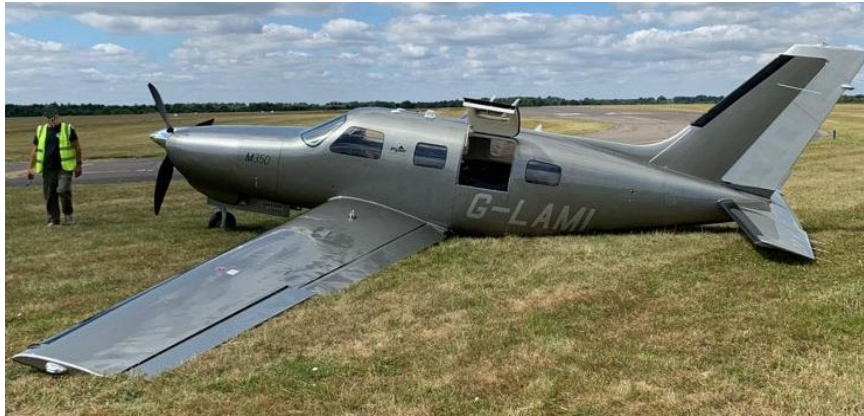
Figure 1

The aircraft decelerated and swung to the right as it ran off the end of the runway onto the taxiway. It continued off the paved surface into the grass and in doing so caused both main landing gears to collapse. The commander estimated they were travelling “not much more than walking pace” as they went onto the grass and came to a stop shortly afterwards (Figure 1).

G-LAMI shortly after the accident

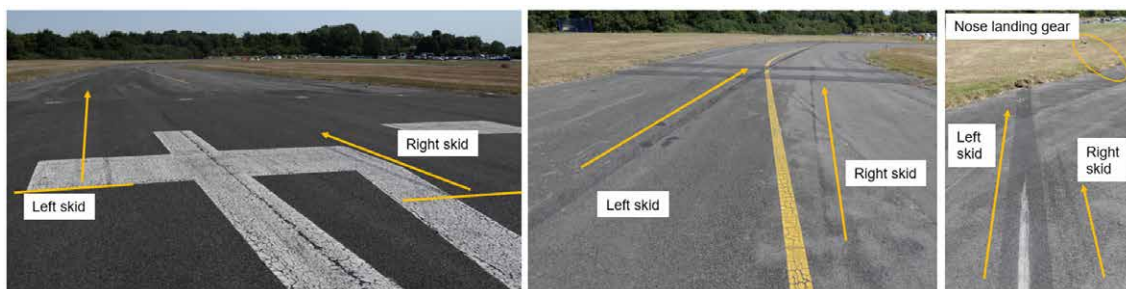
Figure 2

Inspection of the end of Runway 06 revealed two lines of black skid marks starting from the painted Runway 24 numbers (Figure 2 left). The distance between the lines was 3.6 m and were to the left of the runway centreline. The skid marks continued in an arc to the right (Figure 2 centre) and converged at a point where they left the paved surface (Figure 2 right). The left skid mark was darker and there was evidence of the tyre scrubbing sideways, whereas the right skid mark was lighter, and the skid was in the direction of travel. At the point where the main gears left the paved surface there was another skid mark, 4.2 m to the right, from the nose landing gear (Figure 2 right).

Skid marks on the runway

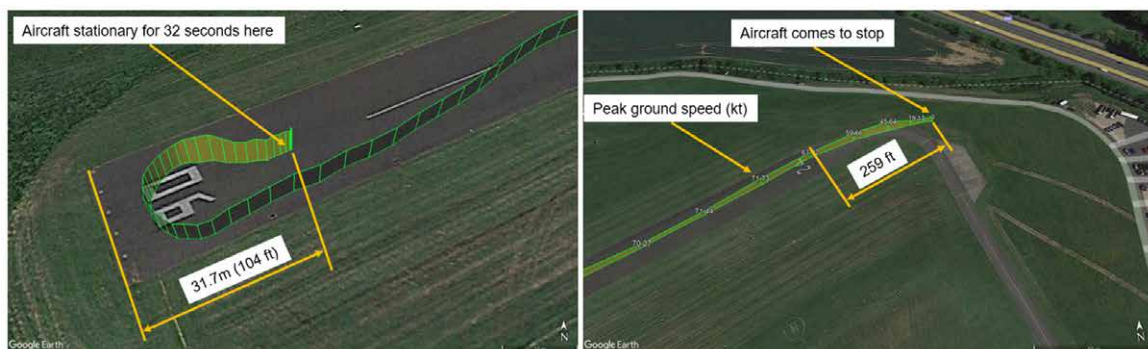
Figure 3

Using the positional data from IFD, it was possible to determine that after the 180° turn, the aircraft lined up to take off 31.7 m (104 ft) from the end of Runway 06 (Figure 3). It reached a peak ground speed of 71 kt (and KIAS of 71kt) after 30 seconds and had used 2,272 ft of the available runway. The positional track data overlaid with the skid marks seen with good correlation and the aircraft came to rest 259 feet from the end of the runway.

Take off roll start (left), Peak ground speed and stop point (right)

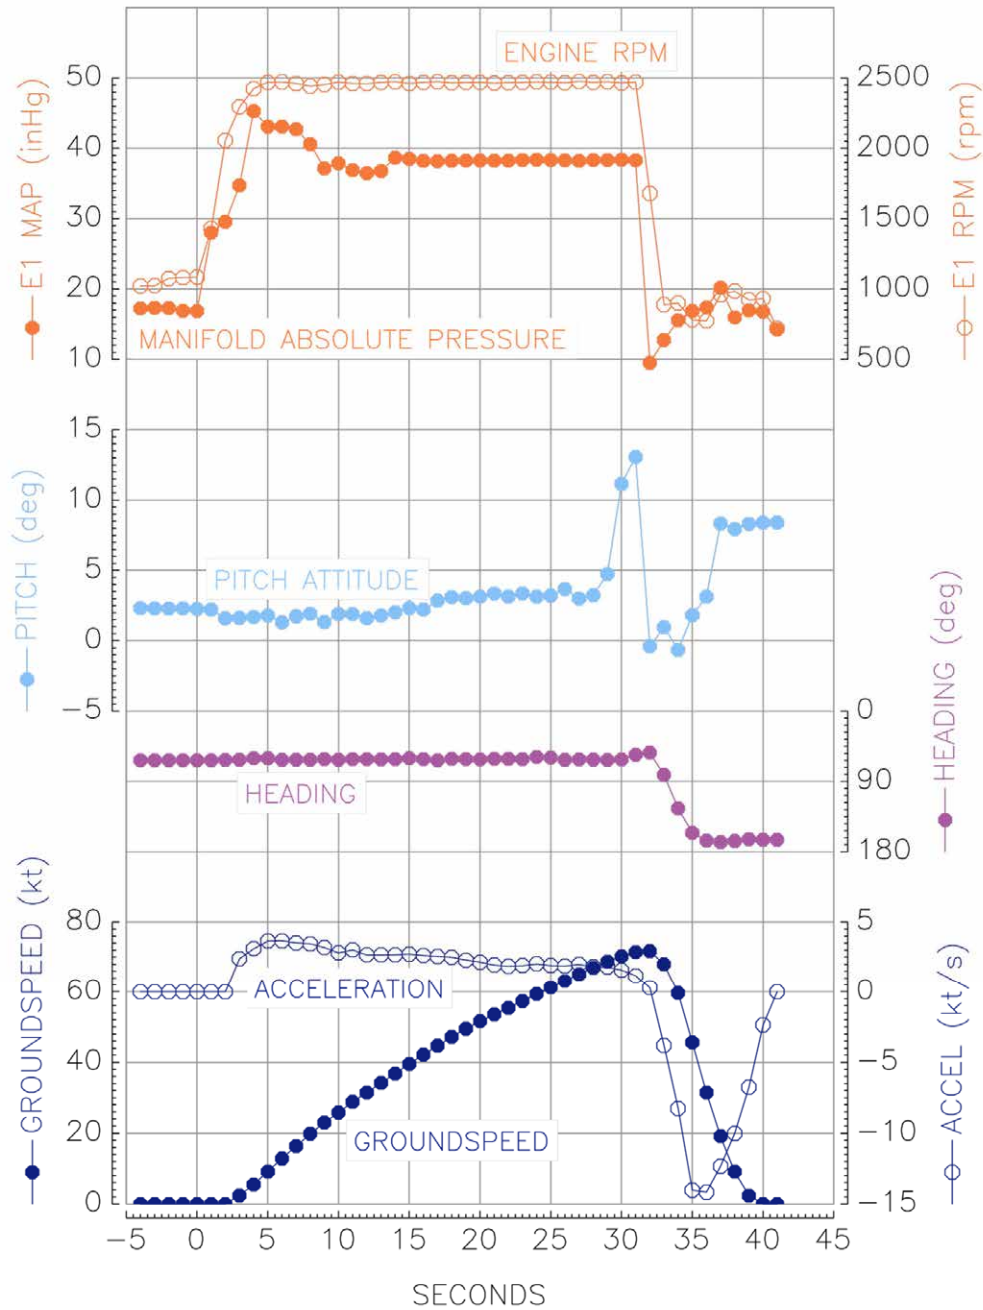
The ground speed, aircraft pitch, aircraft heading, MAP and engine rpm from the IFD was plotted against time in Figure 4 along with the calculated acceleration. At T=1 second the engine rpm starts to increase with a corresponding increase in MAP. The aircraft is moving at 2.4 kt at T=3 seconds when the MAP is 34.75 inches Hg, and the engine speed is 2,294 rpm. The MAP peaks 3 seconds later at 45.3 inches Hg and remains above the 42 inches Hg threshold for the CAS red warning for 4 seconds. It is then reduced and stabilised at 38 inches Hg for the remainder of the takeoff with the engine speed at 2,450 +/- 25 rpm.

The ground speed increases under constant acceleration between T=11 to T=29 seconds with a corresponding increase in IAS until the aircraft pitch increases to 13° nose up at T=31 seconds where the acceleration decreases. 1 second later the ground speed and IAS peak at 71 kt after which the throttle is closed, and the aircraft deaccelerates rapidly. As the aircraft pitched up, the heading veered slightly to the left, then swung 100° to the right after the brakes were applied and it came to a stop in 7 seconds.

Figure 4
Garmin G1000 IFD data

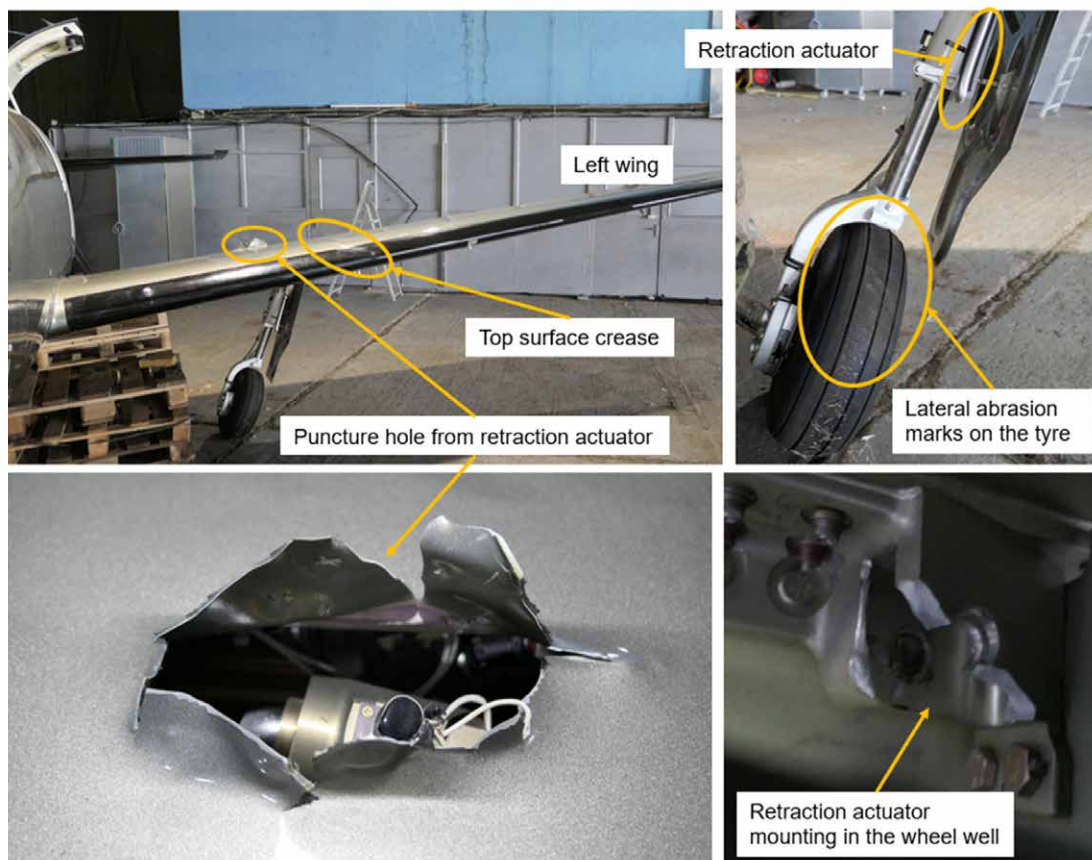
The aircraft was inspected by the AAIB after it had been recovered following the accident. The left-wing top surface was creased outboard of the landing gear attachment with damage to the wing tip structure (Figure 5 top left). There was a puncture hole in the top surface (Figure 5 lower left) near the retraction jack actuator and the actuator had failed in compression and bending (Figure 5 top right). The actuator mounting lug on the wing spar had sheared (Figure 5 lower right) and the tyre had lateral abrasion marks (Figure 5 top right).

Figure 5
Left wing and landing gear damage

As the left main landing gear reached the curb the lateral forces exerted on it caused the retraction actuator to buckle, snap and puncture the wing top skin. The landing gear collapsed causing the left wing to be damaged as it travelled across the grass. The nose landing gear remained intact which resulted in the rear fuselage contacting the ground behind the cabin door. The right landing gear retraction actuator was overloaded in tension as it crossed the curb and when it failed, the landing gear over extended and was damaged by contact with the weather radar pod.

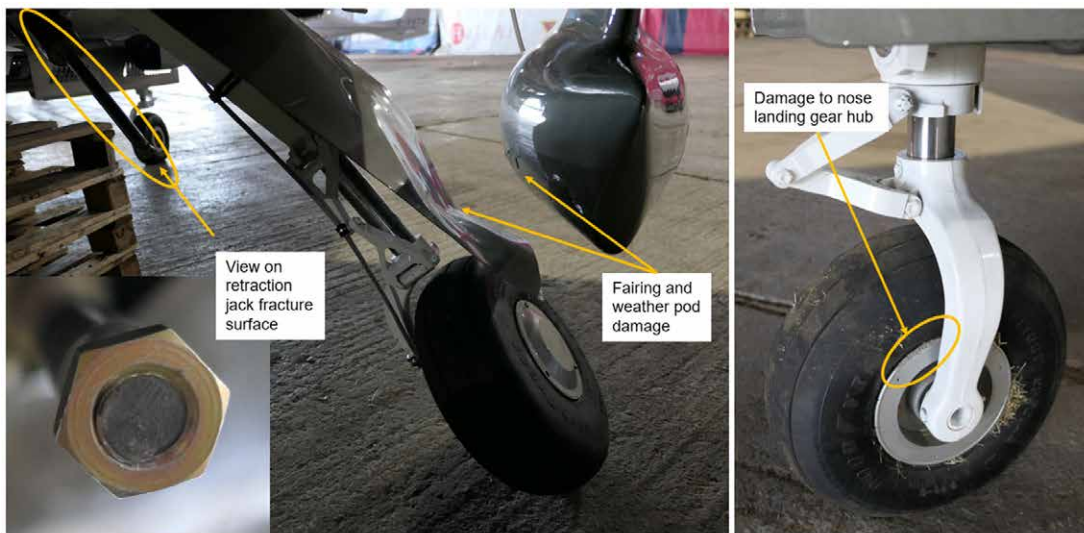
Figure 6

The right landing gear retraction actuator had failed in tension overload and the landing gear fairing had been damaged where it had contacted the weather radar pod (Figure 6 left). There were deep abrasion marks on the left side of the nosewheel rim with corresponding damage to the tyre (Figure 6 right).

Right landing gear damage (left), nose landing gear damage (right)

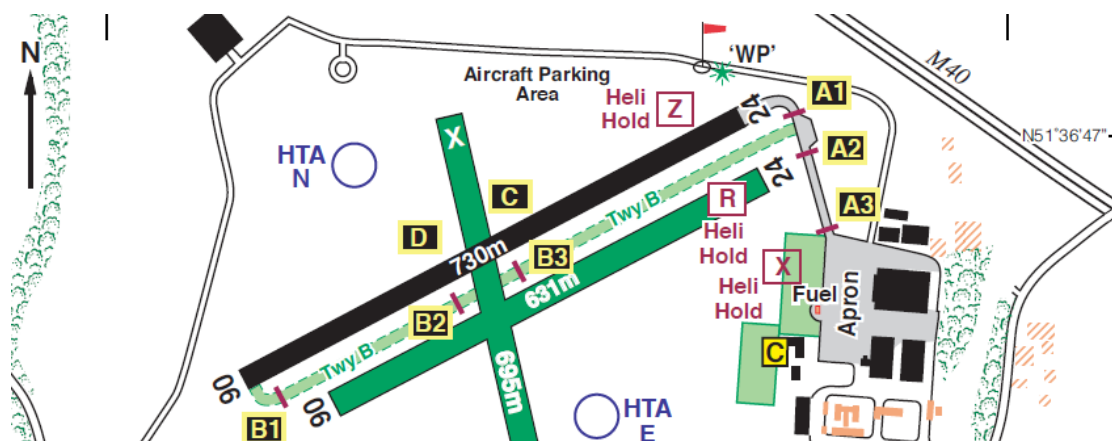
Figure 7

Wycombe Air Park has five runways; two asphalt 06/24 and three grass 06/24 & 35 (Figure 7). Runway 06 has a TORA of 730 m (2,395 ft) with a tall stand of trees (visible in Figure 2 left) 2,800 ft from the threshold and the M40 motorway beyond. Entry to Runway 06 is via the Alpha taxiway which joins to the Runway 24 threshold thereby necessitating a backtrack along Runway 24 or taxiing along the grass Taxiway Bravo which runs parallel.

Wycombe Air Park runways and taxiways

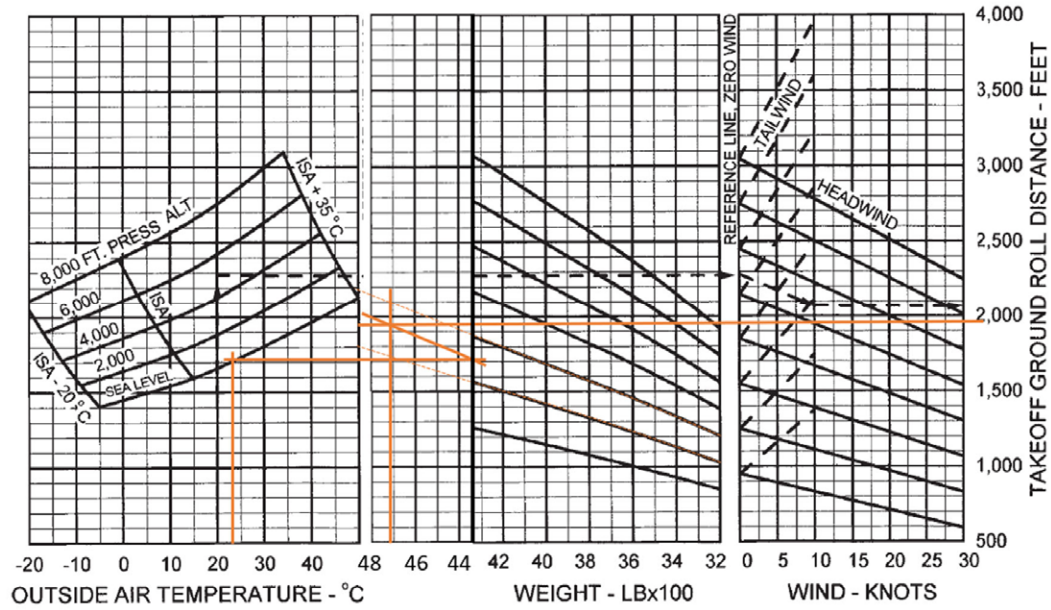
Appendix 1 - Takeoff ground roll calculation:

The takeoff ground roll and 50 ft obstacle clearance performance calculations were evaluated using the data obtained during the investigation (Appendix 1 and 2). The Pilots Operating Handbook (POH) graphs were extrapolated (under advice from the aircraft manufacturer) to include the higher TOW. The conditions used were:

Applying the general safety factor of 1.33, as recommended in the CAA Skyway Code, resulted in a takeoff ground roll of 1,950 ft x 1.33 = 2,593 ft. The takeoff over 50 ft obstacle clearance distance was 3,150 ft.

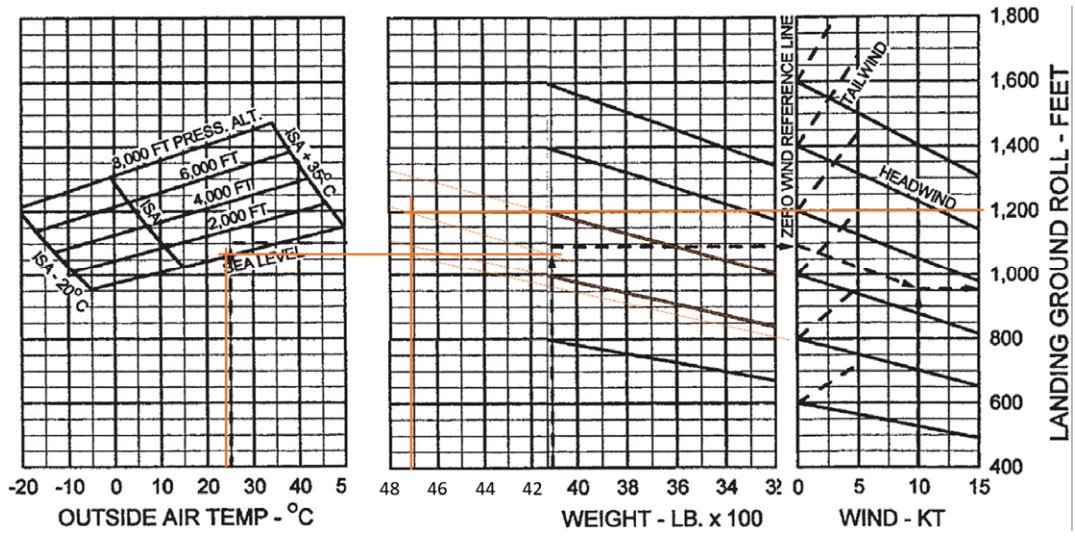
Appendix 3 – Estimated braking distance calculation:

The aircraft manufacturer had not published any performance graphs to calculate the braking distance required following a rejected takeoff. The landing ground roll distance calculations assume throttle closed, flaps 36°, braking heavy and a full stall on touchdown on a paved, level dry runway. G-LAMI was on the edge of stall with flaps 10° when the throttle was closed and heavy braking applied. To obtain the approximate braking distance required the calculations were performed but extrapolated for the increased TOW. The calculations showed a landing ground roll of nearly 1,200 ft would have been required (Appendix 3). This is equivalent to approximately half of the runway length.
