ACCIDENT

Aircraft Type and Registration:	Bede BD-4, G-BOPD	
No & Type of Engines:	1 Lycoming O-320-A2B piston engine	
Year of Manufacture:	1974 (Serial no: 632)	
Date & Time (UTC):	10 July 2022 at 0930 hrs	
Location:	Fishburn Airfield, County Durham	
Type of Flight:	Private	
Persons on Board:	Crew - 1	Passengers - None
Injuries:	Crew - None	Passengers - N/A
Nature of Damage:	Left landing gear leg failed, propeller strike, and damage to left wing, left door, and engine cowls	
Commander's Licence:	Private Pilot's Licence	
Commander's Age:	68 years	
Commander's Flying Experience:	1,597 hours (of which 1,444 were on type) Last 90 days - 10 hours Last 28 days - 6 hours	
Information Source:	Aircraft Accident Report Form submitted by the pilot and further enquiries by the AAIB

Synopsis

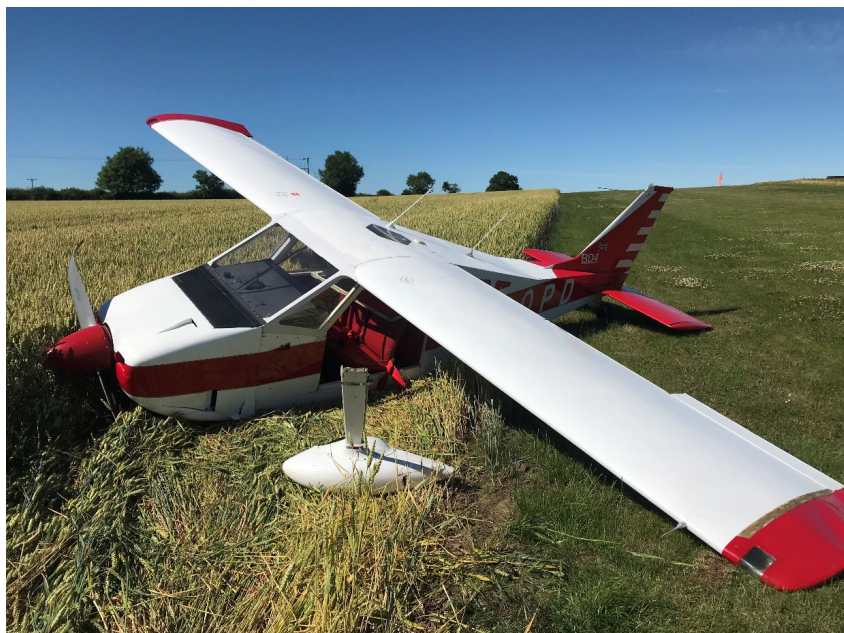
Figure 1

The pilot had owned the BD-4 high-wing tailwheel aircraft since 1984 and had logged 1,444 hours with it. The aircraft was operated on a Permit to Fly and had accumulated 1,686 hours since manufacture in 1974. After a normal landing the pilot applied the brakes and the left landing gear leg detached. The propeller struck the ground and the aircraft veered to the left, coming to rest in a field of crops on the left side of the grass runway (Figure 1).

G-BOPD after the accident

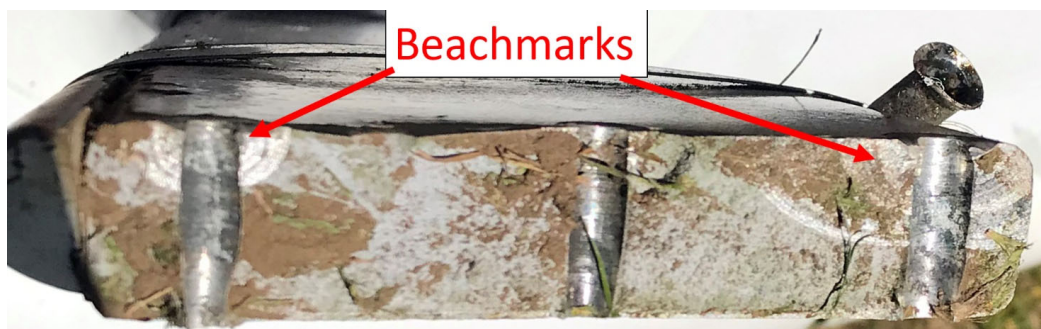
Figure 2

After a normal landing the left landing gear leg detached. The leg fracture surface revealed beachmarks which were consistent with a failure due to metal fatigue. The pilot estimated that the aircraft landing gear had probably made over 2,000 landings, which the manufacturer said was probably the highest number of landings of this aircraft type.

A photograph of the landing gear leg fracture surface revealed beachmarks which were consistent with a failure due to metal fatigue (Figure 2). The pilot contacted the aircraft manufacturer who informed him that they had not seen a fatigue failure in these landing gear legs before. The pilot estimated that he had probably made over 2,000 landings in it which the manufacturer said was probably the highest number of landings of this aircraft type.

Landing gear leg fracture surface

The manufacturer no longer makes this landing gear leg type as it has been redesigned.
