INCIDENT

Aircraft Type and Registration:	Bell 206B, G-TOYZ	
No & Type of Engines:	1 Allison 250-C20J turboshaft engine	
Year of Manufacture:	1986 (Serial no: 3949)	
Date & Time (UTC):	5 September 2022 at 1110 hrs	
Location:	West Usk Lighthouse, Newport, Gwent	
Type of Flight:	Commercial Air Transport (Passenger)	
Persons on Board:	Crew - 1	Passengers - 4
Injuries:	Crew - None	Passengers - None Other - 1
Nature of Damage:	Ties securing a sign were broken	
Commander's Licence:	Commercial Pilot's Licence	
Commander's Age:	27 years	
Commander's Flying Experience:	422 hours (of which 311 were on type) Last 90 days - 136 hours Last 28 days - 73 hours	
Information Source:	Aircraft Accident Report Form submitted by the pilot and other enquiries by the AAIB

Synopsis

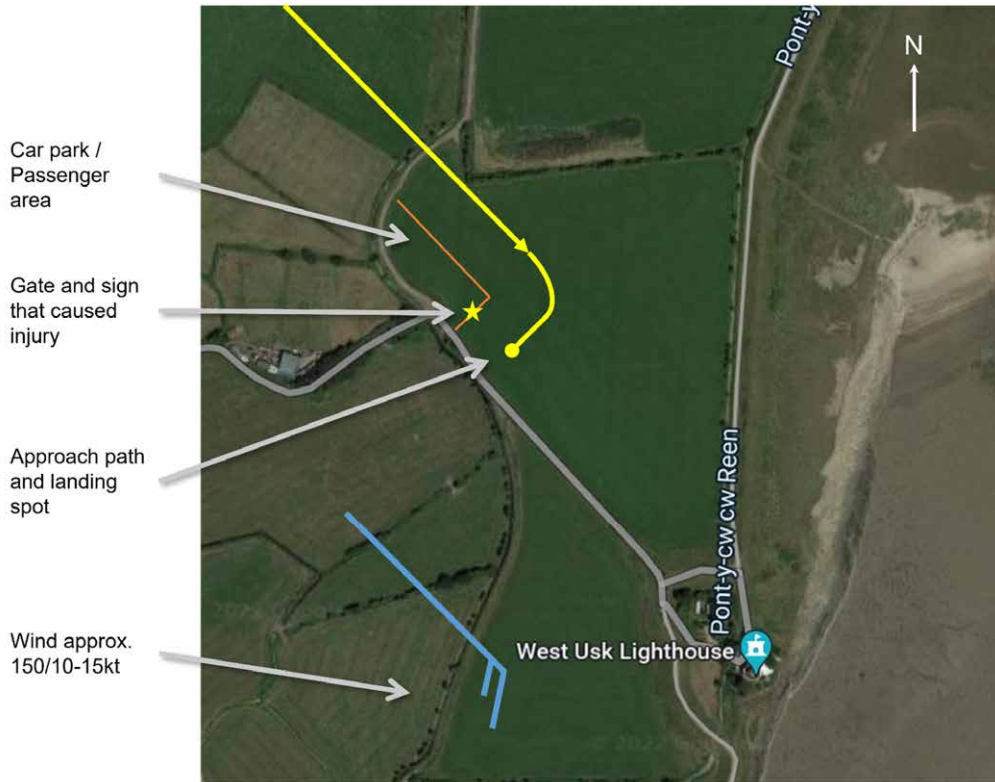
Figure 1

On 4 September 2022, the operator's staff set up a temporary site in a field at West Usk Lighthouse for the operation of helicopter sightseeing flights (Figure 1). This consisted of a passenger parking, waiting and briefing area delineated by a rope cordon with a gate to 'airside'. A sign was displayed next to the gate and was used as part of passenger briefings before they were escorted to board the helicopter.

Site layout at West Usk Lighthouse (reproduced from pilot's sketch, not to scale and showing approximate approach path and landing position) © 2022 Google

The operator took immediate action on the day to increase the distance between the landing helicopter and the passenger area.

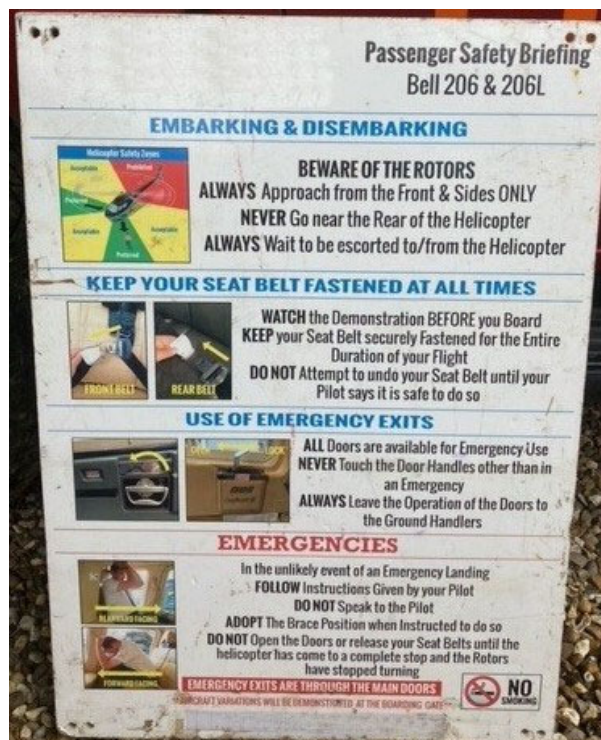
Figure 2

During the site set-up cows escaped on to the site from an adjacent field and needed to be removed and secured. The site set-up was then running late, and passengers were arriving and parking in incorrect locations. The sign was secured with two plastic cable ties on the top corners when normally it would be secured with plastic cable ties on all four corners. The sign measured 800 mm x 575 mm x 10 mm and weighed 2 kg (Figure 2).

Sign that became detached (Image used with permission)

The operator's ground staff were distracted and under time pressure during the site set-up and did not secure the sign as well as usual. The helicopter downwash and prevailing wind acting on the sign were sufficient to break the plastic cable ties, and the sign became detached. It is possible that the sign was exposed to strong winds when left overnight and there was no process to check the safety of the site prior to each day's operation.

The operator issued a flying staff instruction that required the sign to be secured with two cable ties on each corner and ordered metal lanyards to secure the sign in future (Figure 4).

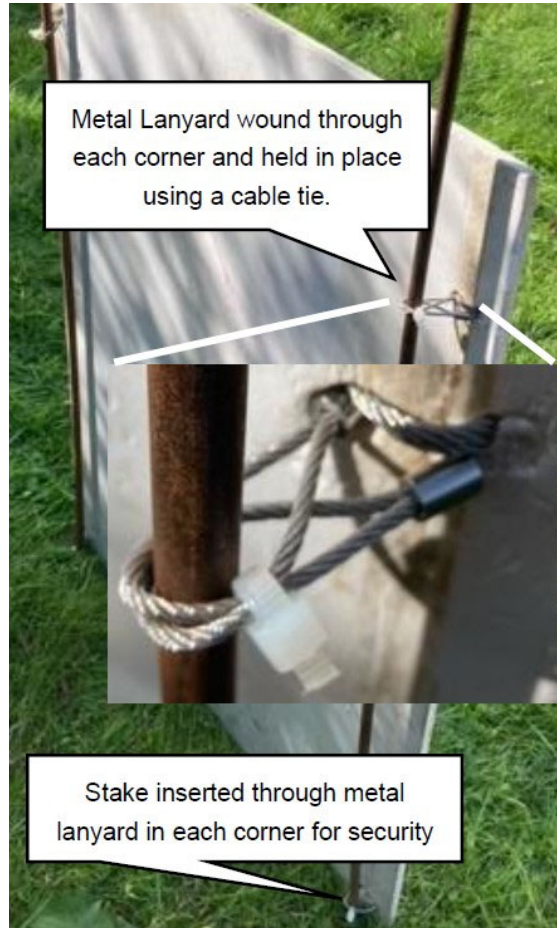
Figure 4

New method of securing the sign (Image used with permission)
