ACCIDENT

Aircraft Type and Registration:	Thruster T600N 450, G-CBIR	
No & Type of Engines:	1 Jabiru 2200A piston engine	
Year of Manufacture:	2002 (Serial no: 0022-T600N-061)	
Date & Time (UTC):	10 August 2022 at 1620 hrs	
Location:	Causeway Airfield, County Londonderry	
Type of Flight:	Private	
Persons on Board:	Crew - 2	Passengers - None
Injuries:	Crew - 1 (Minor) 1 (None)	Passengers - N/A
Nature of Damage:	Landing gear bent, pod damaged, propeller blade damaged	
Commander's Licence:	Private Pilot's Licence	
Commander's Age:	53 years	
Commander's Flying Experience:	3,510 hours (of which 120 were on type) Last 90 days - 26 hours Last 28 days - 12 hours	
Information Source:	Aircraft Accident Report Form submitted by the pilot

BULLETIN ADDENDUM

AAIB Bulletin No 1/2023, page 38 and 39 refer

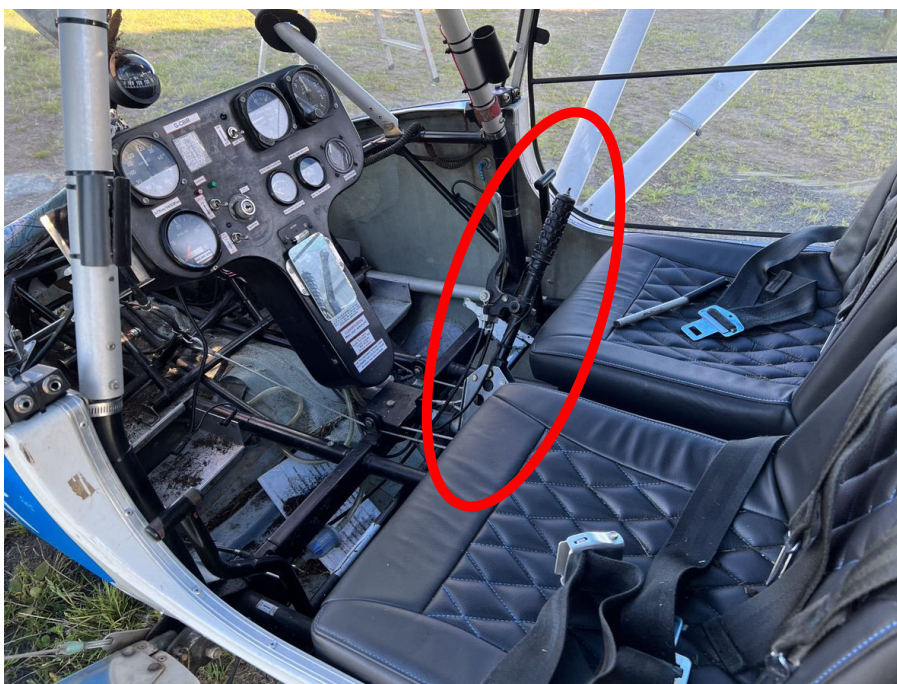
Figure 1

The aircraft landed heavily when the student and instructor both made a nose-down pitch input on the single control stick following a simulated engine failure.

Despite the resulting high rate of descent, it was necessary to maintain a nose down attitude to gain sufficient speed for the elevator authority required to flare. The aircraft landed heavily, causing failure of the main landing gear, and the aircraft became inverted when the nose wheel dug in. Fuel leaked from the tank vent. The instructor vacated the aircraft and assisted the student, and members of the flying club attended shortly afterwards.

Cockpit of G-CBIR (upright after recovery) showing single control stick

The instructor commented that he should have demonstrated the second recovery at a greater height or in circumstances where he could be sure the student would not intervene. He observed that regular practice handing over control would be useful, especially after a period of student solo flying, and to ensure that when an instructor advises "I have control", the student responds with "you have control".
