## SERIOUS INCIDENT

<b>Aircraft Type and Registration:</b>	Cessna 182Q, G-BRRK	
<b>No &amp; Type of Engines:</b>	1 Continental Motors Corp O-470-U piston engine	
<b>Year of Manufacture:</b>	1977 (Serial no: 182-66160)	
<b>Date &amp; Time (UTC):</b>	24 August 2022 at 1006 hrs	
<b>Location:</b>	Finmere Microlight Site, Buckinghamshire	
<b>Type of Flight:</b>	Private	
<b>Persons on Board:</b>	Crew - 1	Passengers - 1
<b>Injuries:</b>	Crew - None	Passengers - None
<b>Nature of Damage:</b>	None	
<b>Commander's Licence:</b>	Private Pilot's Licence	
<b>Commander's Age:</b>	63 years	
<b>Commander's Flying Experience:</b>	545 hours (of which 212 were on type) Last 90 days - 7 hours Last 28 days - 5 hours	
<b>Information Source:</b>	Aircraft Accident Report Form submitted by the pilot

### Summary

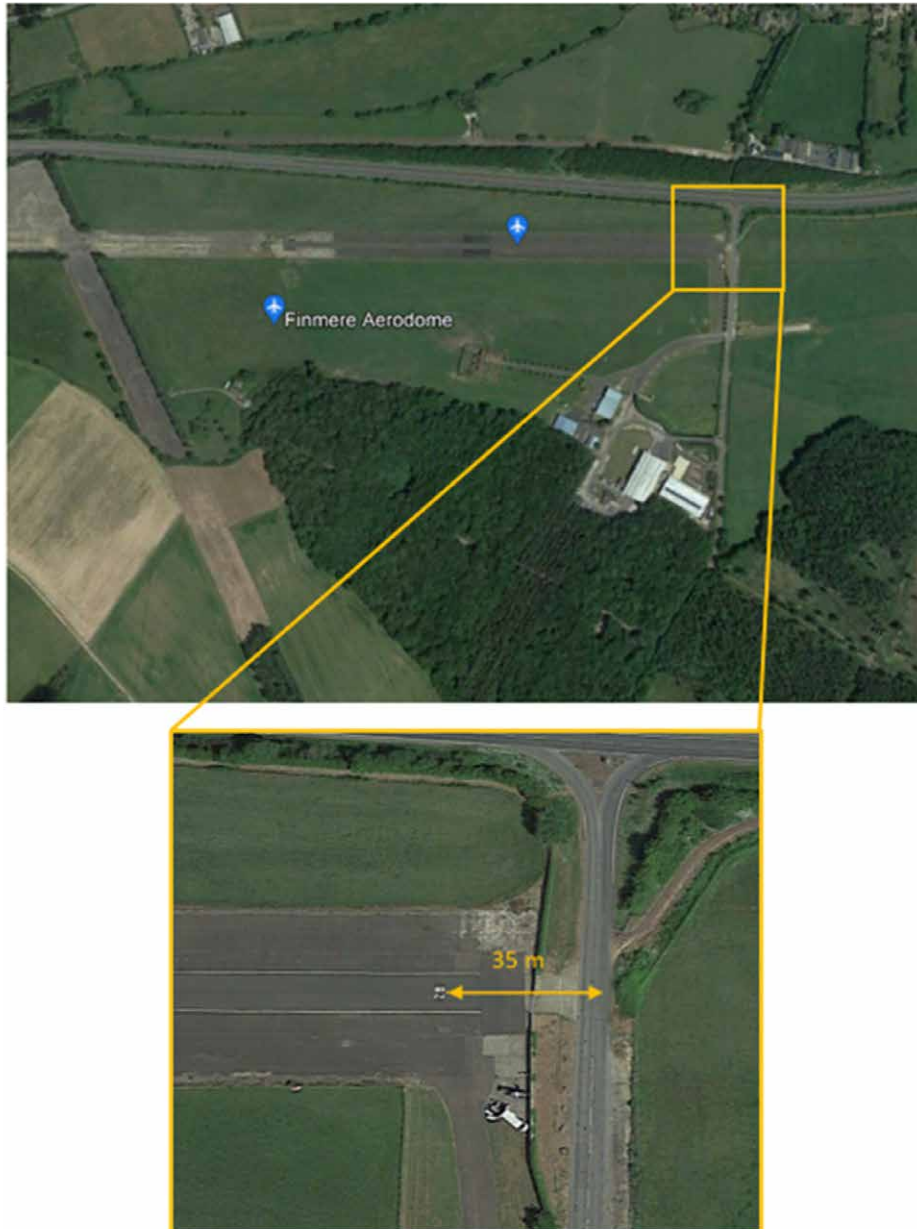
**Figure 1**

Finmere Aerodrome is an unlicensed aerodrome located 11 nm west of Milton Keynes. It has one asphalt runway, 10/28, which is 701 m long. The end of Runway 28 is 35 m from the road (Figure 1). Finmere requires pilots to request permission before visiting.

Distance from Runway 28 markings to public road
