ACCIDENT

Aircraft Type and Registration:	Piper PA-34-200T, G-CAHA	
No & Type of Engines:	2 Continental Motors Corp TSIO-360-EB piston engines	
Year of Manufacture:	1977 (Serial no: 34-7770010)	
Date & Time (UTC):	1 June 2022 at 1130 hrs	
Location:	Dundee Airport	
Type of Flight:	Training	
Persons on Board:	Crew - 2	Passengers - 1
Injuries:	Crew - None	Passengers - None
Nature of Damage:	Damage to both propellers, engines and airframe	
Commander's Licence:	Commercial Pilot's Licence	
Commander's Age:	61 years	
Commander's Flying Experience:	1,401 hours (of which 200 were on type) Last 90 days - 89 hours Last 28 days - 30 hours	
Information Source:	Aircraft Accident Report Form submitted by the pilot

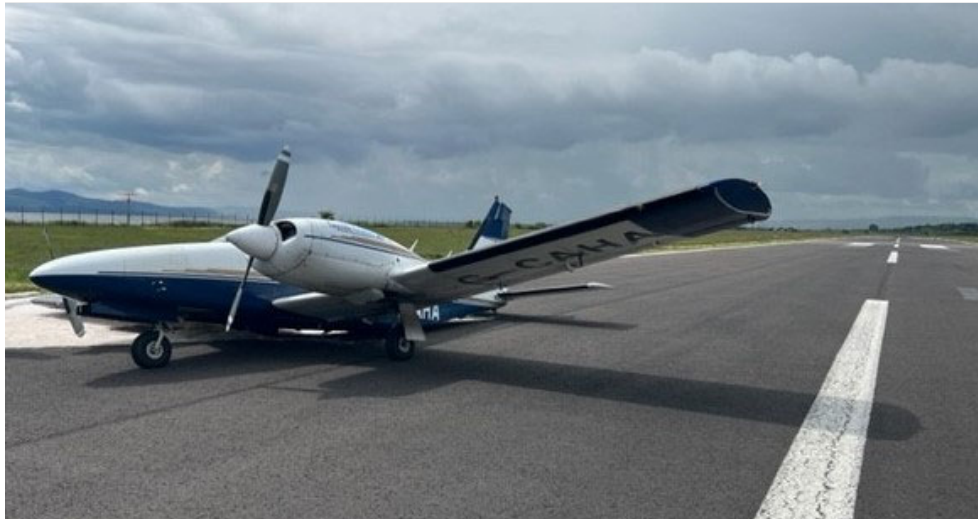
Figure 1

The aircraft had completed a final training flight on a multi-engine pilot (MEP) course and was on final approach at Dundee Airport. The downwind checks had been carried out and the student pilot confirmed "three greens", indicating the landing gear was down and locked. Following what the instructor described as a normal landing, the aircraft began to wobble, listed to the right and the propeller on the right engine and the right wing struck the runway. The instructor took control and managed to keep the aircraft reasonably straight and brought the aircraft to a stop. The occupants escaped unhurt. On exiting the aircraft it was clear the right main landing had collapsed (Figure 1).

After the accident the engineers from the maintenance organisation responsible for the aircraft checked the entire hydraulic and electrical system and no fault could be found. Despite repeated selections of the landing gear there was no evidence of failure of the main and nose landing gear down lock safety mechanism and switches. The aircraft was subsequently not repaired as the aircraft has been written off by the insurers.

G-CAHA post landing (used with permission)
