ACCIDENT

Aircraft Type and Registration:	Enstrom 280FX, G-OJBB	
No & Type of Engines:	1 Lycoming HIO-360-F1AD piston engine	
Year of Manufacture:	1999 (Serial no: 2084)	
Date & Time (UTC):	25 August 2021 at 1618 hrs	
Location:	Rhobell Fawr, Dolgellau, Gwynedd	
Type of Flight:	Private	
Persons on Board:	Crew - 1	Passengers - None
Injuries:	Crew - 1 (Minor)	Passengers - N/A
Nature of Damage:	Damaged beyond economic repair	
Commander's Licence:	Private Pilot's Licence	
Commander's Age:	65 years	
Commander's Flying Experience:	419 hours (of which 419 were on type) Last 90 days - 12 hours Last 28 days - 4 hours	
Information Source:	AAIB Field Investigation

Synopsis

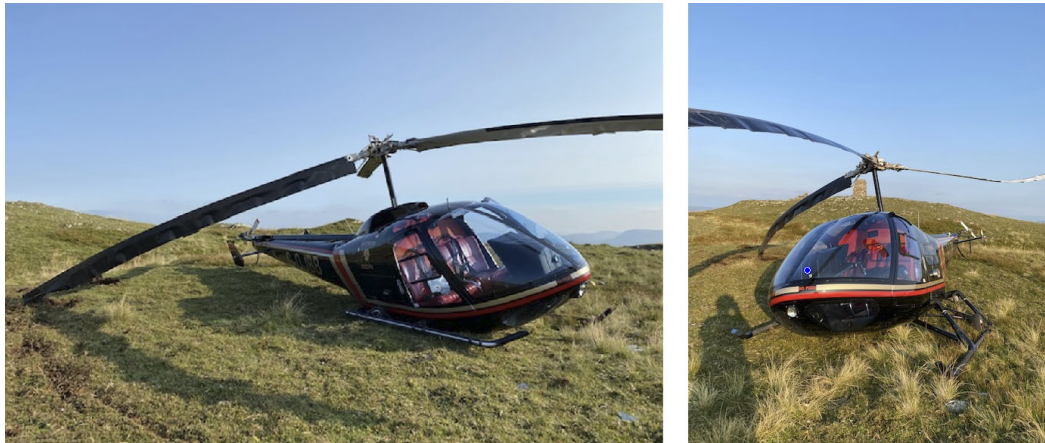
Figure 2

Having selected the fuel and electrical systems off, the pilot vacated the cockpit using the right door. The helicopter's main rotors, tail boom and skids suffered substantial damage (Figures 2 and 3). The pilot sustained minor injuries to his right arm and left leg and was subsequently airlifted from the mountain by a Search and Rescue (SAR) helicopter which flew him to Caernarfon for treatment.

G-OJBB shortly after the accident

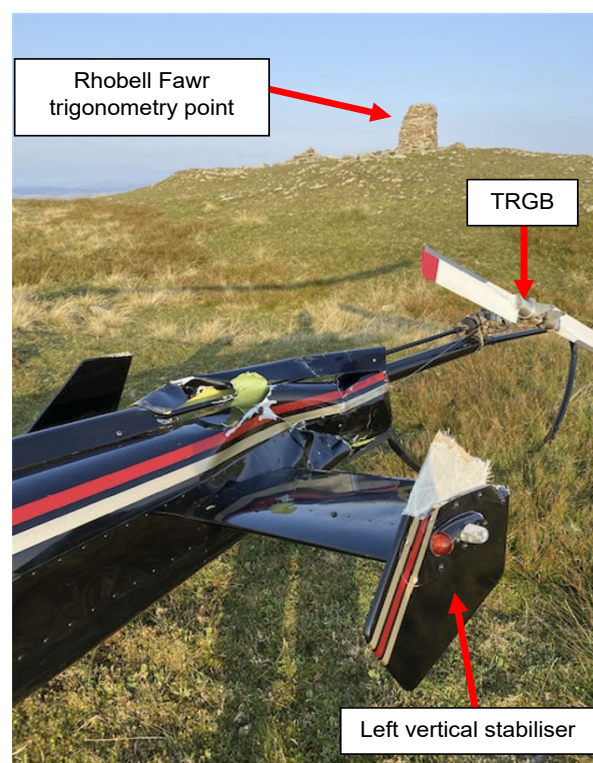
Figure 3

Damage to tail boom and left vertical stabiliser

The helicopter was recovered from the mountain approximately four weeks after the accident, and then transported to its owner's private site. The damage to the helicopter indicated that the main rotors had struck the rear of the tail boom, the tail rotor drive shaft and left rear stabiliser. This had deformed the fuselage, caused the coupling between the main gearbox and tail rotor drive shaft to fail, and severed the upper section of the left vertical stabiliser (Figure 7). The tail rotor blades were intact and their tips undamaged, although one blade had two small indentations adjacent to its leading edge. This was likely to have been caused by the blade striking the severed tip of the left stabiliser.

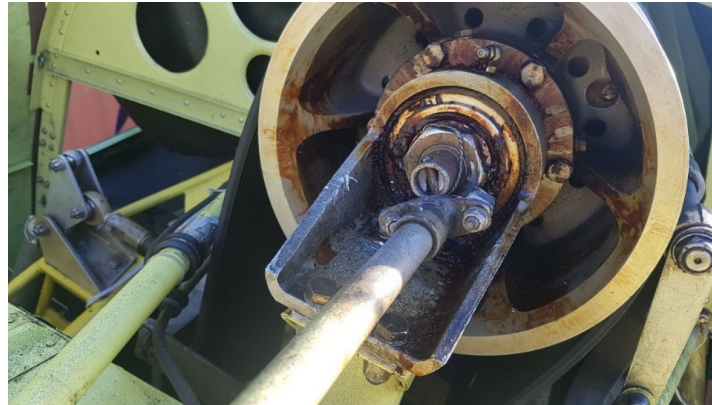
Figure 7

Broken tail rotor driveshaft coupling

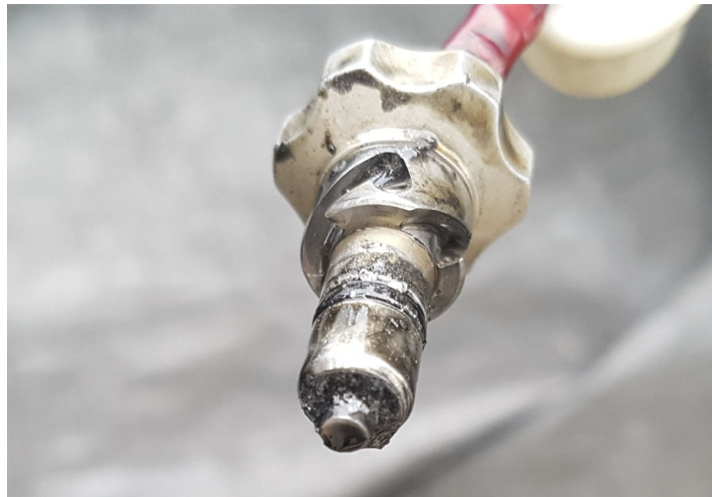
Figure 8

While the input shaft of the TRGB remained stationary, the output shaft and tail rotor could be turned by hand. The TRGB magnetic plug was subsequently removed and found to be covered in metal particles (Figure 8). The engineer reported that when the plug was initially removed, a few drops of oil dripped from the oil drain plug. The plug was then refitted and the TRGB and tail rotor were sent to the AAIB for detailed examination. Subsequent checks on the helicopter showed that the TRGB CHIP indicator in the cockpit operated correctly when the TRGB magnetic plug connector was electrically shorted to the airframe.

TRGB magnetic plug

The metallic fragments in the TRGB oil would have been created when ferrous bearing material was liberated as a result of spalling during the bearing failure sequence. From the photograph of the magnetic plug taken shortly after the helicopter was recovered (Figure 6)

and from the extent of damage subsequently found within the TRGB, it was considered that the TRGB CHIP indicator light in the cockpit should have illuminated. However, the pilot reported that he had not seen it illuminate during either the accident flight, or any preceding, flight.

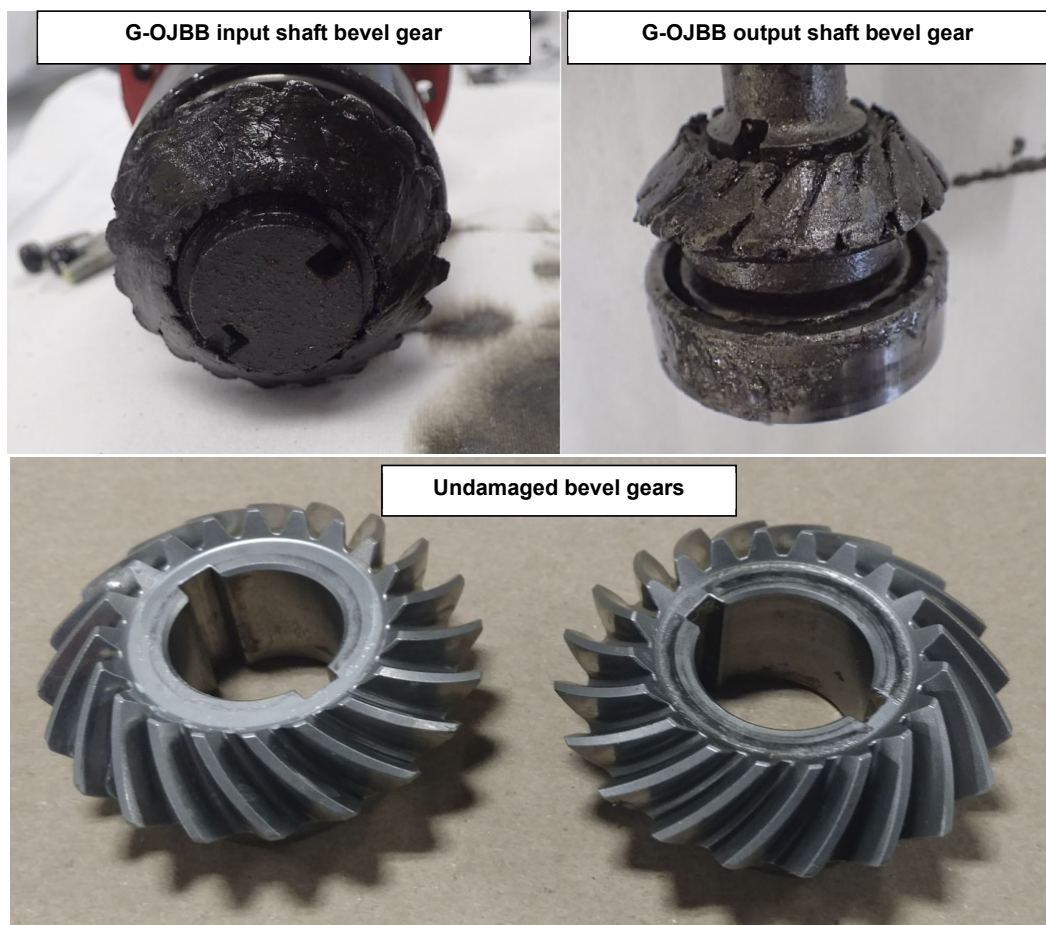
Figure 9

Inspection of the bevel gears using a borescope inserted through the inspection port showed that the teeth on both gears exhibited extensive damage, and this allowed the input and output shaft to rotate independently of each other. The TRGB was then disassembled. The shafts, bevel gears, bearings, bearing housings and the internal surface of the TRGB case were coated in an oily sludge which had a metallic appearance.

The teeth on both bevel gears were severely deformed to the extent that they had the appearance of an almost toothless cone (Figure 9).

Damage to G-OJBB input and output shaft bevel gears

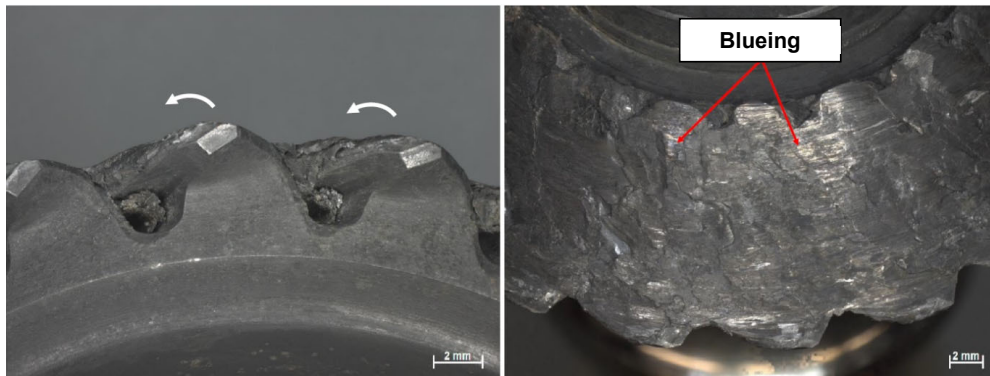
Figure 10

On the input shaft bevel gear, the apexes of the teeth had folded over into the roots and the surface of the gear showed evidence of high temperature oxidation (blueing) in places (Figure 10). The damage to the output shaft bevel gear appeared similar.

G-OJBB input shaft bevel gear

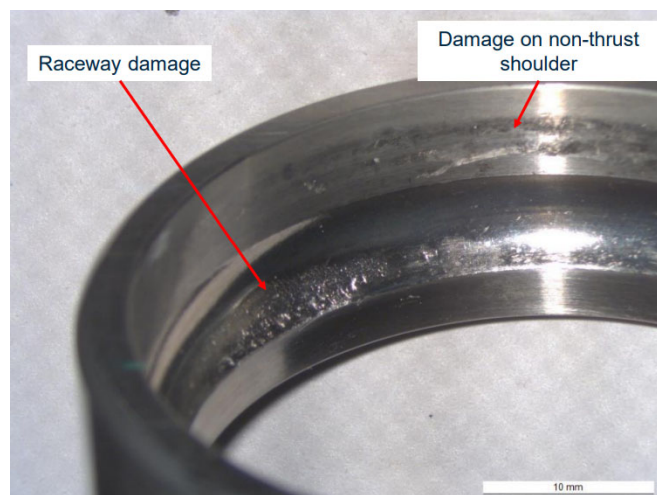
Figure 11

Damage was present on the raceway over approximately one quarter of its circumference. The entire circumference of the non-thrust shoulder also exhibited damage (Figure 11).

Outer race of input shaft, inner bearing

Examination of the outer race in the scanning electron microscope (SEM) revealed that the damage in the raceway consisted of tongues of material pushed from the surface and smeared along it. Fragments of a foreign material had also been pressed into the raceway in some areas and Energy Dispersive X-Ray (EDX) analysis showed that it was aluminium. The damage on the non-thrust shoulder was similar but also included fractures, which appeared to have resulted from adhesive wear, with material torn from the surface and then rolled into adjacent areas.

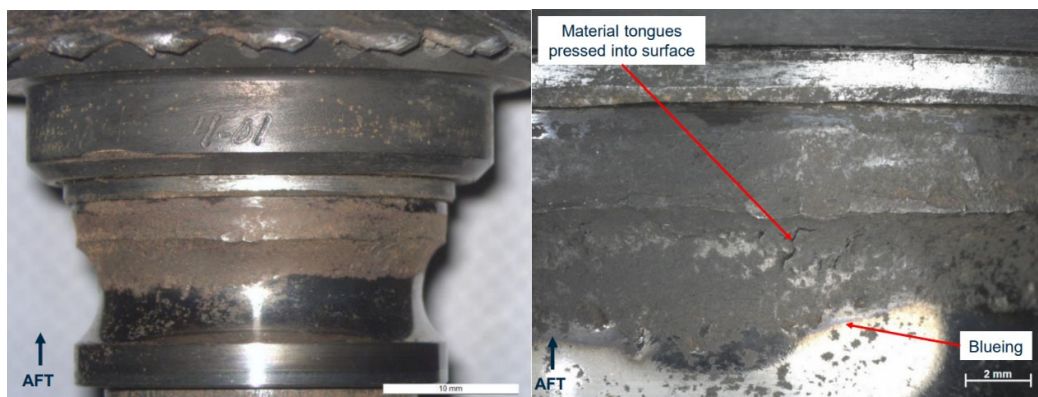
Figure 12

The inner race was damaged around its full circumference, across the rear half of its raceway and rear shoulder. In contrast to the damage observed on the outer race, the inner race damage was heavily oxidised and showed evidence of blueing in places, as well as material tongues rolled into the surface (Figure 12). Material removal in the form of pits was evident in the raceway. The damage on the shoulder was consistent with balls having run along it.

Inner race of input shaft, inner bearing

Reduced lubrication would have caused increased friction in the rolling elements of the bearings, resulting in excessive temperatures. Evidence of overheating (blueing) and oxidation on the inner race of the input shaft inner bearing indicated that the bearing had been running hot. An absence of similar indications on the outer race suggested that the inner race was running hotter than the outer race; possibly because the outer race was in contact with the TRGB casing that is air cooled. The bearing cage showed evidence of resin loss, indicating that it had likely exceeded its maximum operating temperature of 107 °C. This would have made the cage brittle. Increased drag on the cage by the balls due to a lack of lubrication is likely to have caused the cage to fail, especially in its embrittled condition. The final failure may have been precipitated by the higher loads that would have been placed on the transmission as the pilot brought the helicopter into the hover.

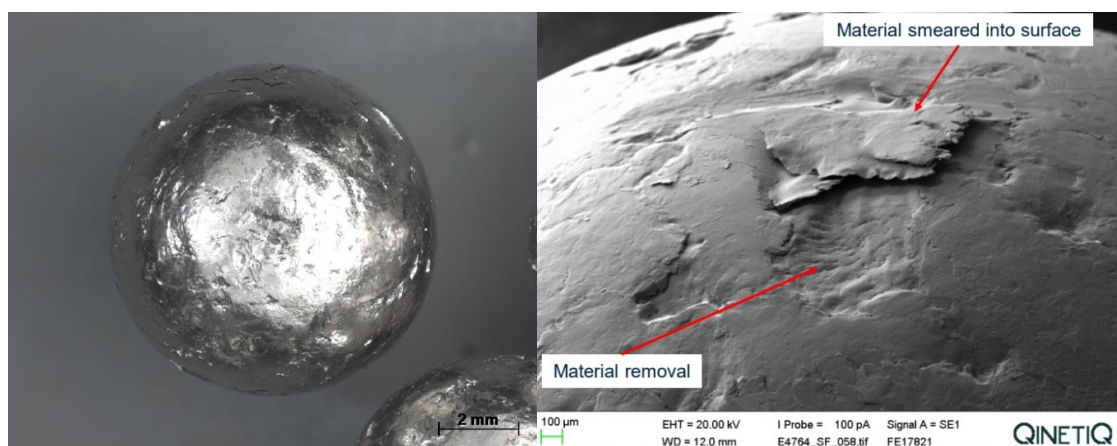
Figure 13

The surfaces of the 10 balls were deformed, with material removal, surface dents and tongues of smeared material present (Figure 13).

Example of damage to ball from input shaft,
inner bearing (left) and detailed SEM view (right)

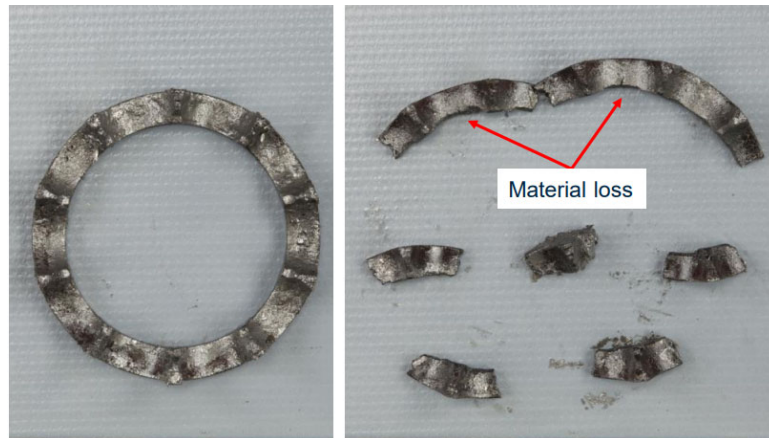
Figure 14

The bearing cage is a single-piece cotton-fibre reinforced phenolic resin cage, formed from two faces joined by axial posts. The cage had broken into eight pieces; one piece made up the whole of one face and the remaining seven pieces made up the other face (Figure 14). Material loss was evident on the inner circumference of the face that had broken into seven pieces, but not on the inner circumference of the intact face. SEM examination of one of the fractured axial posts showed cotton fibres present with very little phenolic resin visible. Resin was also missing from the sidewall adjacent to the fracture.

Cage from input shaft, inner bearing

Once the bearing cage had failed, the balls within the bearing would no longer be separated or equally spaced. This would allow contact between adjacent balls (with an associated increase in friction and temperature), unequal loading, and damage to both the raceways and balls. Damage observed on the shoulders of both raceways provided evidence that the balls had moved out of the raceway. Either this, or grouping together of all the balls, is likely to have caused the input shaft to move out of axial alignment. Loss of alignment would alter the normal engagement of the input and output bevel gears so that they could move apart. This in turn would result in increased contact between the tips of the teeth, leading to skipping and deformation. When the deformation progressed to the extent that the gears were effectively 'toothless' (Figure 7), there would have been no effective connection between the TRGB input and output shafts. At this point, the anti-torque thrust from the tail rotor would have been lost, resulting in the rapid rotation of the helicopter and subsequent loss of control.

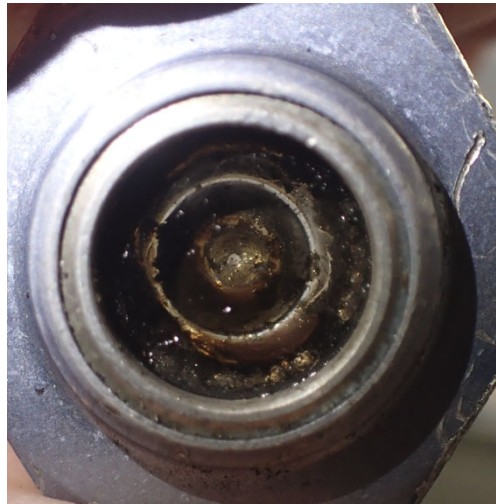
Figure 15

Examination of the oil sight glass showed that it had dark coloured deposits of oil present on the inside of the glass (Figure 15). The sight glass was fitted to a test container and oil was then gradually added so that when viewed from the inside of the container, the oil level could be set at just below the sight, at its centre and above it. However, when viewing the oil level from the outside of the sight glass, its appearance did not significantly alter such that it was unclear as what level the oil was inside the container.

Oil quantity sight glass removed from G-OJBB's TRGB

The sight glass was found to be covered in dark deposits. Testing showed that in this condition, it did not provide a clear indication of the actual oil level. The engineer could not recall if he had cleaned the sight glass during the annual inspection. If not, it is possible that the deposits on the glass affected the engineer's ability to read the oil level. Several similarities were noted with a previous serious incident investigated by the AAIB on another helicopter type, which resulted in an insufficient quantity of oil in the TRGB. In that case the sight glass was darkly stained and gave the illusion of a satisfactory oil level.

It is recommended that Enstrom Helicopter Corporation amends the wording in Section 4-15 of the Enstrom F28F and 280F series Maintenance Manual, to clearly identify the minimum and maximum oil levels required for tail rotor gearbox operation.
