## ACCIDENT

<b>Aircraft Type and Registration:</b>	Piper PA-23-250, G-BJNZ	
<b>No &amp; Type of Engines:</b>	2 Lycoming IO-540-C4B5 piston engines	
<b>Year of Manufacture:</b>	1979 (Serial no: 27-7954099)	
<b>Date &amp; Time (UTC):</b>	2 April 2022 at 1535 hrs	
<b>Location:</b>	Enfield, Greater London	
<b>Type of Flight:</b>	Private	
<b>Persons on Board:</b>	Crew - 1	Passengers - 3
<b>Injuries:</b>	Crew - None	Passengers - None
<b>Nature of Damage:</b>	Damage to the engines, propellers, landing gear, left flap and underside of the fuselage	
<b>Commander's Licence:</b>	Private Pilot's Licence	
<b>Commander's Age:</b>	67 years	
<b>Commander's Flying Experience:</b>	1,859 hours (of which 1,090 were on type) Last 90 days - 33 hours Last 28 days - 21 hours	
<b>Information Source:</b>	AAIB Field investigation

## Synopsis

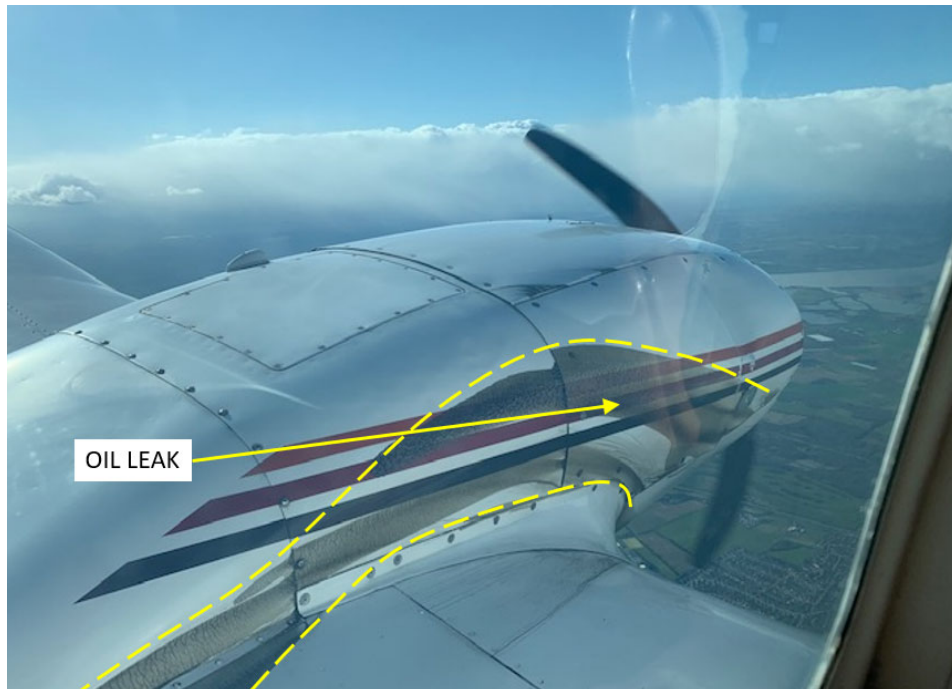
**Figure 2**

G-BJNZ took off for the return flight to Wellesbourne at 1422 hrs. The pilot followed a standard instrument departure and climbed to FL90 routing towards Lydd then Detling (the route flown is shown in Figure 1). The pilot reported that at FL90 he was above the convective weather present in the English Channel on the day. As the aircraft approached DET, still at FL90, the pilot observed oil leaking from the left engine (Figure 2). The oil pressure, oil temperature and cylinder head temperature indications were normal, but oil was clearly visible on the engine cowling. Shortly afterwards the left engine started to vibrate, so the pilot elected to shut the engine down and feather the propeller.

Photograph taken inflight of the oil leak from the left engine

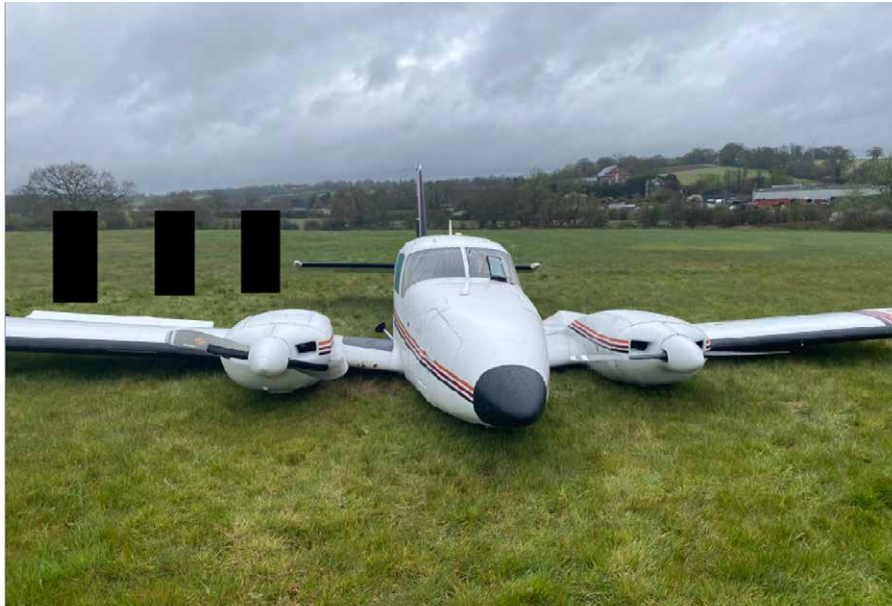
**Figure 5**

The aircraft landed in a grass field near Enfield, Greater London, approximately 7.8 nm from Elstree Aerodrome (Figure 5). Ground marks made by the aircraft showed that the landing gear had been extended at touchdown, before it had then rapidly collapsed. The right main

and nose landing gear legs were pushed upwards into their landing gear wells and the left main leg had detached. The left flap was partially detached from the wing.

G-BJNZ following the forced landing

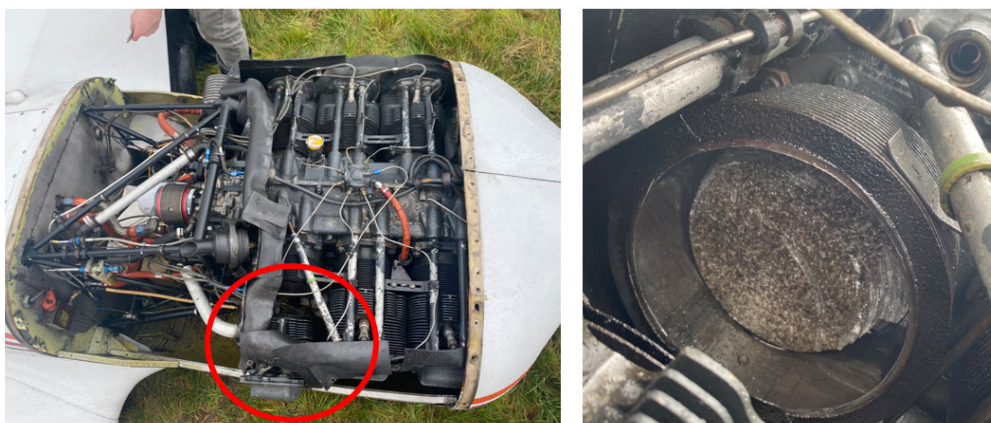
**Figure 6**

Left engine fractured No 5 cylinder and exposed piston

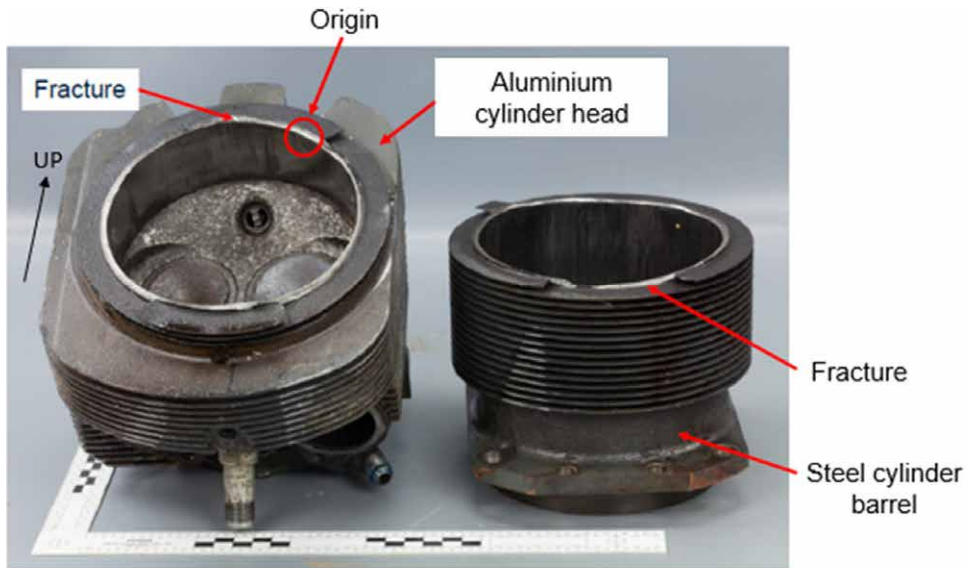
**Figure 7**

The fracture in the No 5 cylinder occurred in the steel cylinder barrel, 13 mm from the point where the aluminium cylinder head is screwed onto the steel barrel (Figure 7). The crack started at the 1 o'clock point on the barrel section, on the upper part of the cylinder.

Fracture location in No 5 cylinder (image courtesy QinetiQ)

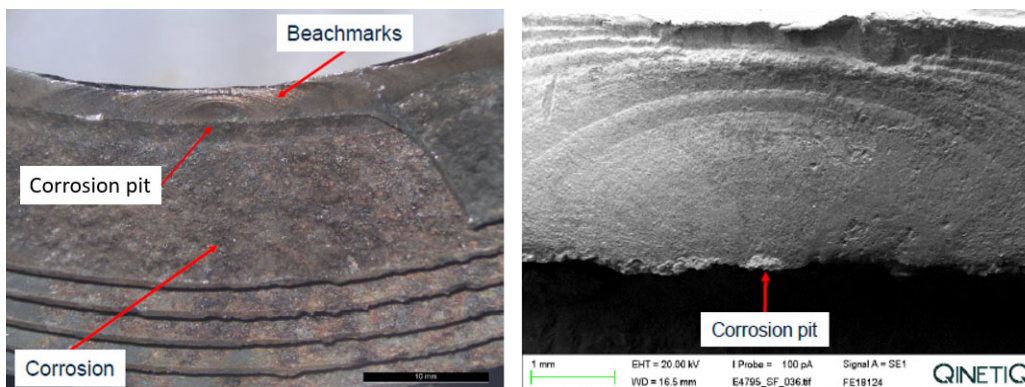
**Figure 8**

The fractured cylinder was examined by a metallurgist who concluded that the crack originated at a corrosion pit on the cylinder's outer surface (Figure 8). The steel barrels of all the other cylinders of both engines were inspected and all were observed to be corroded on their outer surfaces.

Corrosion pit at crack origin (images courtesy QinetiQ)

The left engine failed as a result of a fatigue crack in the steel barrel section of the No 5 cylinder, originating at a corrosion pit. The differential-compression test carried out at the annual inspection did not identify low compression in the cylinder and it is possible that the crack developed during operation of the aircraft after the annual inspection was carried out.

The licenced engineer who carried out the inspection did not consider the surface corrosion present on the cylinders to be a cause for their rejection. The guidance material in GR No 24 relating to corrosion does not contain any quantitative limits on the acceptable degree of cylinder corrosion. Cylinder corrosion is a common observation in the UK general aviation fleet and the CAA stated to the AAIB that assessment of the degree of cylinder corrosion, and any resulting decision to reject cylinders due to excessive corrosion, remains within the engineering judgement of licenced engineers.

The aircraft's maintenance organisation has amended its maintenance programme for aircraft fitted with piston engines operating beyond the manufacturer's recommended overhaul life. The revised maintenance programme includes a rate-of-climb air test to detect a loss of engine power output and introduction of an oil sample analysis monitoring programme.

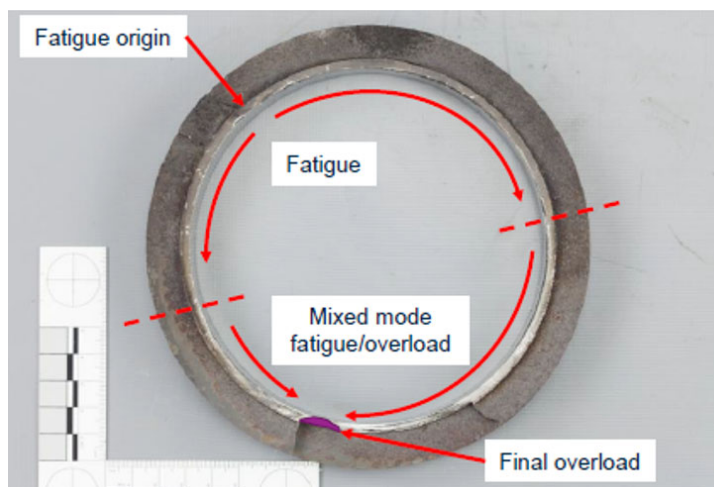
**Figure 9**

The fracture propagated by fatigue for approximately 50% of the cylinder cross-section (Figure 9). The fracture then continued to grow in a mixed fatigue-overload mode, before the cylinder finally failed in overload.

Crack growth progression (image courtesy QinetiQ)

The fracture surface was coated in a layer of lead bromide, a component of exhaust gases. The degree of coating varied along the fracture surface, with the heaviest deposits around the crack initiation site. This indicates that the cracking had occurred progressively, whilst the engine was operating, although it was not possible to accurately state when the cracking had started.

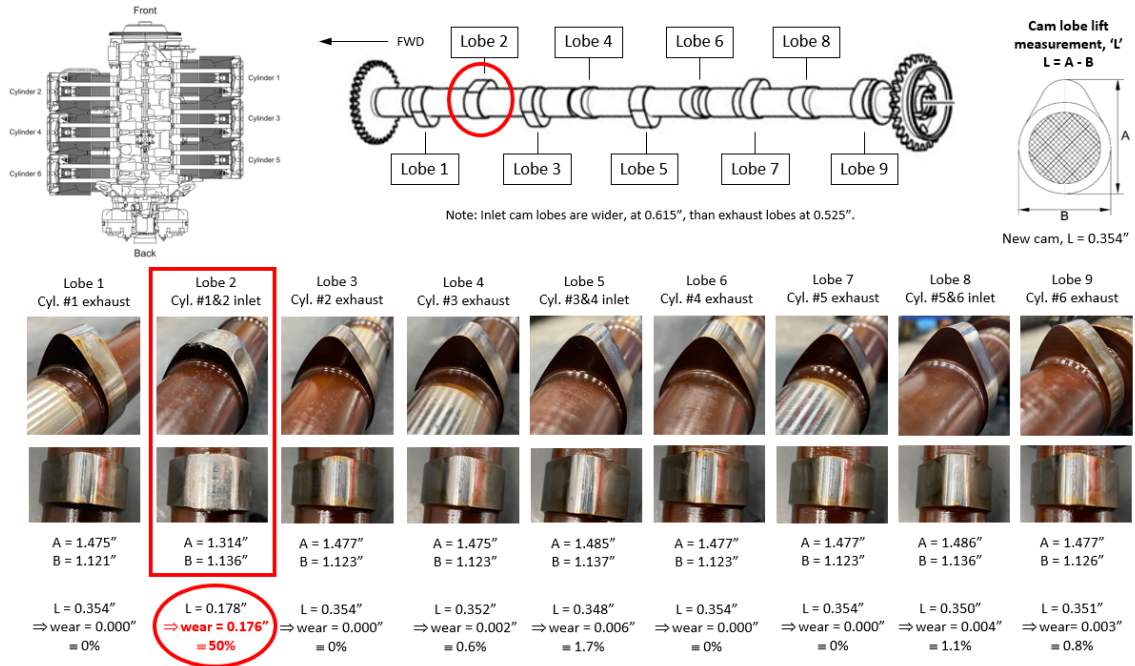
The engine was disassembled to determine the condition of its components. Severe wear was noted on the second camshaft lobe, which actuates the inlet valves for both the No 1 and No 2 cylinders (Figure 10). The lift of this camshaft lobe was measured to be 0.178", which is approximately 50% of the lift of an unworn camshaft. The other eight camshaft lobes showed minor wear that would not have significantly affected the engine's performance.

**Figure 10**  
Measured wear of G-BJNZ's right engine camshaft lobes

The aircraft's right engine was found to produce only 81% of its stated power output when tested after the accident. Severe wear of the second camshaft lobe was identified, which resulted in a significant loss of inlet valve lift for the engine's No 1 and No 2 cylinders. This is likely to account for most of the engine's power deficit, as no other major defects were noted when the engine was examined.

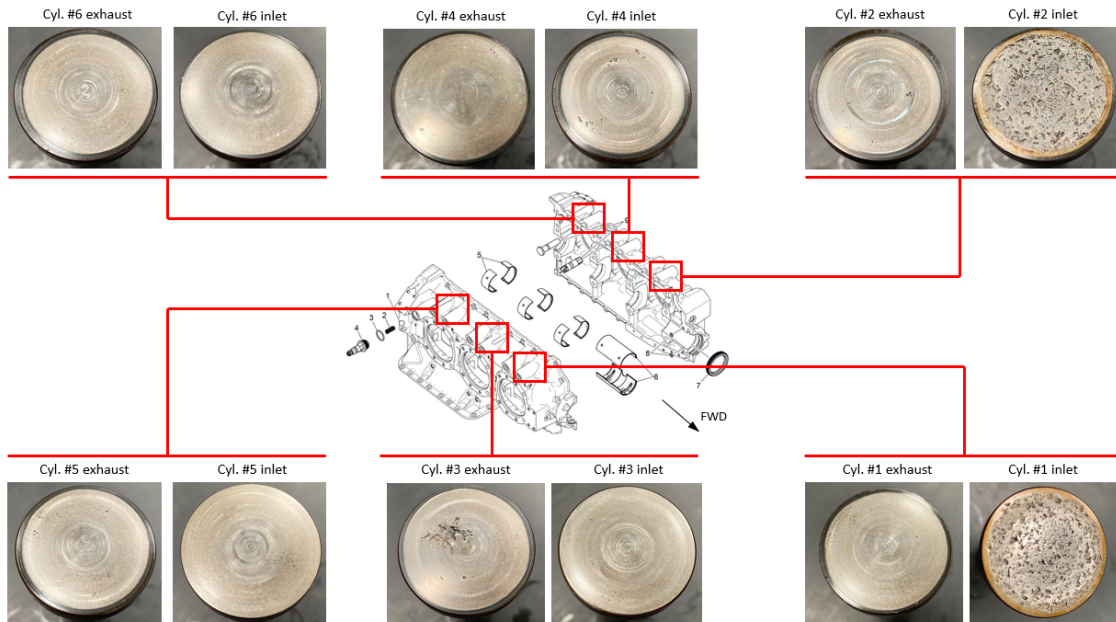
The faces of the hydraulic tappet bodies for the No 1 and No 2 inlet valves, which are in direct contact with the second camshaft lobe, exhibited heavy surface spalling (Figure 11). The tappet bodies transmit motion of the camshaft into movement of pushrods that actuate the inlet and exhaust valves. The other tappet bodies exhibited surface spalling and visible wear which would require their rejection at engine overhaul.

**Figure 11**  
Observed wear of G-BJNZ's right engine tappet bodies
