## ACCIDENT

<b>Aircraft Type and Registration:</b>	Freefly Systems Inc. Alta X	
<b>No &amp; Type of Engines:</b>	4 electric motors	
<b>Year of Manufacture:</b>	2021 (Serial no: Q848350)	
<b>Date &amp; Time (UTC):</b>	29 June 2022 at 1124 hrs	
<b>Location:</b>	Henley-on-Thames, Oxfordshire	
<b>Type of Flight:</b>	Commercial Operations (UAS)	
<b>Persons on Board:</b>	Crew - N/A	Passengers - N/A
<b>Injuries:</b>	Crew - N/A	Passengers - N/A
<b>Nature of Damage:</b>	Aircraft not recovered	
<b>Commander's Licence:</b>	Other	
<b>Commander's Age:</b>	53 years	
<b>Commander's Flying Experience:</b>	831 hours (of which 18 were on type) Last 90 days - 73 hours Last 28 days - 28 hours	
<b>Information Source:</b>	Aircraft Accident Report Form submitted by the pilot and further AAIB enquiries

## Synopsis

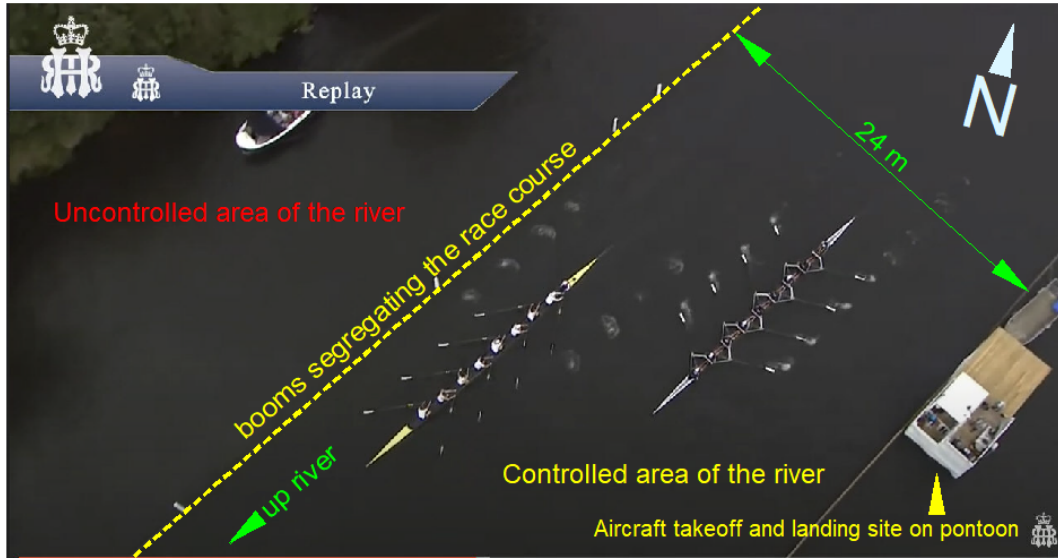
**Figure 1**

At 1120 hrs, the aircraft took off on its 21<sup>st</sup> flight of the day, which was to film race 35. The flight initially proceeded as normal, with the pilot flying the aircraft overhead two competing boats (Figure 1) at a height of about 50 m (164 ft agl). Operating on the uncontrolled side of the river were several privately operated boats. This included The Celtic Queen (Figure 2), which was travelling down-river. Onboard this boat were six people, of which two were seated near the bow of the boat.

Image taken from the aircraft's camera showing the takeoff and landing pontoon and the adjacent controlled/uncontrolled sides of the river

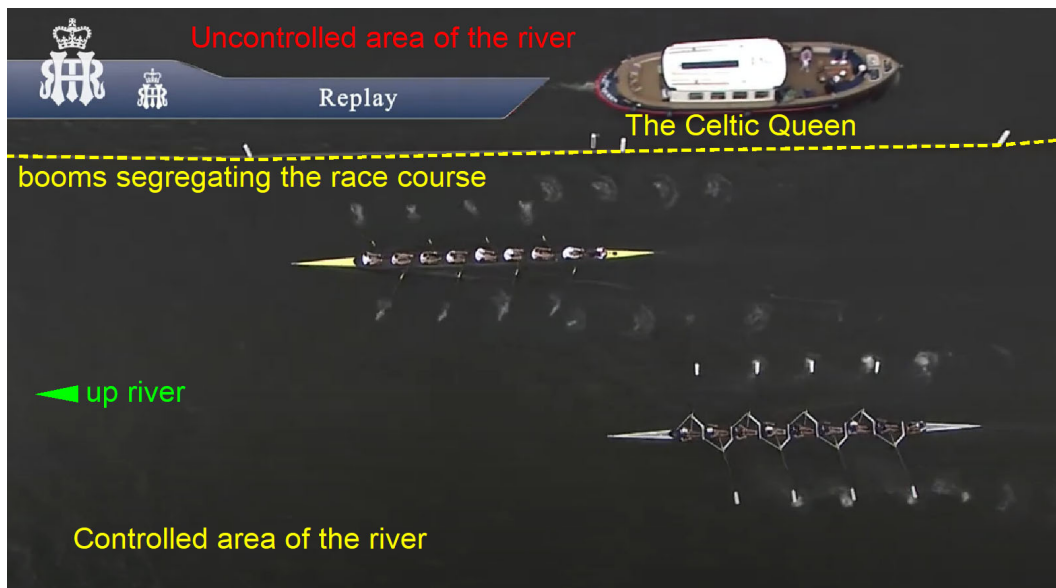
**Figure 2**

Image from the aircraft, with The Celtic Queen travelling down-river.

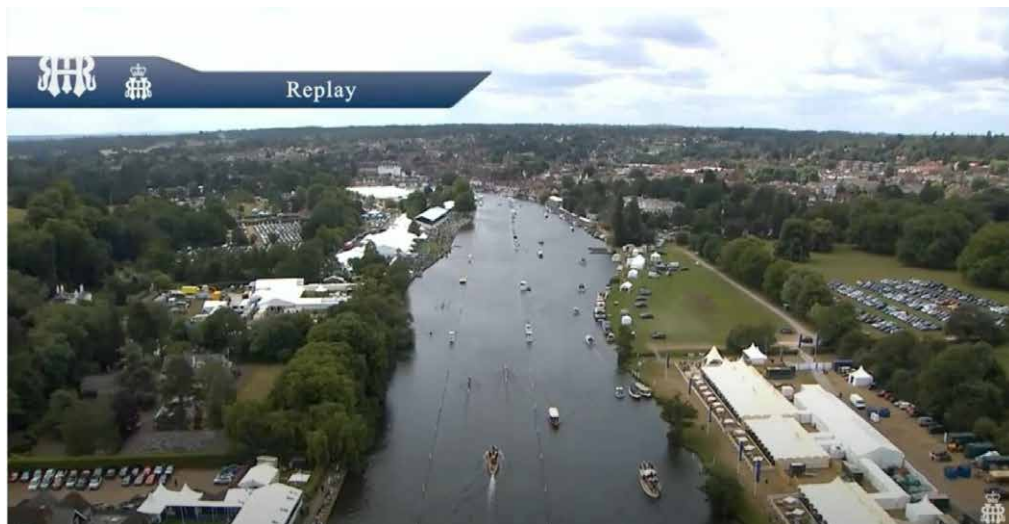
**Figure 3**

When the aircraft was about 250 m up-river from the pontoon, the aircraft's low voltage battery warning activated. The pilot responded by flying the aircraft back towards the pontoon to expedite its landing. However, when the aircraft was almost overhead the pontoon at a height of about 50 m, it stopped responding to the pilot's commands and started to rotate whilst also descending rapidly. The aircraft struck The Celtic Queen, which was now almost abeam the pontoon, before falling into the river. No persons were injured. One of the aircraft's batteries came to rest between the two passengers seated near the bow, which was about 2 m away from where the aircraft had struck the boat. The aircraft was not recovered from the river.

Image from the aircraft taken shortly before its loss of control

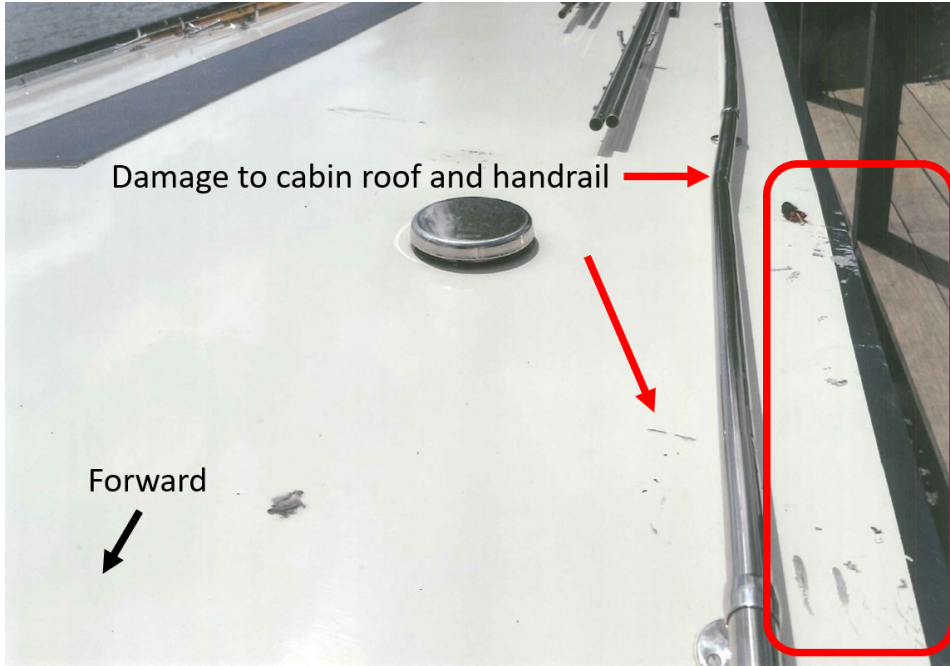
**Figure 5**

The aircraft had initially collided with the forward left side cabin roof causing deformation in a section of the stainless-steel handrail and damage to the surface of the roof (Figure 5). The aircraft then struck the left side of the cabin and adjacent gunwale, prior to it falling into the river and sinking. Composite material from the aircraft had been embedded into the wooden surface on the gunwale (Figure 6) and one of its batteries had detached from the aircraft and come to rest on the forward deck (Figure 7).

Damage to cabin roof and left side handrail

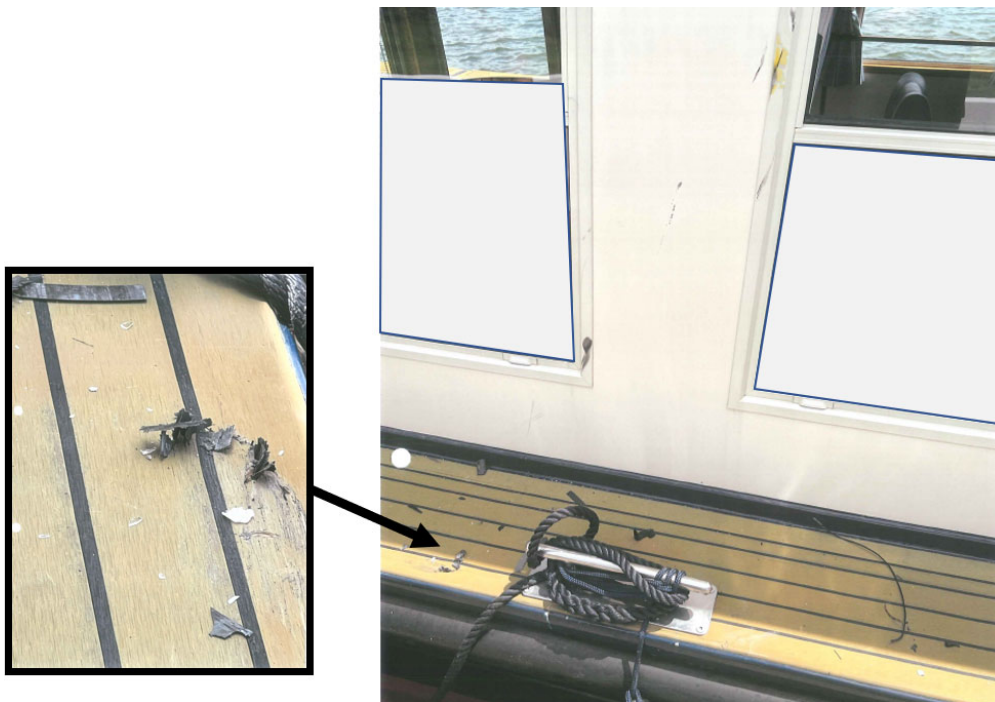
**Figure 6**

Damage to the cabin and gunwale

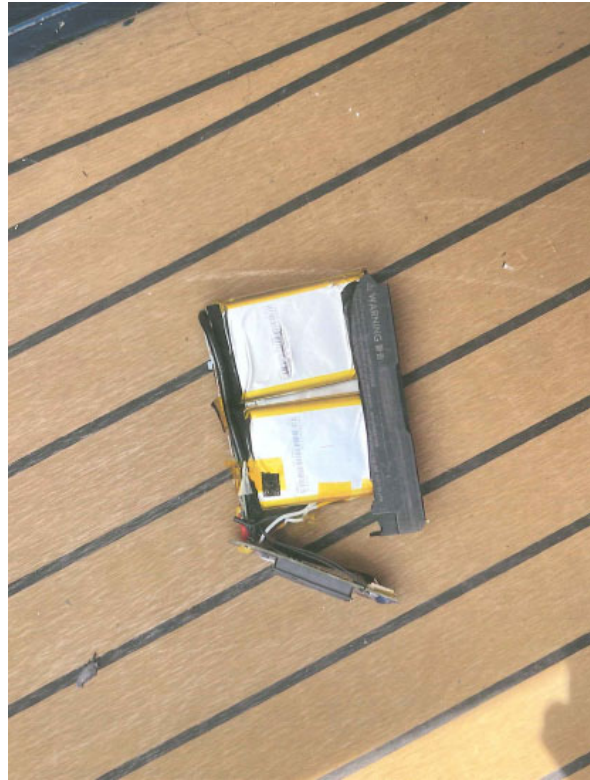
**Figure 7**

Aircraft battery on forward deck
