Our Reference:  
FOI2022/07075  
Date:  
4 August 2022

**ENGINEERING OFFICER'S EXECUTIVE SUMMARY - SEFIT 11-0133-SI SUPPORT VEHICLE (SV) CARGO LIGHT 6 TONNE 4X4 EURO 4 MAN, FULL BOWMAN FIT VRN – HK76AB FRONT LEFT HAND WHEEL STATION FAILURE**

CLAMP ASSEMBLY FAILURE

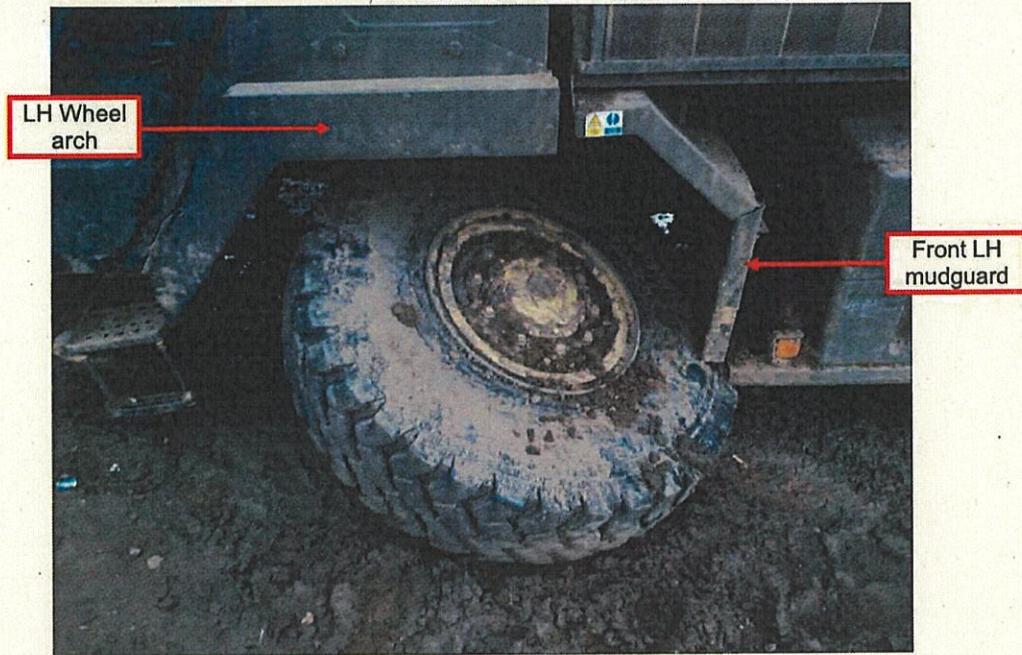
- a. The front LH wheel station complete with hub, mounting studs and wheel nuts was located inside of the LH wheel arch with its outer hub facing upwards position and was pushed up against the LH mudguard (Figure 4).

Figure 4 – LH wheel and hub

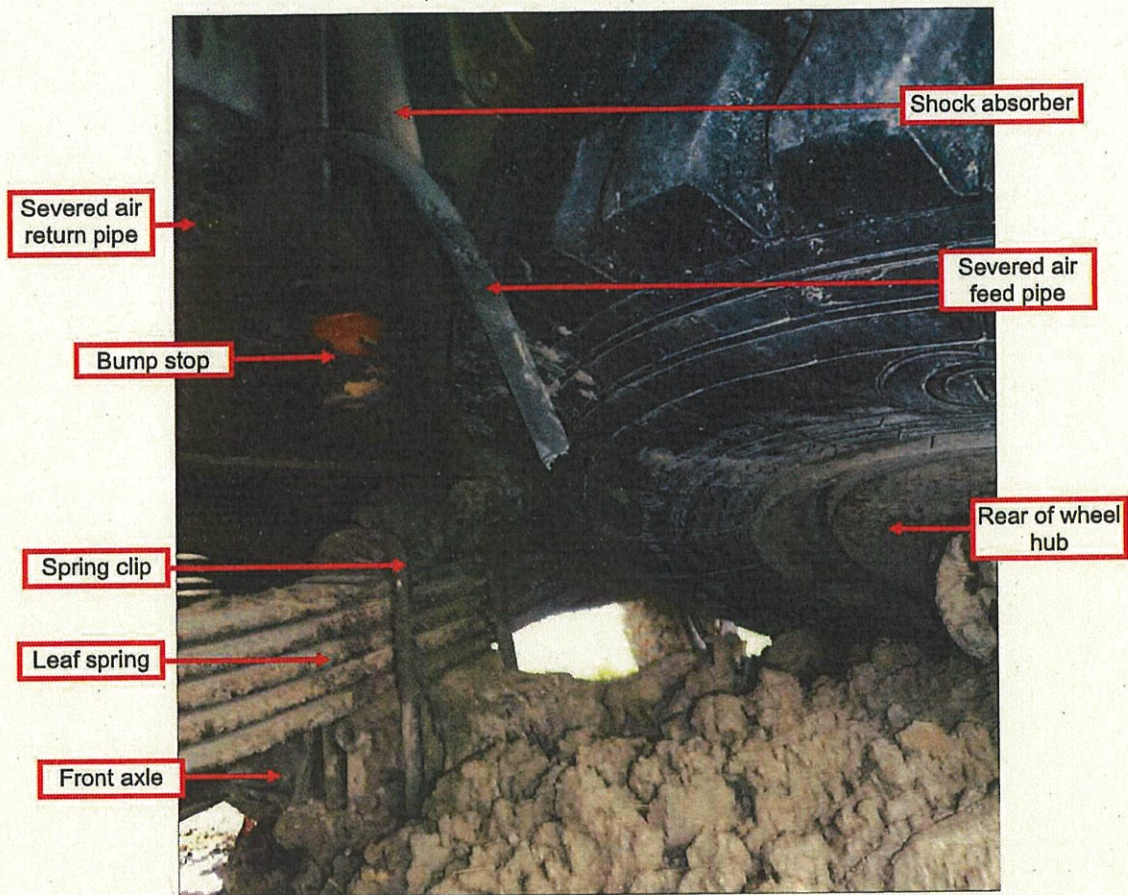
- b. The front LH side of the axle and the rear of the hub assembly were entrenched in the dirt. The air feed pipe, air return pipe, electrical cables and shroud had severed. The steering tie rod had disconnected at the knuckle joint on the damaged wheel station (Figure 5).

**Figure 5 – Area of front LH wheel station**

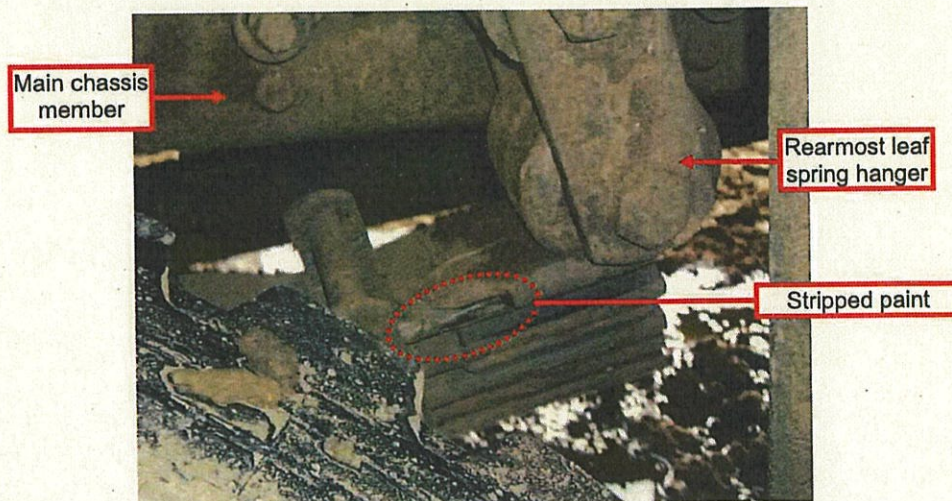
c. An area of stripped paint, consistent with contact with the tyre was noted on the leaf spring forward of the rearmost leaf spring hanger (Figure 6).

**Figure 6 – Stripped paint on leaf spring**

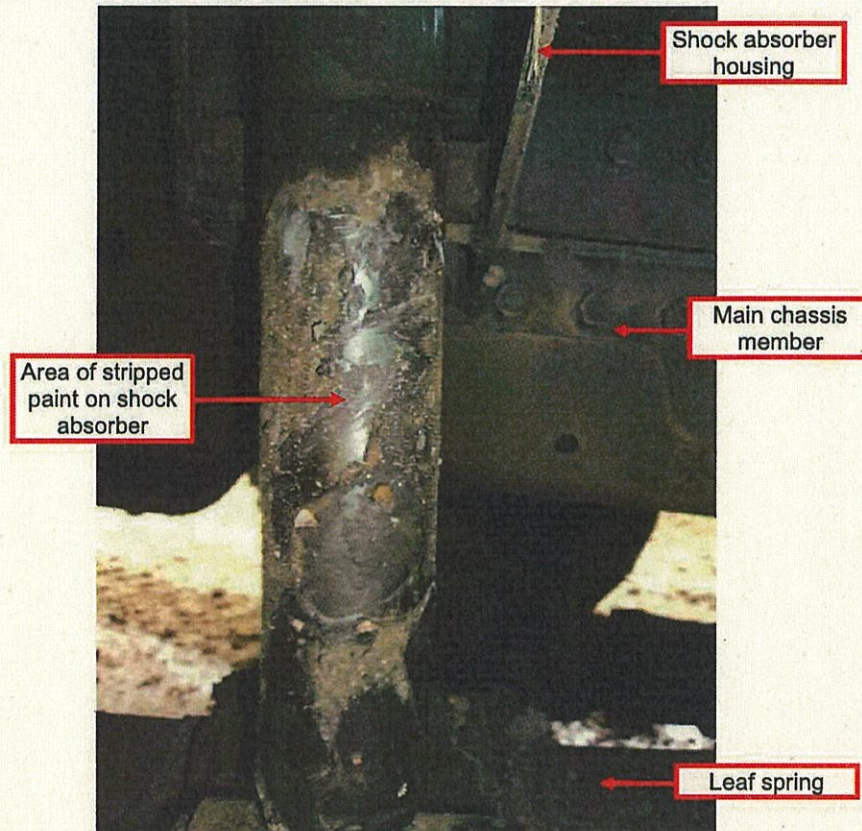
d. A further area of stripped paint was noted on the shock absorber directly in line with the upper, outer circumference of the front LH tyre (Figure 7).

Figure 7 – Stripped paint on shock absorber

16. The damage to the drive shaft is congruent with impact damage, harsh braking and subsequent failure of the upper and lower swivel housings, causing the driveshaft to hyper-extend and shear. At this point the air feed pipe, air return pipe and electrical cable have also been severed. Once disconnected from the axle the upper half of the tyre has made contact with the shock absorber, stripping the paint from its surface.

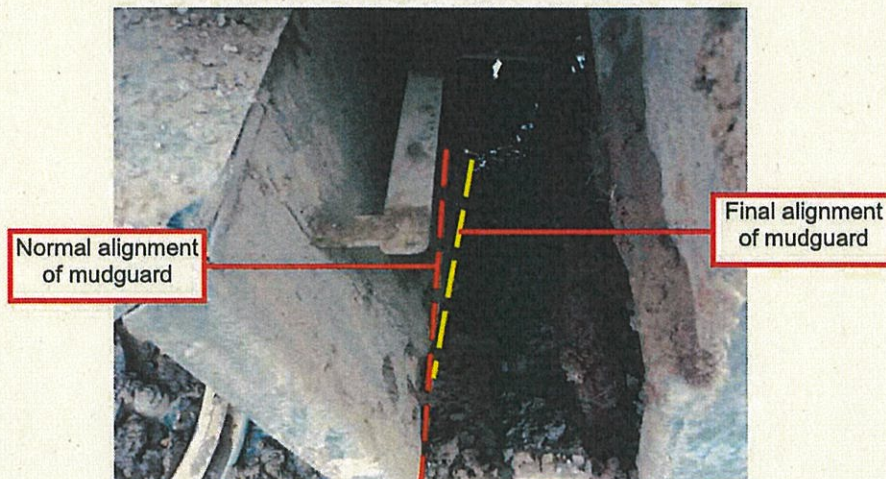
e. The front LH mudguard had suffered damage consistent with impact from the tyre and was deformed outwards (Figure 8).

Figure 8 – Deformed front LH mudguard

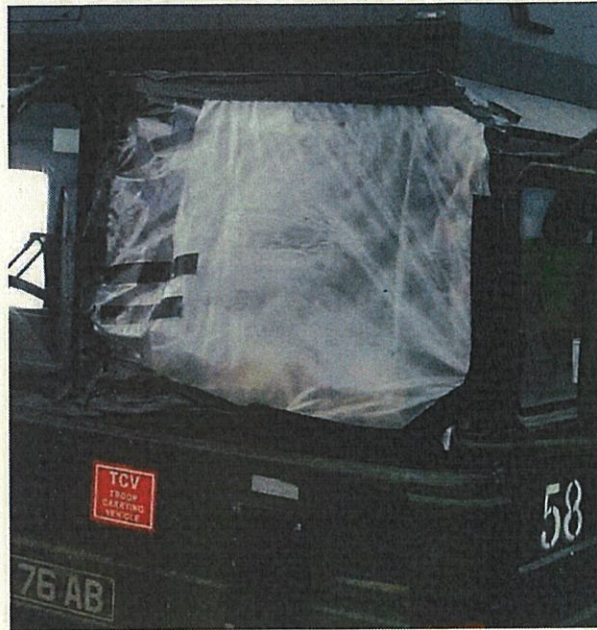
f. The LH windscreen was not fitted. 3 sheets of opaque plastic had been taped over the windscreen cavity (Figure 9).

Figure 9 – Plastic sheets taped over windscreen cavity

19. It is possible that the lack of a LH windscreen contributed to the incident. Had the commander been able to see the track conditions ahead he would have been able to advise the driver accordingly.

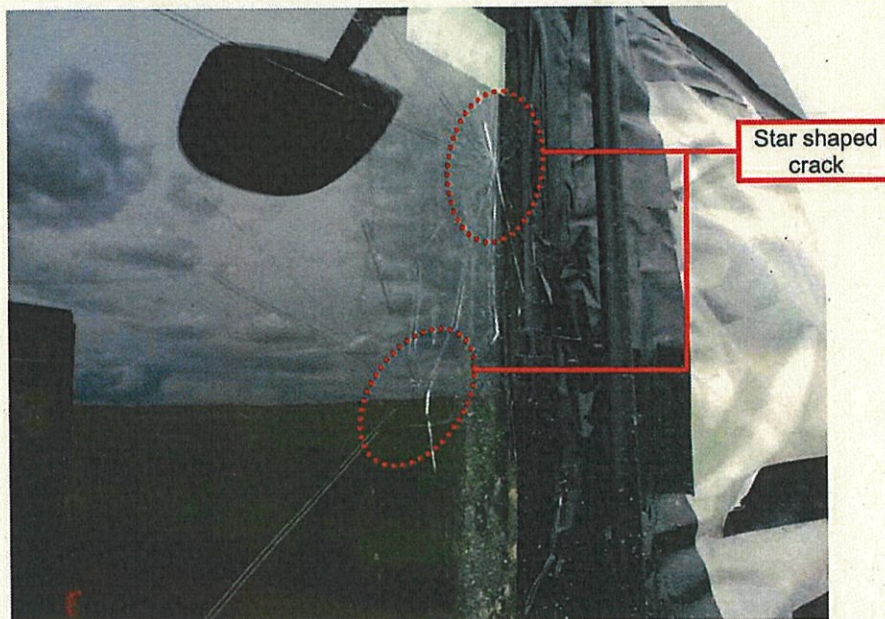
g. The RH windscreen had 2 distinct star shaped cracks in the area towards the central windscreen pillar. Both of these cracks had joined at various locations and radiated across the windscreen (Figure 10).

Figure 10 – Damage to RH windscreen

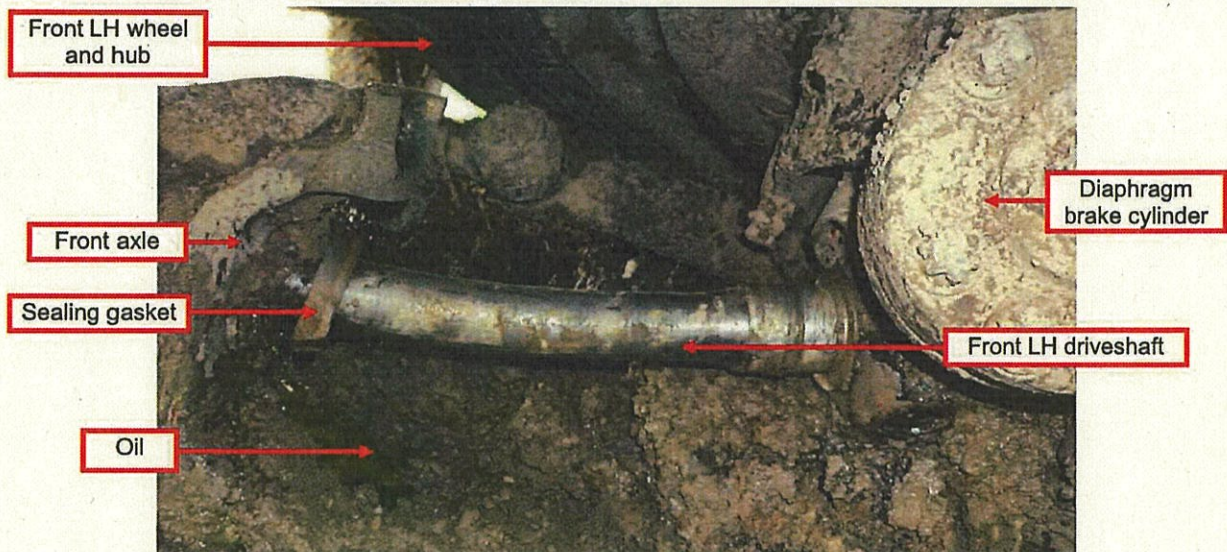
a. The front LH drive shaft had slid out of the cavity in the front axle and was bent upwards at the hub end. The sealing gasket at the axle end of the driveshaft had unseated and slid partially down the driveshaft allowing oil to leak (Figure 11).

Figure 11 – Front LH driveshaft damage

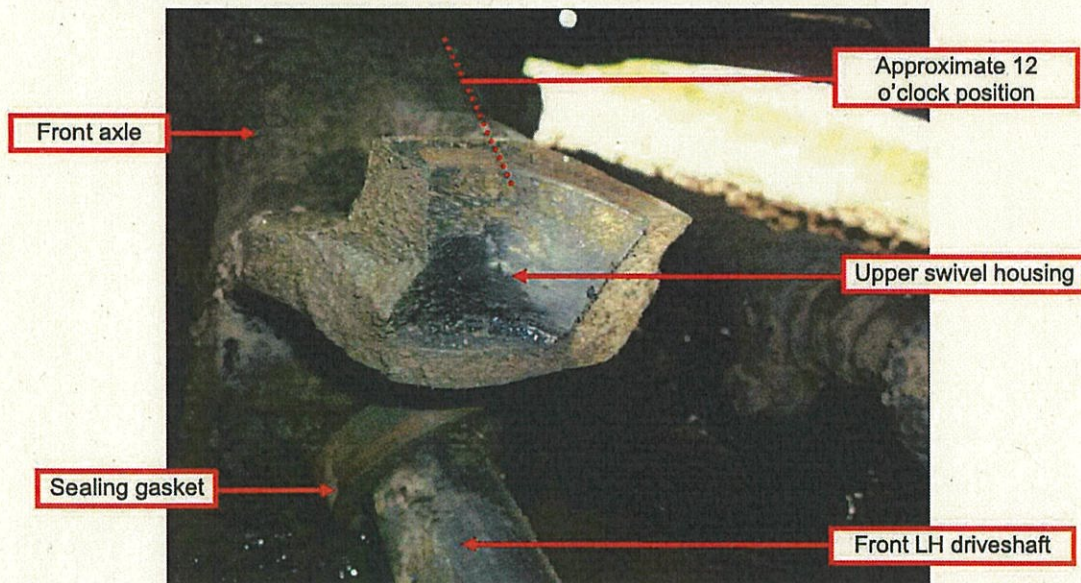
b. The upper swivel housing had sheared at both its upper and lower edges at the approximate 11 and 2 o'clock positions from where the housing arm extends from the main body of the axle (Figure 12).

Figure 12 – Sheared upper swivel housing

15. The damage witnessed at the upper and lower swivel housings and driveshaft is consistent with the wheel station suffering an impact from below. This was further compounded by the effect of harsh braking placing excessive weight on the front end of the vehicle. The impact would have

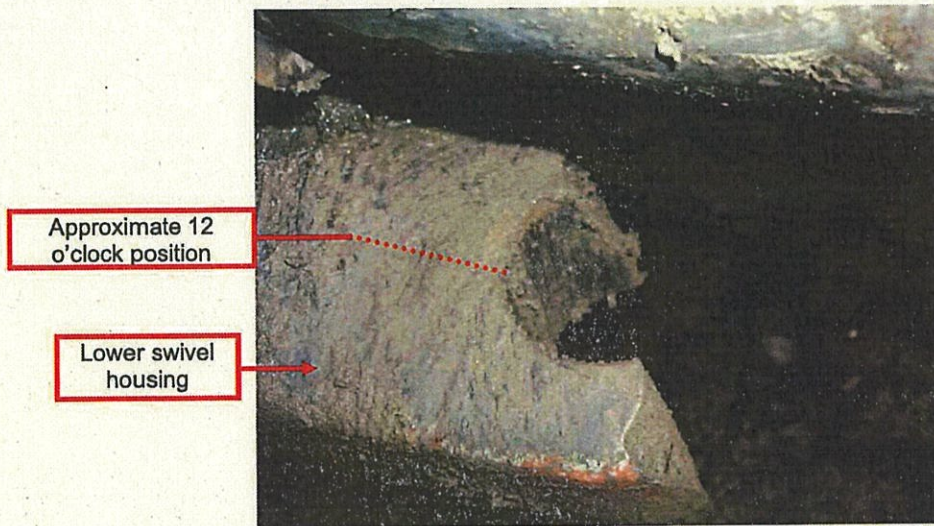
c. The lower swivel housing had sheared at the approximate 8 and 2 o'clock positions in the area where the lower trunnion locates (Figure 13).

Figure 13 – Sheared lower swivel housing

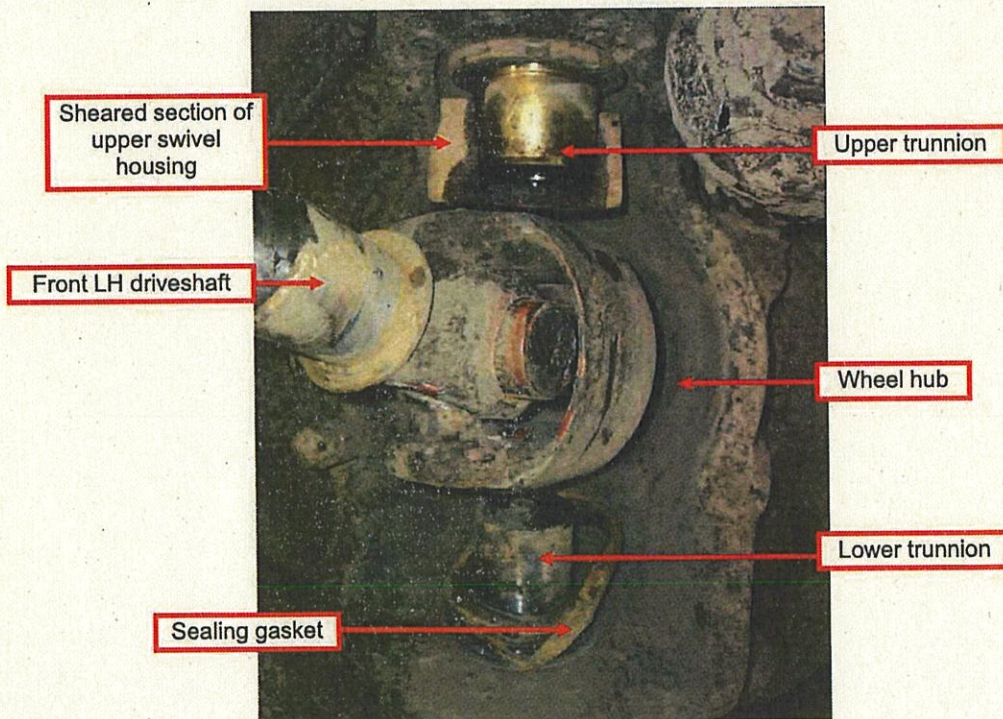
d. The connecting sheared section of the upper swivel housing was attached to the upper trunnion on the detached LH wheel hub. The upper and lower trunnions were also attached to the wheel hub. The sealing gasket on the lower trunnion had dismantled from its seat (Figure 14)

Figure 14 – Rear of LH wheel hub

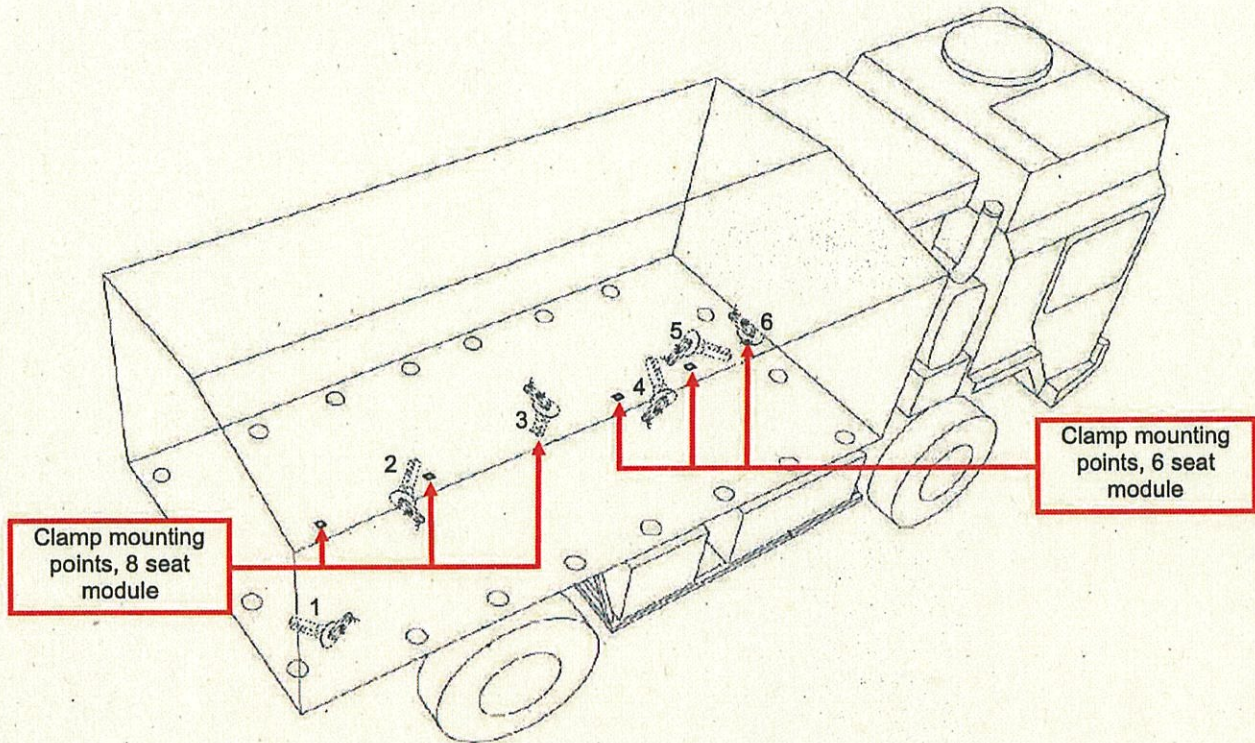
Figure 15 – Final positions and condition of TCV ES clamps

- a. Of the 6 clamps normally fitted to secure the seating modules to the cargo bed one clamp remained fully fitted in its mounting hole and one remained partially fitted (Reference E describes the operation and fitment of the clamps). Figure 15, labels 1-6 show the final positions and details the condition of the clamps at the time of investigation (For clarity the TCV ES modules are not shown).

Clamp No	Position
1	Located rear right of the cargo bed. Upper collar had detached from top plate and slid down the body of the clamp. Clamp unlocked and handle partially open.
2	Located across the central frame of the seating module. The clamp was undamaged and in the unlocked position.
3	Located partially seated in the mounting hole up to the upper collar of the clamp. The clamp was undamaged and in the locked position.
4	Located inside of the central frame of the seating module. The clamp was undamaged and in the locked position.
5	Located inside of the central frame seating module. The clamp was undamaged and in the unlocked position with the handle fully open.
6	Located within the mounting hole, fully fitted. The clamp was undamaged and in the locked position.

18. The TCV ES system moved as a result of the impact sustained to the subject vehicle. It is probable that the TCV ES mounting clamps were either not fitted or not tightened in accordance with Reference E which resulted in the 14 injuries. If the clamps had been fitted correctly and locked in place then similar damage witnessed in Reference F, would have been sustained to the clamps as they would have been forced from their mounting holes.

- (1) Immediately instigate a programme of further training aimed at drivers and commanders of MAN SV emphasising the need to ensure that TSV ES clamp assemblies are fitted correctly and frequently checked in accordance with Reference E.
- (2) Inspect the subject vehicle and make a repair decision.
- (3) Complete the attached RRF and return it to SEFIT (B) within 30 days of the date of the report.

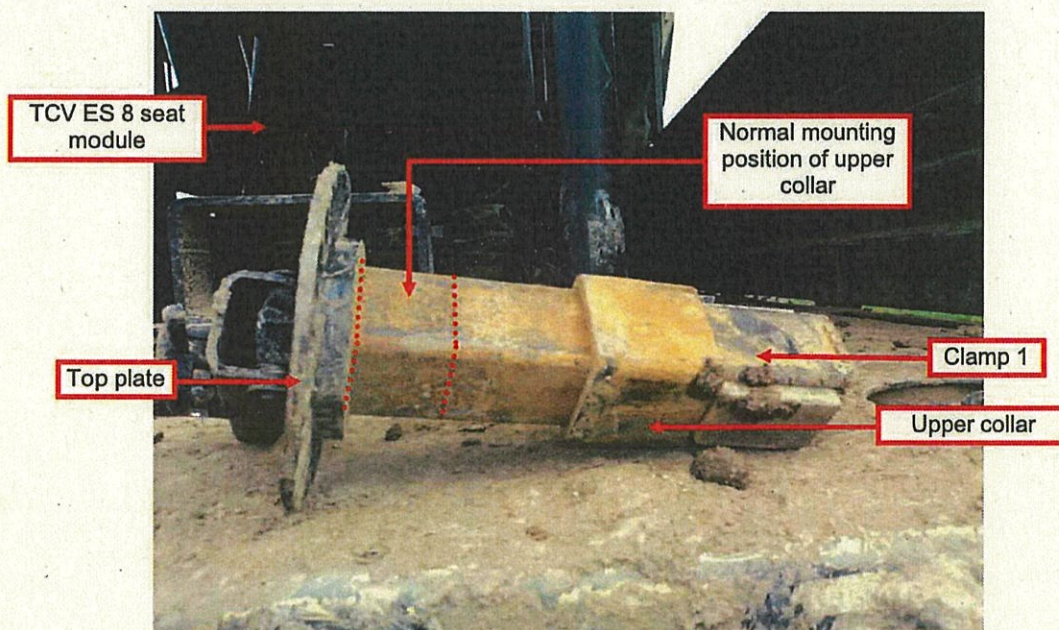
b. The rearmost clamps upper collar had slid down the body of the clamp. This collar is normally connected to the top plate of the clamp (Figure 16) (Reference F details a similar occurrence of a failed clamp).

**Figure 16 – Clamp 1 showing upper collar disconnected from top plate**

- (1) In accordance with the recommendations made in Reference F, further raise awareness of the TCV ES clamping system procedure.
- (2) Record the incident and monitor future trends.
- (3) Complete the attached Report Response Form (RRF) and return it to SEFIT (G) within 30 days of the date of the report.

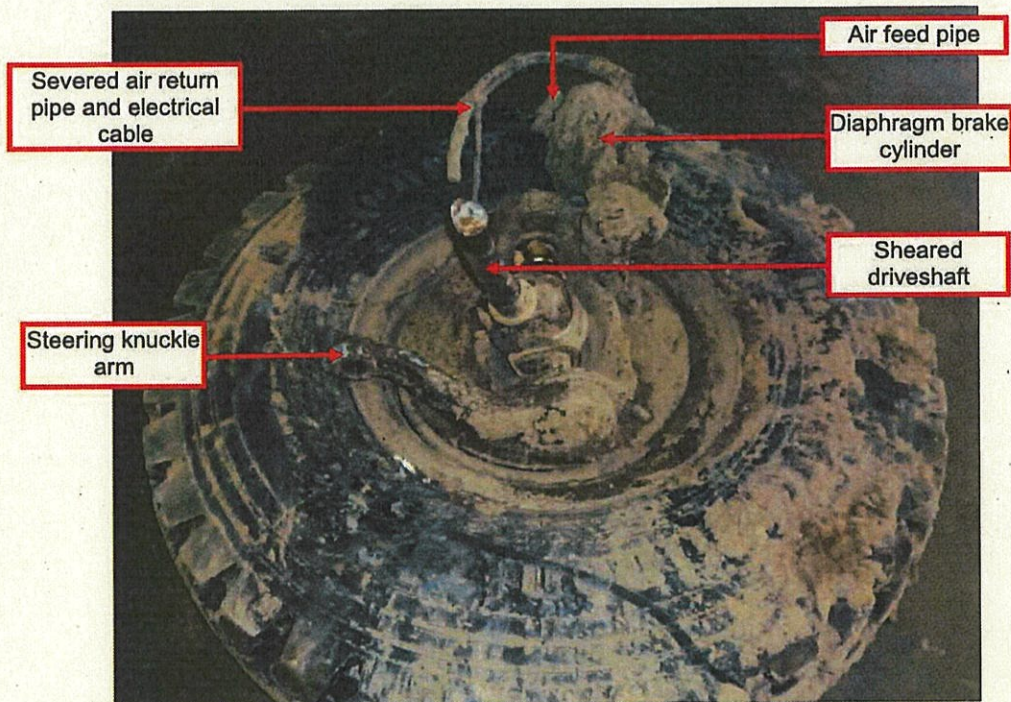
a. The driveshaft had sheared approximately 30 cm along its length away from the hub. The left steering knuckle arm and diaphragm brake cylinder were still attached to the hub. The air return pipe was severed approximately 30 cm from the connection at the hub end. The electrical cable was severed approximately 40 cm from the hub end; both the air return pipe and electrical cable were attached to the diaphragm brake cylinder. The air feed pipe had severed flush with its inlet on the diaphragm brake cylinder (Figure 17).

**Figure 17 – Rear of LH wheel hub**

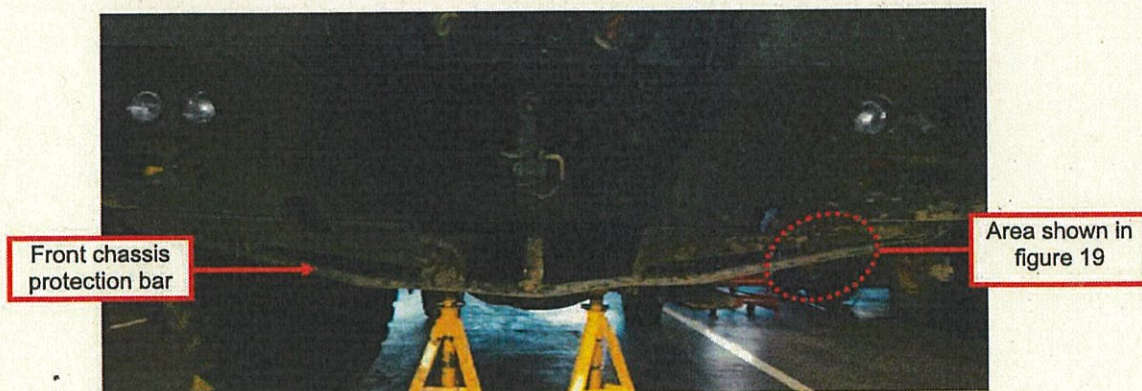
b. The front chassis protection bar had been pushed backwards and was deformed upwards on its RH side and had impacted with the leaf spring on the LH side (Figures 18 & 19).

**Figure 18 – Deformed front chassis protection bar**

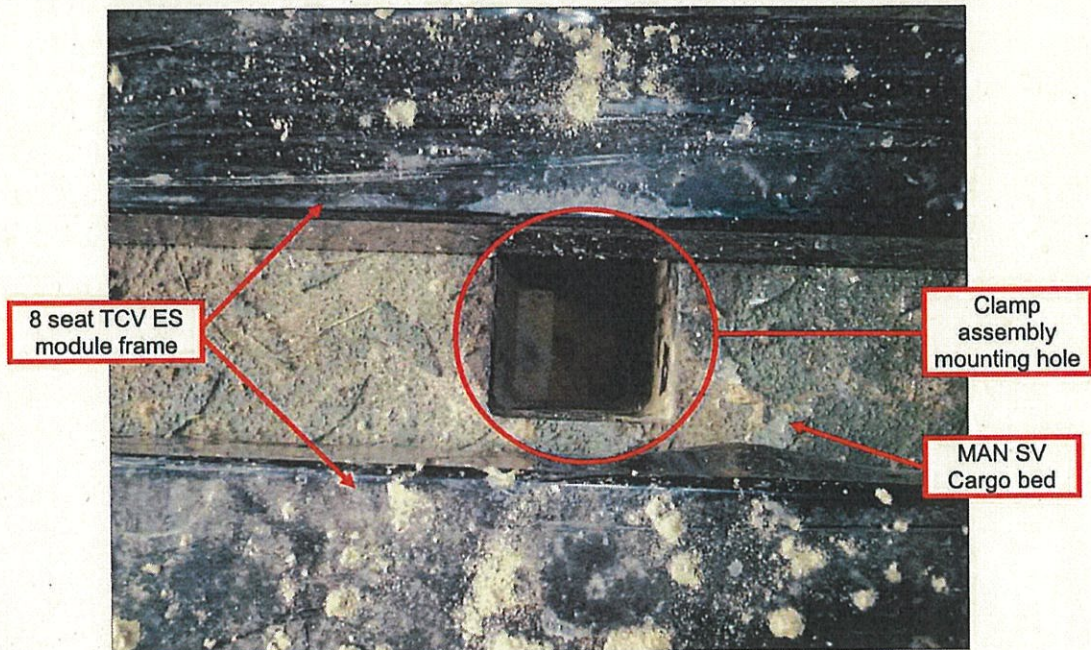
b. The rearmost clamp assembly of the 8 seat TCV ES module had been removed from its mounting hole by the driver at the scene of the incident. When manipulated by hand there was limited lateral movement of the seating frame. Figure 7 illustrates the failed clamp assembly mounting hole.

Figure 7 – Failed clamp assembly mounting hole

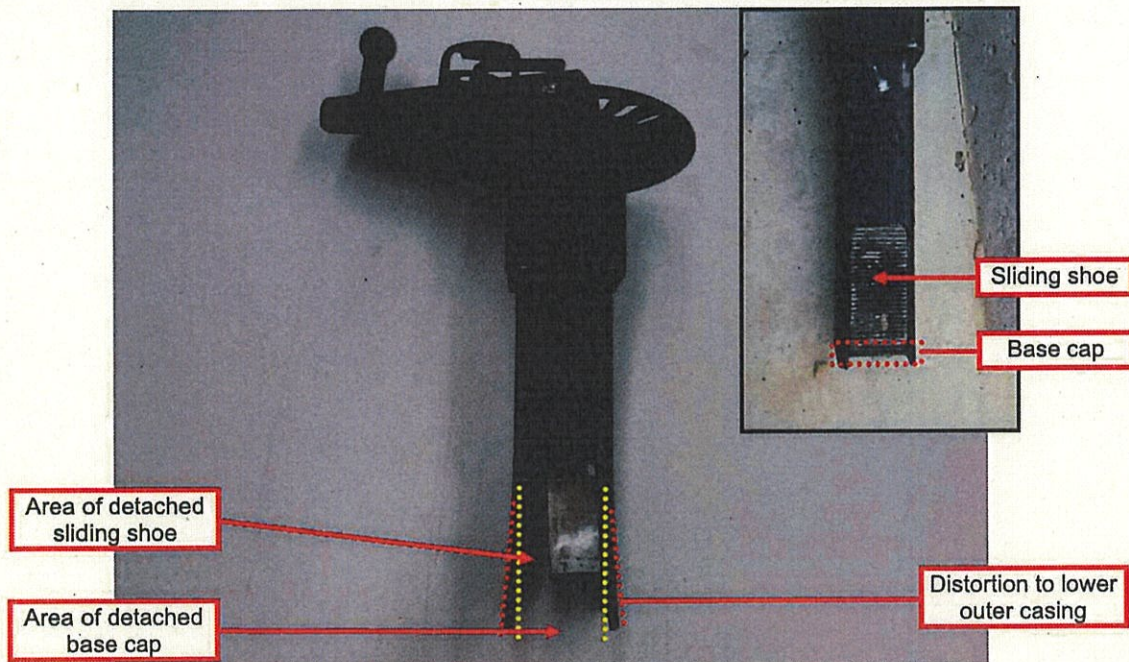
c. The base cap of the clamp assembly and both sliding shoes were detached, these were not recovered from the scene. The lower portion of the outer casing was distorted and the fitting points for the base cap had both fractured. The M16 screw shaft had sheared approximately 1 cm from its lower end (Figures 8 & 9).. The upper portion of the clamp assembly, handle and safety lever remained complete and operated as designed when tested.

Figure 8 – Failed clamp assembly showing distorted outer casing<sup>1</sup>

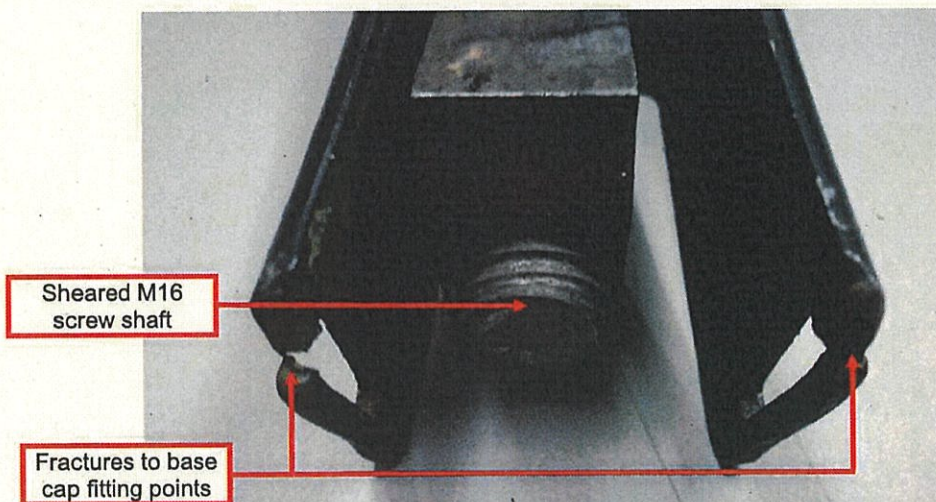
Figure 9 – Fractures to base cap fitting points and sheared M16 screw shaft

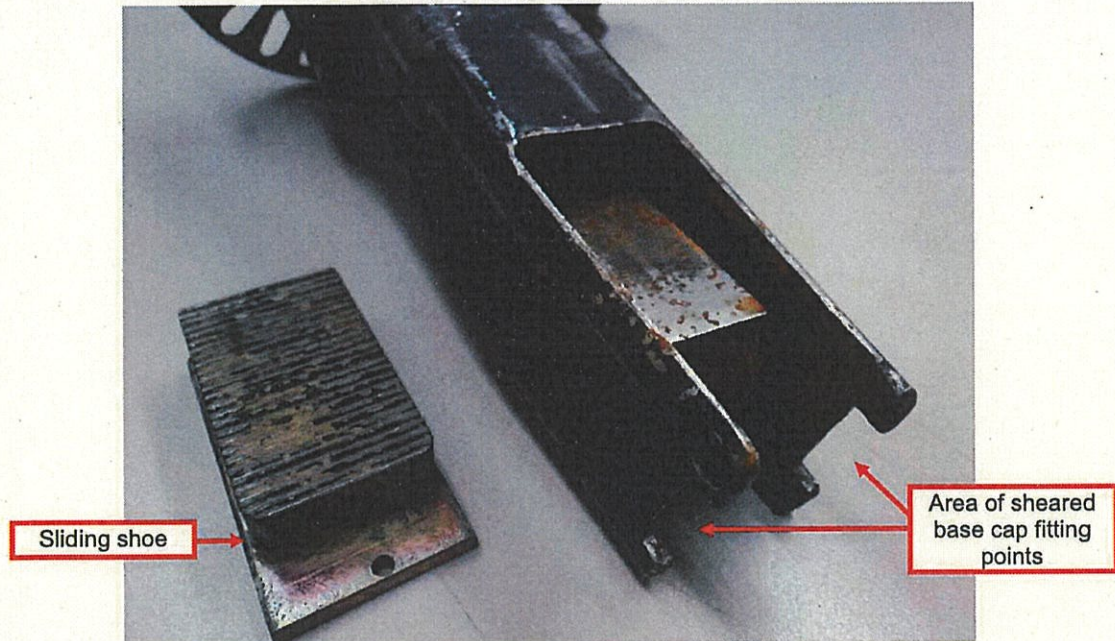
6. The TCV ES system on 4 further MAN SV 6T vehicles from the BATUS fleet were checked for serviceability, during which a second failed clamp assembly was found fitted to TCV ES Ser No – ESK02442. This clamp assembly had failed in a similar mode as the subject equipment. The base cap and one of the sliding shoes were detached from the clamp assembly and the base cap fitting points had sheared from the outer casing (Figure 10).

Figure 10 – Failed clamp assembly, Ser No - ESK02442

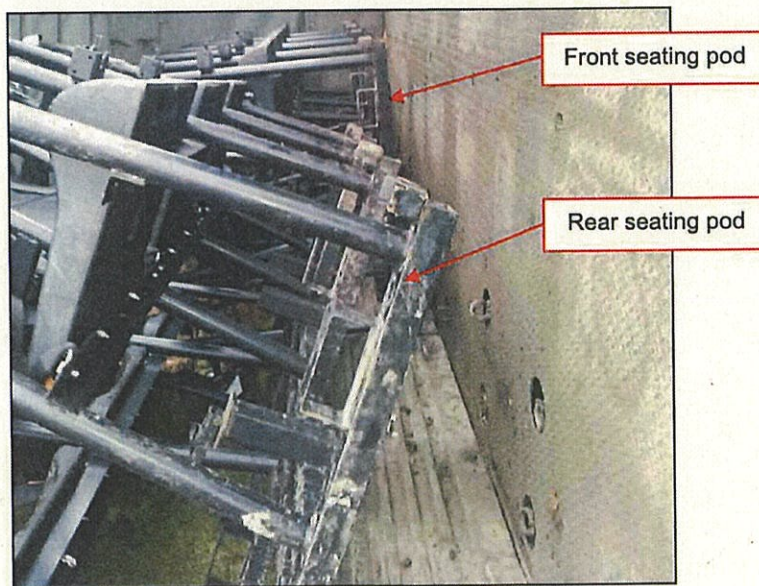
Figure 3 – Detached TCV ES Mk2 pods<sup>2</sup>

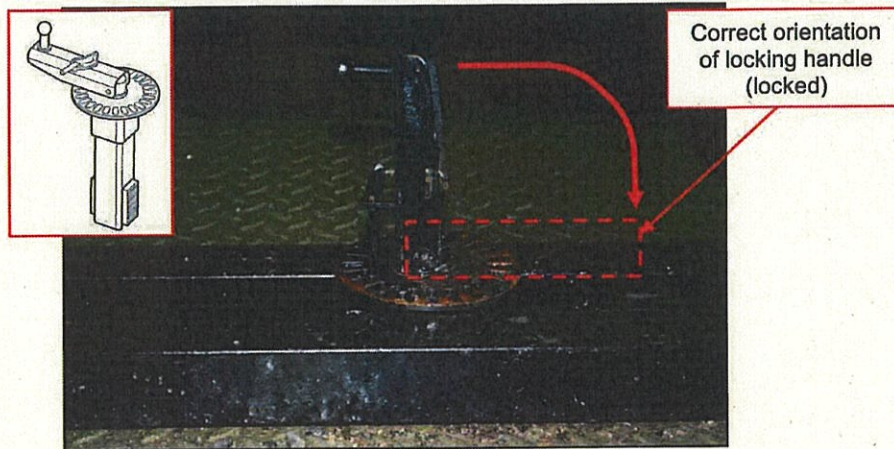
Figure 6 – Incorrectly fitted clamp<sup>3</sup>
