SERIOUS INCIDENT

Aircraft Type and Registration:	AW189, G-MCGV	
No & Type of Engines:	2 General Electric Co CT7-2E1 turboshaft engines	
Year of Manufacture:	2017 (Serial no: 92008)	
Date & Time (UTC):	7 January 2022 at 1622 hrs	
Location:	Lydd Airport, Kent	
Type of Flight:	Training	
Persons on Board:	Crew - 4	Passengers - None
Injuries:	Crew - None	Passengers - N/A
Nature of Damage:	Collapsed heating duct, contamination of cockpit and cabin by insulation particles	
Commander's Licence:	Airline Transport Pilot's Licence	
Commander's Age:	51 years	
Commander's Flying Experience:	5,823 hours (of which 963 were on type) Last 90 days - 79 hours Last 28 days - 14 hours	
Information Source:	Aircraft Accident Report Form submitted by the pilot

Synopsis

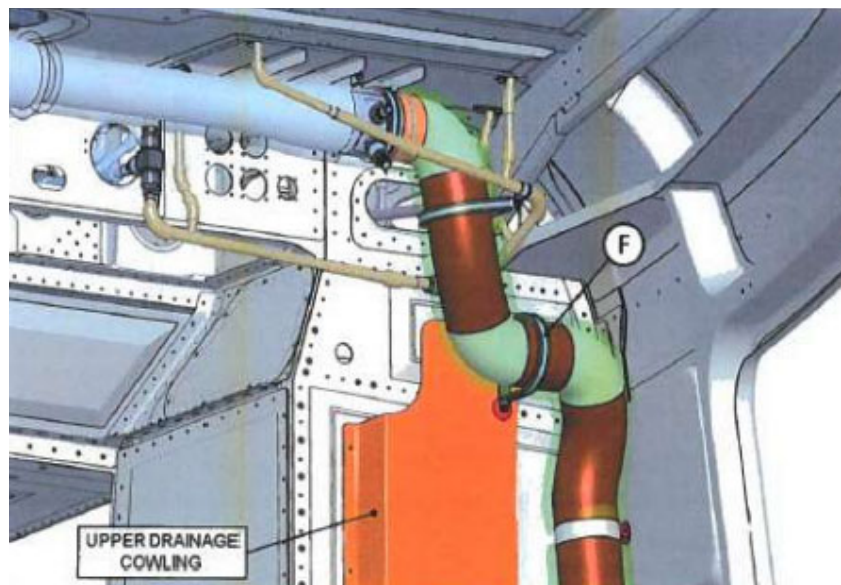
Figure 1

Subsequent examination showed that the aft heating duct had failed, allowing duct insulation material to be drawn into the heating and ventilation system.

Heating duct on AW189 showing flexible sections in brown and rigid sections in green (Circle 'F' indicates a securing 'P-clamp')

Following the aircraft manufacturer's laboratory examination of the failed ducts from G-MCGU and G-MCGT, they were sent to the duct manufacturer for further examination along with the failed duct from G-MCGV. The duct manufacturer determined that the relevant manufacturing processes and procedures were followed and the ducts met the applicable drawing specification. It also reviewed the bonding of the duct joints, the manufacturing instructions, the aircraft installation and the qualification test data for the ducts. While recognising that non-uniform adhesion of the bonded joints was evident on the failed ducts, the duct manufacturer considered that it did not mean this was the single causal factor resulting in the failure of the ducts. It indicated that redesign considerations would take account of improving the strength of the bond between the flexible and rigid sections of duct, reducing the number of joints and relocating clamping positions to rigid duct elements, thereby reducing the ability of the duct to creep along the clamp over a number of flight cycles.

As a result of the duct failure on G-MCGV, the aircraft manufacturer plans to publish Revision A of SB189-296 in the fourth quarter of 2022, to provide further instructions on the installation of the heating duct. Revision A will require removal of the duct from the aircraft and reinforcement of the duct joints by the application of aramid lacing tape and silicon covered glass cloth tape. It will also require additional fixing points to be added and will introduce a change to the sequence of the duct installation instructions to avoid introducing any pre-load on the duct. The intention is that helicopters already compliant with the original issue of SB 189-296 must also comply with Revision A.
