## ACCIDENT

| <b>Aircraft Type and Registration:</b> | Beechcraft 200, G-GHSV | |
| <b>Location:</b> | Exeter Airport, Devon | |

## Synopsis

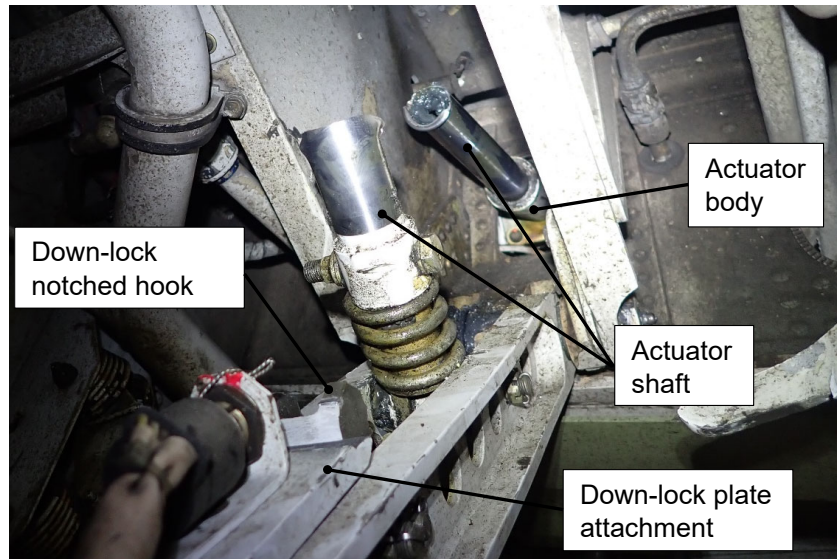
**Figure 3**

The aircraft was recovered to a maintenance facility where the landing gear could be examined. With the aircraft jacked, the left main landing gear lowered under gravity revealing that the actuator shaft had failed close to rod end clevis. The down-lock mechanism was also damaged and was missing the hook and lever attachment on the notched hook (Figure 3). The missing components from the down-lock mechanism were not recovered after the accident.

Left main gear fracture actuator and damaged down-lock

The damage to the down-lock mechanism suggests that when the landing gear was lowered the locking plate did not fully engage with the notched hook and therefore the landing gear remained in an unlocked condition. When the aircraft landed, the unlocked drag brace started to fold. As it did so it forced the locking plate through the partially engaged hook, causing the hook to fracture. The drag brace continued to fold loading the actuator, causing it to buckle. This loaded the lever attachment of the notched hook, causing it to fail as the gear continued to collapse.

It is likely that the down-lock rigging had lost adjustment which manifested itself in the left main gear down-lock not fully engaging. This, in turn, resulted in the left main gear green light not illuminating, as the hook did not contact the indicator switch.

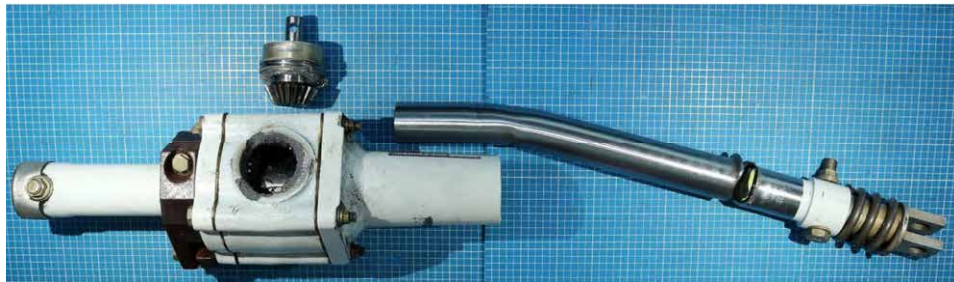
**Figure 4**

The damaged actuator was removed from the aircraft and examined in a laboratory where it was discovered that the actuator shaft had failed in buckling around its thinnest section. The actuator shaft had also bent where it exited the actuator body when fully extended. The actuator trunnions had fractured (Figure 4).

Left main landing gear actuator with actuator shaft removed from actuator body

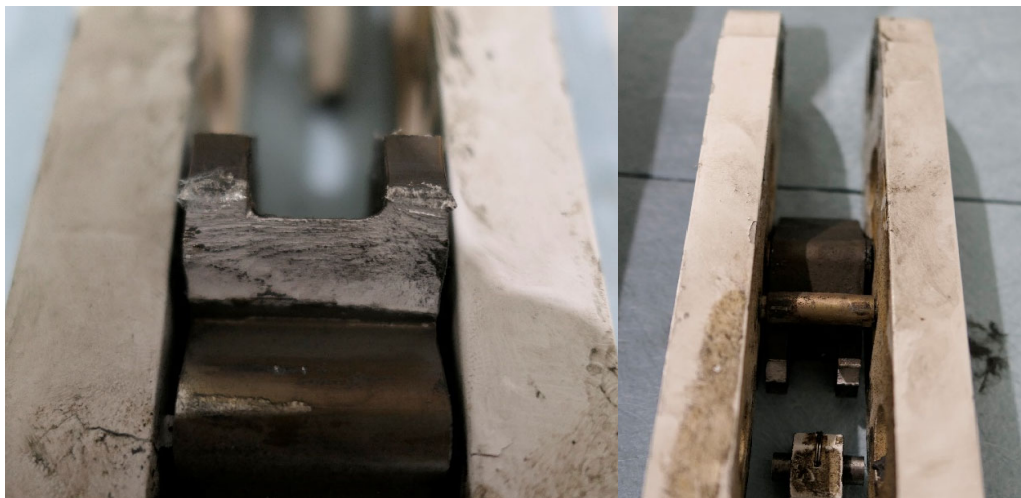
**Figure 5**

The fractures on the down-lock notched hook were assessed to have been in sheer overload with no evidence of pre-existing cracks (Figure 5).

Damaged notched hook
