SERIOUS INCIDENT

Aircraft Type and Registration:	AS-350, D-HKMB	
No & Type of Engines:	1 Arriel 2D turbine engine	
Year of Manufacture:	2013	
Date & Time (UTC):	17 September 2022 at 1045 hrs	
Location:	Auchmacoy, Aberdeenshire	
Type of Flight:	Specialised operations	
Persons on Board:	Crew - 1	Passengers - None
Injuries:	Crew - None	Passengers - N/A
Nature of Damage:	None	
Commander's Licence:	Commercial Pilot's Licence	
Commander's Age:	73 years	
Commander's Flying Experience:	23,700 hours (of which 20,000 were on type) Last 90 days - 32 hours Last 28 days - 20 hours	
Information Source:	Aircraft Accident Report Form submitted by the pilot

Synopsis

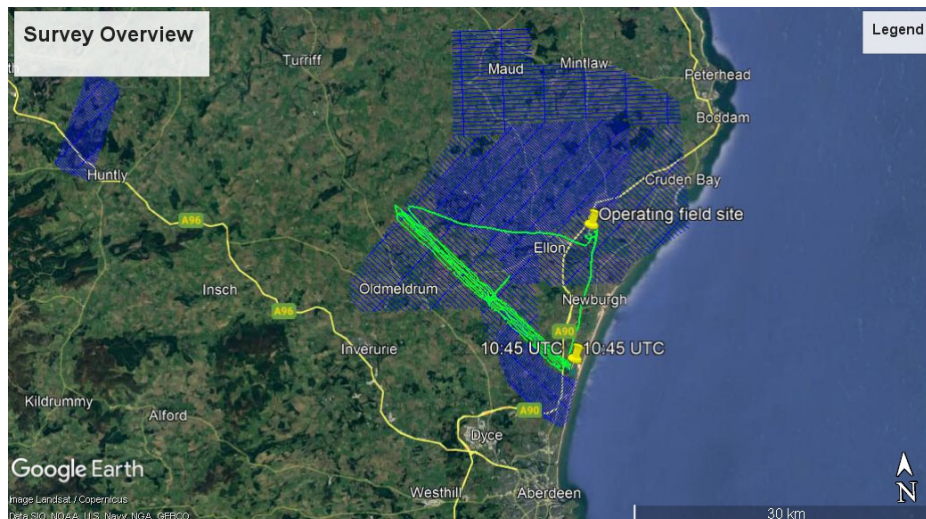
Figure1

Survey Overview

Blue Grid - Planned survey area, Green line - Incident flight

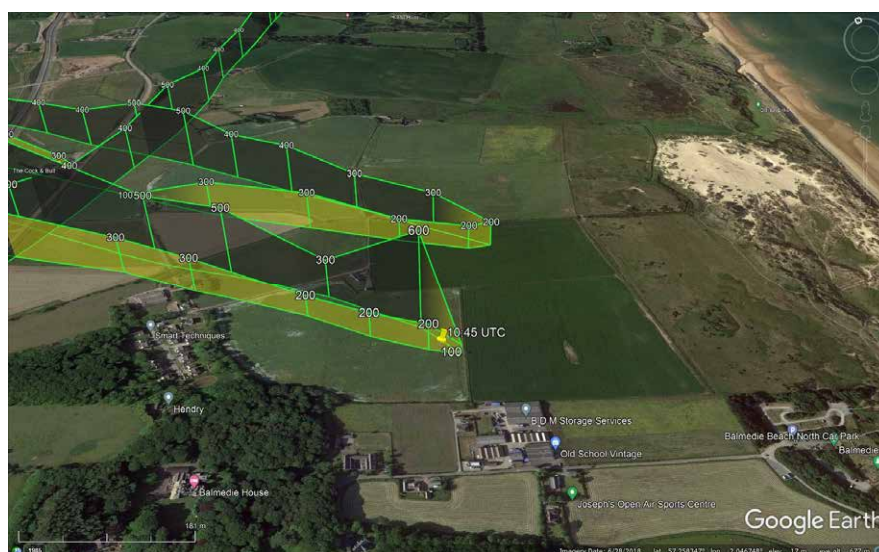
Figure 2

At 1045 hrs the pilot was manoeuvring the helicopter from one planned survey track to the next. To ensure he stayed clear of buildings he had reduced speed to minimise the turning radius. As the speed reduced, the power required to maintain level flight would have increased as translational lift reduced. During the manoeuvre the helicopter lost height and the underslung antenna array struck a 8 m (26 ft) tall electricity supply pylon north of Balmedie (Figures 1 and 2). The collision severed the power cables and interrupted the power supply to 1,682 properties. An expanded view of the incident area is at Figure 2. The pilot stated that he was unaware that the antenna had struck the pylon, so continued the sortie as planned, and was only made aware of the event after landing at the operating field location.

Flight path, with incident at 1045 hrs, showing barometric altitudes

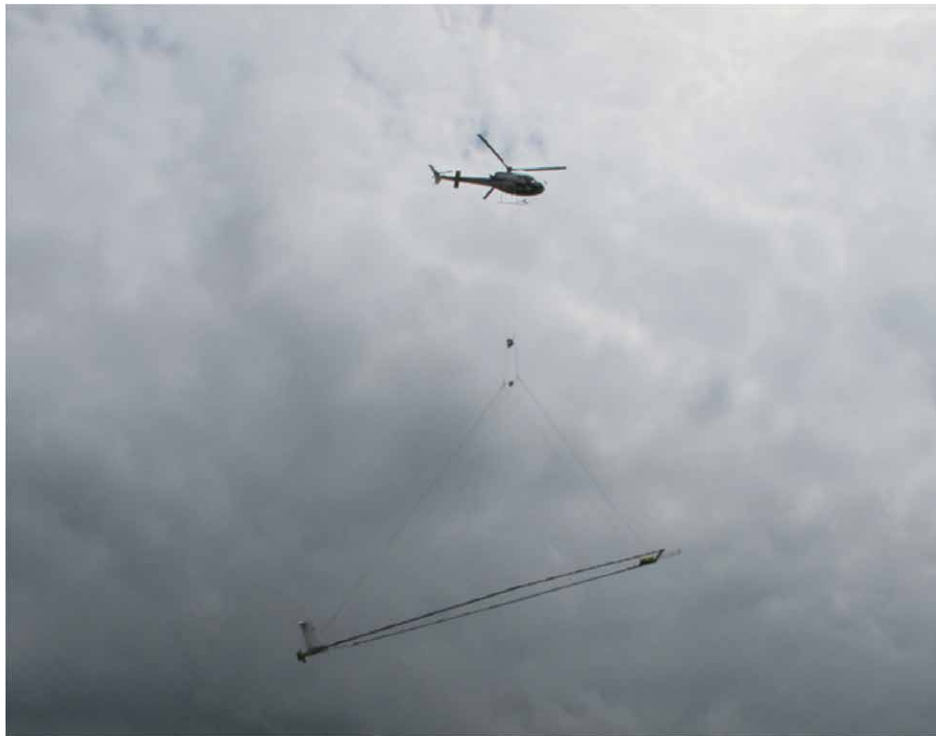
Figure 3

To conduct the geophysical survey the helicopter carried an underslung antenna array (Figure 3). The whole system including its internal generator weighs 780 kg. To avoid the structure of the helicopter affecting the measurements taken by the system the antenna is carried 50 m below the aircraft. The antenna frame is 28 m long, 16.5 m wide, and covers an area of 340 m². The operator had no specific flight test data related to the load but stated that the Rotorcraft Flight Manual limited the speed to 80 kt for underslung loads but gave no limit for angle of bank.

Antenna suspended from an AS350

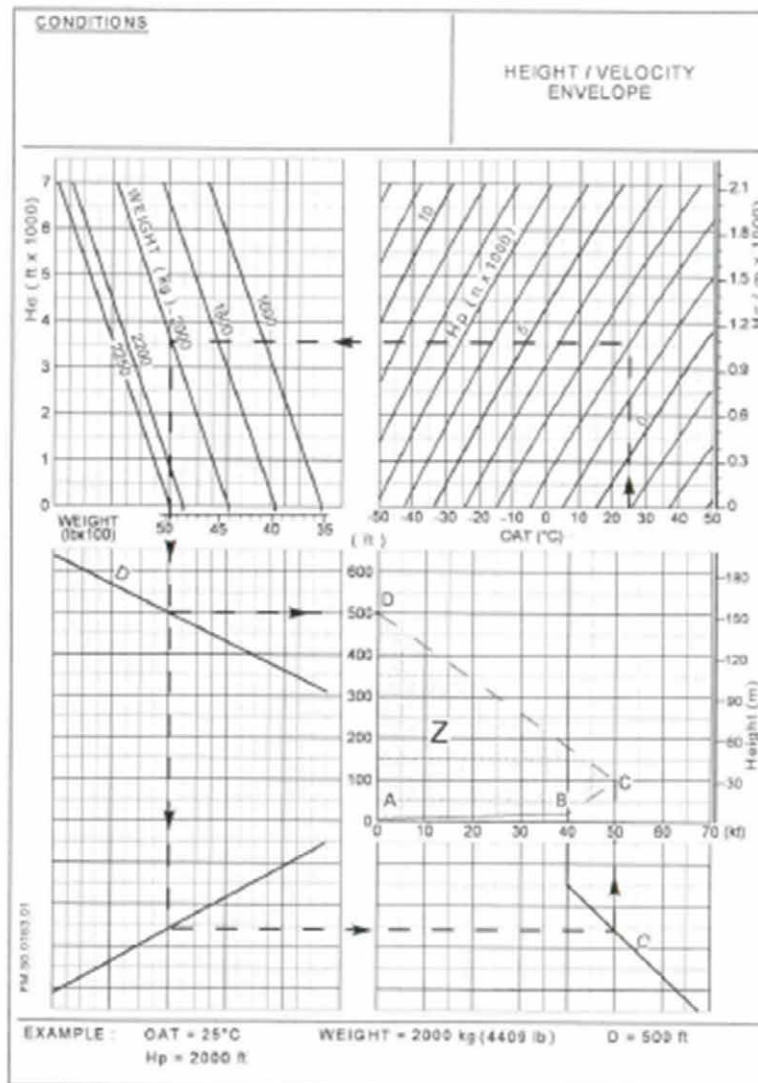
The SOP for the operation with the underslung antenna array recognised that significant portions of such flights would be carried out within the avoidance zone of the Height/Velocity diagram¹. The Height/Velocity diagram for the AS350 is at Figure 4 and the avoidance zone is shown by a 'Z'. Within the avoidance zone if an engine failure occurs a safe landing is unlikely. This risk is also addressed in the risk register and classified in the high category. The suggested mitigations are good maintenance, using trained, experienced pilots and avoiding built up areas, houses and roads. If an engine failure occurs within the Height/Velocity diagram avoidance zone, the aircraft has insufficient performance to affect a safe landing. A twin engine helicopter would have much reduced exposure to the risk of engine failure but would carry a much greater commercial cost.

AS350 Height/Velocity diagram

At low speed and height the helicopter was operating within the unsafe area of the Height/Velocity diagram. As a result, if the aircraft suffered an engine failure, then a safe landing would be unlikely. As the aircraft would lack the performance to achieve a safe landing the training and experience of the pilot, suggested by the operator as a mitigation would
