ACCIDENT

Aircraft Type and Registration:	Beech F33A, G-MOAC	
No & Type of Engines:	1 Continental Motors Corp IO-550-B piston engine	
Year of Manufacture:	1989 (Serial no: CE-1349)	
Date & Time (UTC):	9 September 2022 at 1615 hrs	
Location:	Alderney Airport, Guernsey	
Type of Flight:	Private	
Persons on Board:	Crew - 1	Passengers - 2
Injuries:	Crew - None	Passengers - None
Nature of Damage:	Damage to leading edge of right wing and outer leading edge of left wing. Aircraft damaged beyond economic repair	
Commander's Licence:	Private Pilot's Licence	
Commander's Age:	83 years	
Commander's Flying Experience:	2,520 hours (of which 2,313 were on type) Last 90 days - 13 hours Last 28 days - 4 hours	
Information Source:	Aircraft Accident Report Form submitted by the pilot

Synopsis

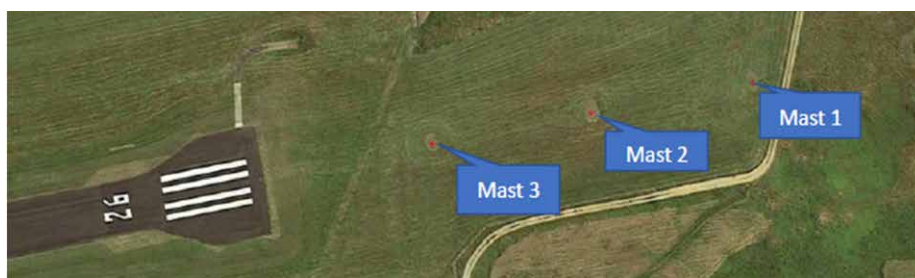
Figure 3
Approach light positions

The light masts are shown in Figure 3 in sequence with 1 being the first mast struck.

Mast 1 was severed approximately half way up and so the aircraft was already below the level of the runway at that point. Mast 2 appeared to have been struck low down and ground marks suggested it was likely the aircraft touched the ground at this point. It is probable

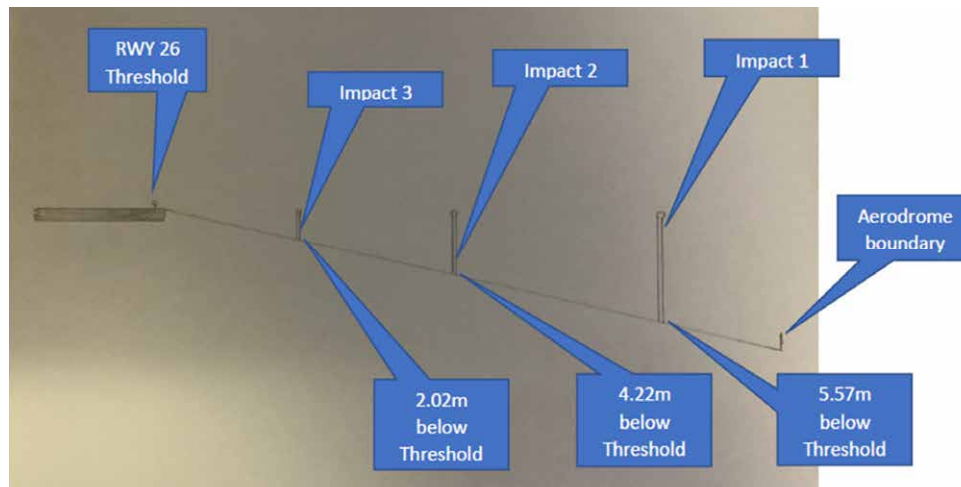
Figure 4

A cross section view of the approach lights is shown in Figure 4. The lights were mounted on masts to give the correct perspective to pilots.

that the most serious damage to the right wing occurred at Mast 2, still approximately 117 m from the runway threshold. The fuel spill trail began at Mast 2 and continued until the aircraft was 90 m along the runway surface.

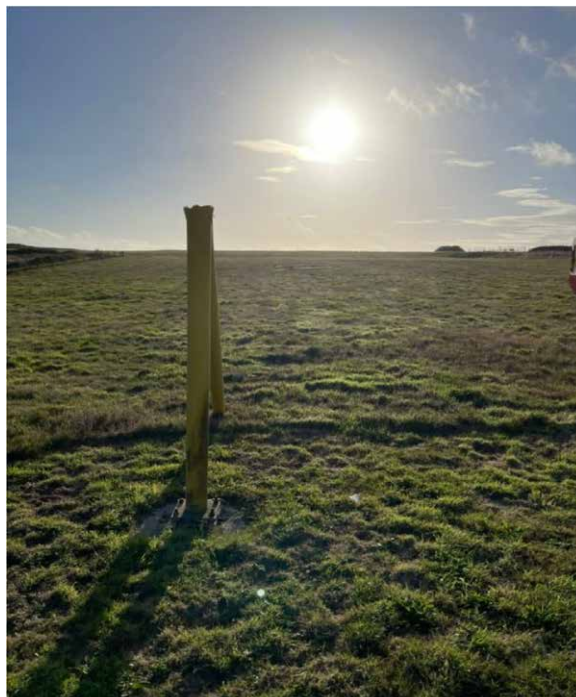
Figure 5 shows an image, taken by the RFFS, of a view from the approach lights looking toward the Runway 26 threshold.

The sun is relatively low in the sky and aligned with the runway.

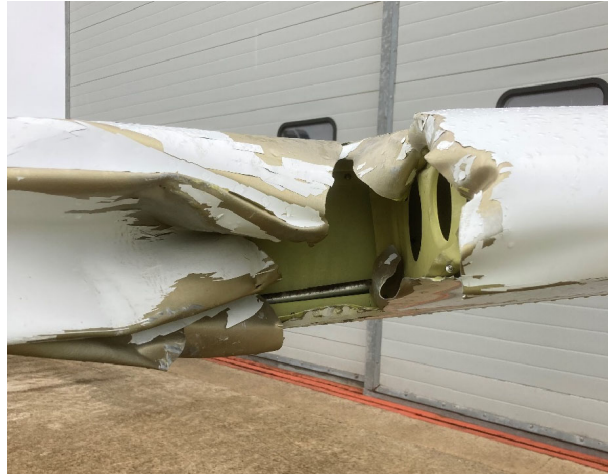
The aircraft was not examined by the AAIB but the airport authority supplied pictures of the damage. Figure 6 shows the damage to left wing believed to have been sustained during the collision with Mast 1.

Left wing leading edge damage

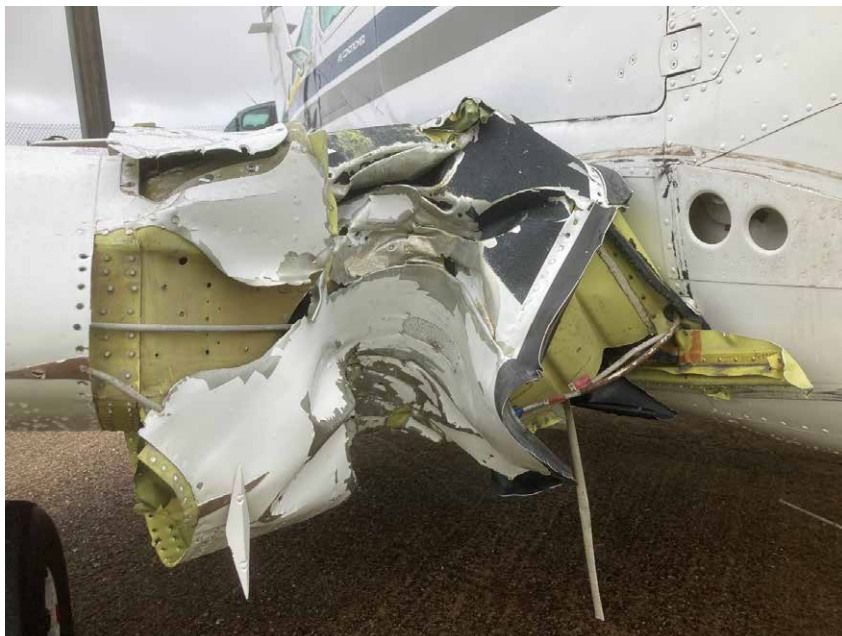
Figure 7

The most serious damage was likely sustained on the right wing when the aircraft struck Mast 2 and this is shown at Figure 7.

Right wing root damage
