SERIOUS INCIDENT

Aircraft Type and Registration:	DHC-1 Chipmunk 22, G-BXHA	
No & Type of Engines:	1 De Havilland Gipsy Major 10 Mk 2 piston engine	
Year of Manufacture:	1952 (Serial no: C1/0801)	
Date & Time (UTC):	22 March 2022 at 1410 hrs	
Location:	Sevenoaks, Kent	
Type of Flight:	Training	
Persons on Board:	Crew - 2	Passengers - None
Injuries:	Crew - None	Passengers - N/A
Nature of Damage:	Cracked propeller and boss blocks	
Commander's Licence:	Airline Transport Pilot's Licence	
Commander's Age:	38 years	
Commander's Flying Experience:	9,000 hours (of which 5 were on type) Last 90 days - 70 hours Last 28 days - 16 hours	
Information Source:	Aircraft Accident Report Form submitted by the pilot and additional enquiries by AAIB

Synopsis

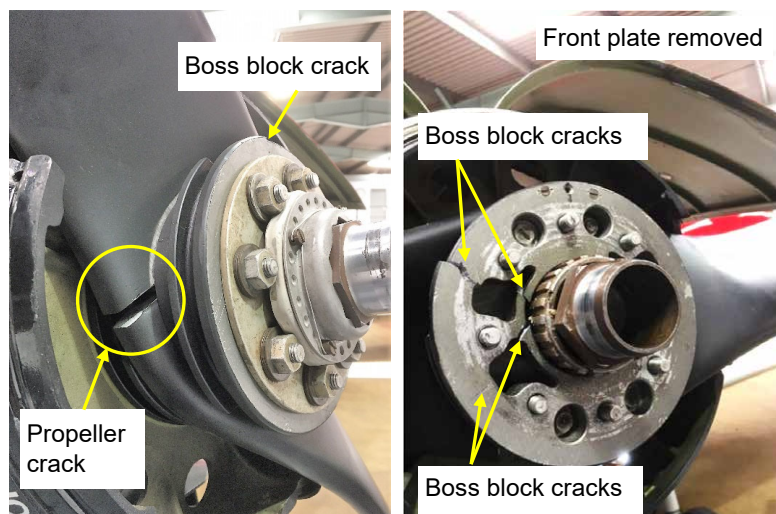
Figure 2

Two cracks were found in the propeller, four cracks in the forward boss block and three in the aft boss block (Figure 2).

Propeller assembly with spinner removed showing cracks in forward boss block and propeller

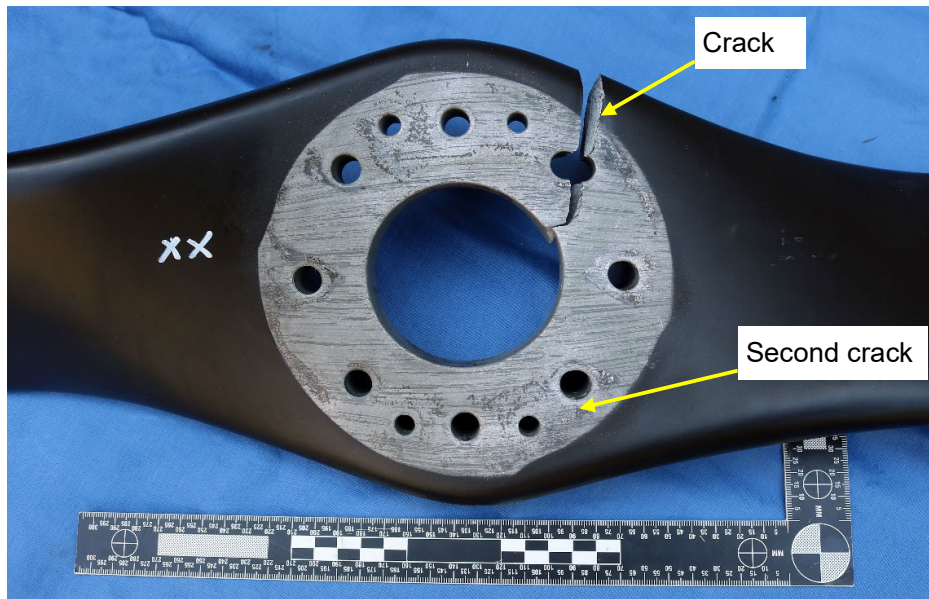
The propeller had a crack that extended through a hub bolt hole, completely through the material's thickness. A second crack was evident at a second propeller hub bolt hole (Figure 3).

The surface finish of the bolt hole radii² and propeller face were not '*smooth and highly polished*' as specified in the Fairey Reed Repair Specification³.

Figure 3
Cracks in propeller

The primary fatigue crack of the propeller initiated on opposite sides of a propeller hub bolt hole (Figure 6). There is no evidence of damage associated with crack initiation on one side of the hole. On the other side of the hole, the crack initiated from a small gouge; however, this damage was not considered to be large enough to have initiated the fatigue failure.

The secondary fatigue crack in the propeller also initiated from the radius of a bolt hole; there was no evidence of pre-existing damage around this hole.

The surface finish of the radii on the bolt holes and the propeller face were not in accordance with the manufacturer's specification. However, this was not considered to be the primary origin of the fatigue failures in these areas.

Will promulgate a Technical News Sheet to its subscribers which will include enhanced guidance for continued airworthiness of Fairey Reed propellers. This will include the use of Non-Destructive Testing, and inspections for corrosion, fretting and correct surface finish.

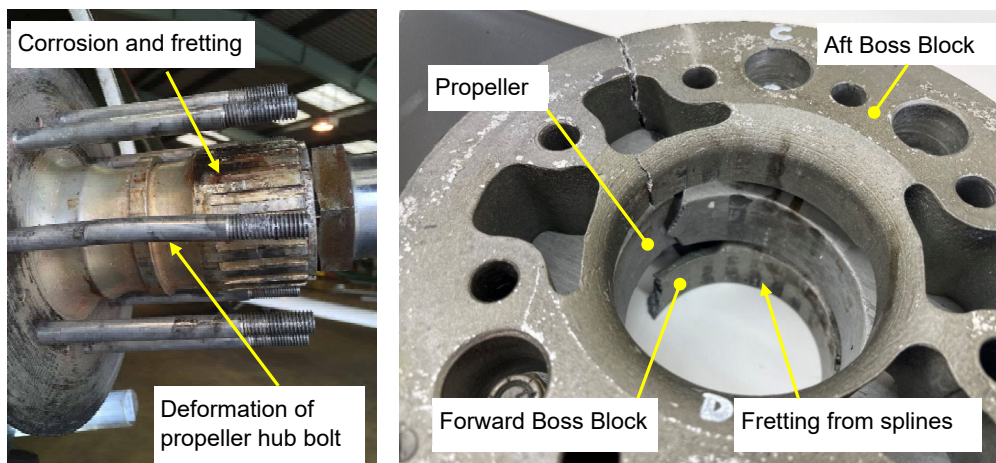
Figure 4

There was evidence of fretting and corrosion on the splines of the engine hub with corresponding marks on the inner surfaces of the boss blocks and the propeller (Figure 4). Some marking of the forward boss block inner diameter is considered typical for the propeller's age and type.

Engine hub corrosion and fretting, and fretting of inner surfaces of blocks and propeller

The initiating failure of the propeller assembly was caused by fatigue cracking of the forward boss block and propeller, resulting from fretting and corrosion. The existing SB to inspect the propeller assembly does not specify inspection of the inner diameter of the boss blocks for wear or corrosion.

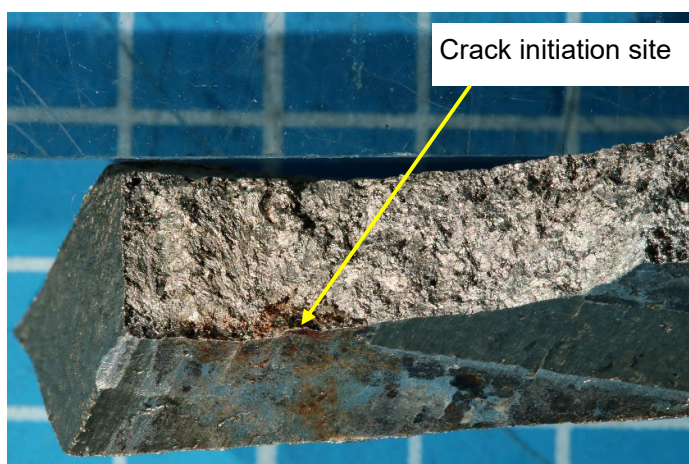
Figure 5

Of the four cracks in the forward boss block, one was assessed as the primary fatigue fracture and the remaining three were assessed as secondary overload failures. The primary fracture originated from a worn area on the inner diameter, caused by fretting from the splines of the removable propeller hub. Thumbnail shaped deposits of oxide and rust at the edge of the fracture surface (Figure 5) indicated that the crack initially grew slowly and then accelerated when it was a few millimetres deep. The crack had grown to approximately 20 mm in length when final failure occurred.

Primary fracture surface of forward boss block

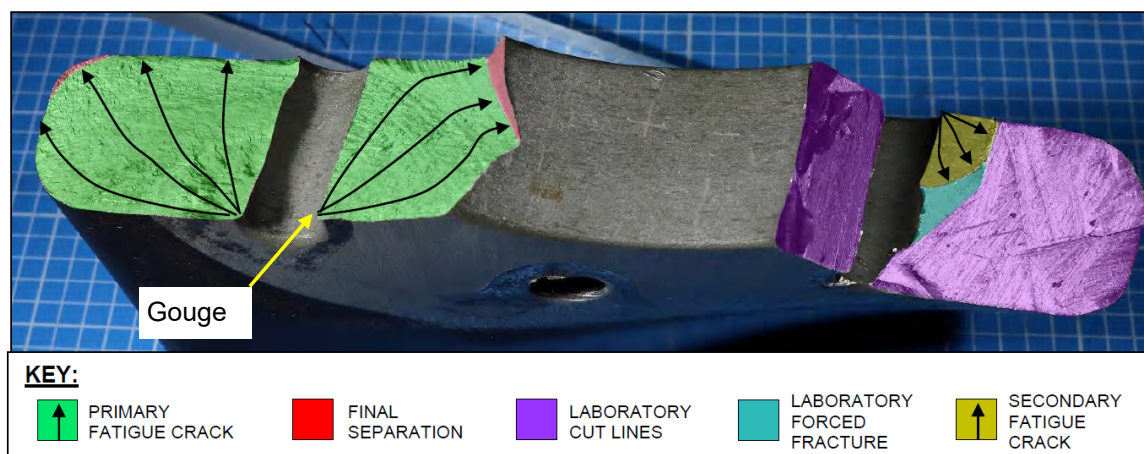
Figure 6

Propeller fracture surfaces
