ACCIDENT

Aircraft Type and Registration:	DG-300 Elan, G-CKJH	
No & Type of Engines:	None	
Year of Manufacture:	2004 (Serial no: 3E506)	
Date & Time (UTC):	7 July 2022 at 1730 hrs	
Location:	Near Winchcombe, Gloucestershire	
Type of Flight:	Private	
Persons on Board:	Crew - 1	Passengers - None
Injuries:	Crew - 1 (Fatal)	Passengers - N/A
Nature of Damage:	Impact damage to lower forward fuselage, broken canopy, and damage to both wings. Main landing gear forced back into wheel well	
Commander's Licence:	N/A	
Commander's Age:	85 years	
Commander's Flying Experience:	Approximately 3,900 hours Last 90 days - 24 hours Last 28 days - 13 hours	
Information Source:	AAIB Field Investigation

Synopsis

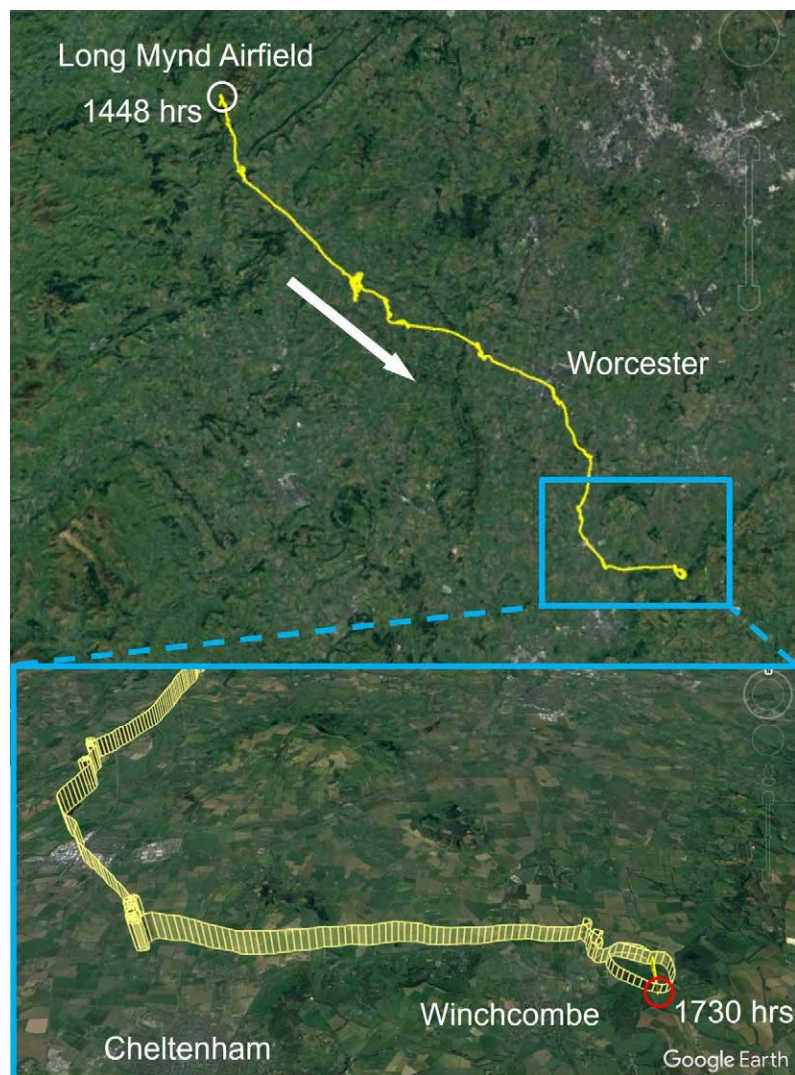
Figure 1

Ground track of accident flight recorded on IGC logger

The pilot noted after the accident that there were some larger, flatter fields lower down in the valley, but they had corn growing in them, so he chose a pasture on the side of the hill (Figure 1). Information provided to the investigation showed that nearly all the flatter fields had unharvested crop in them which was mature and yellow in colour. Other flatter grass grazing fields were also by and large yellow in colour due to the extended drought and hot weather of 2022.

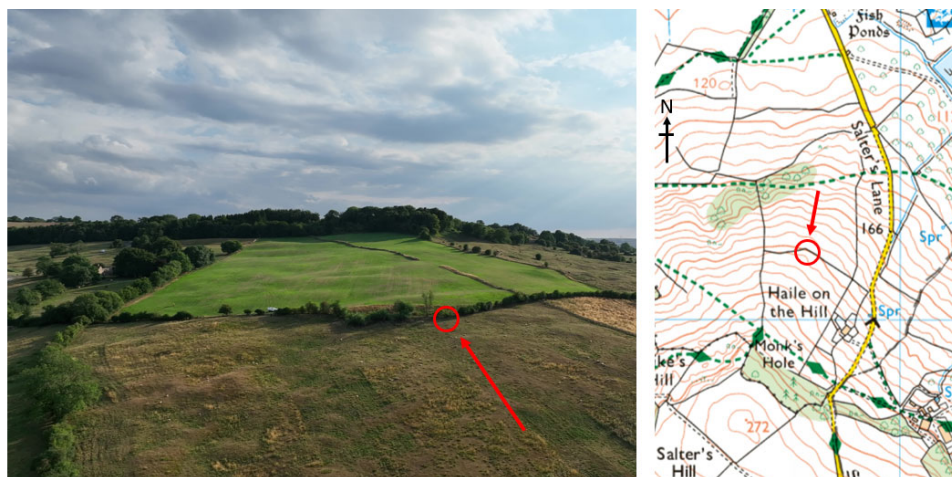
Figure 2

The glider came to rest in a hedge at the uphill end of a grass field at Haile on the Hill, approximately 6 nm northeast of Cheltenham, Gloucestershire (Figure 2). The hedge contained a wire stock fence which the nose of the glider penetrated, breaking the canopy transparency and trapping the canopy frame in the closed position.

Accident site looking south (left image) and accident location (right image), with approach direction into field indicated with a red arrow. © 2022 Ordnance Survey

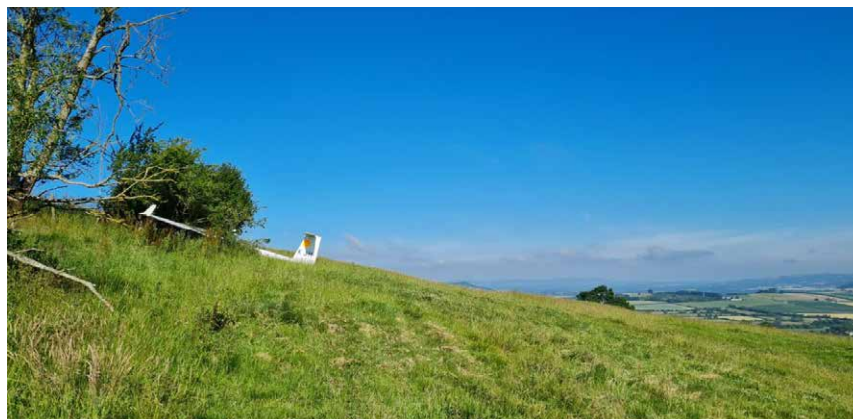
Figure 3

The surface of the field was undulating grass pasture, with a steep upslope of approximately 20% (Figure 3).

Accident site, looking north-west

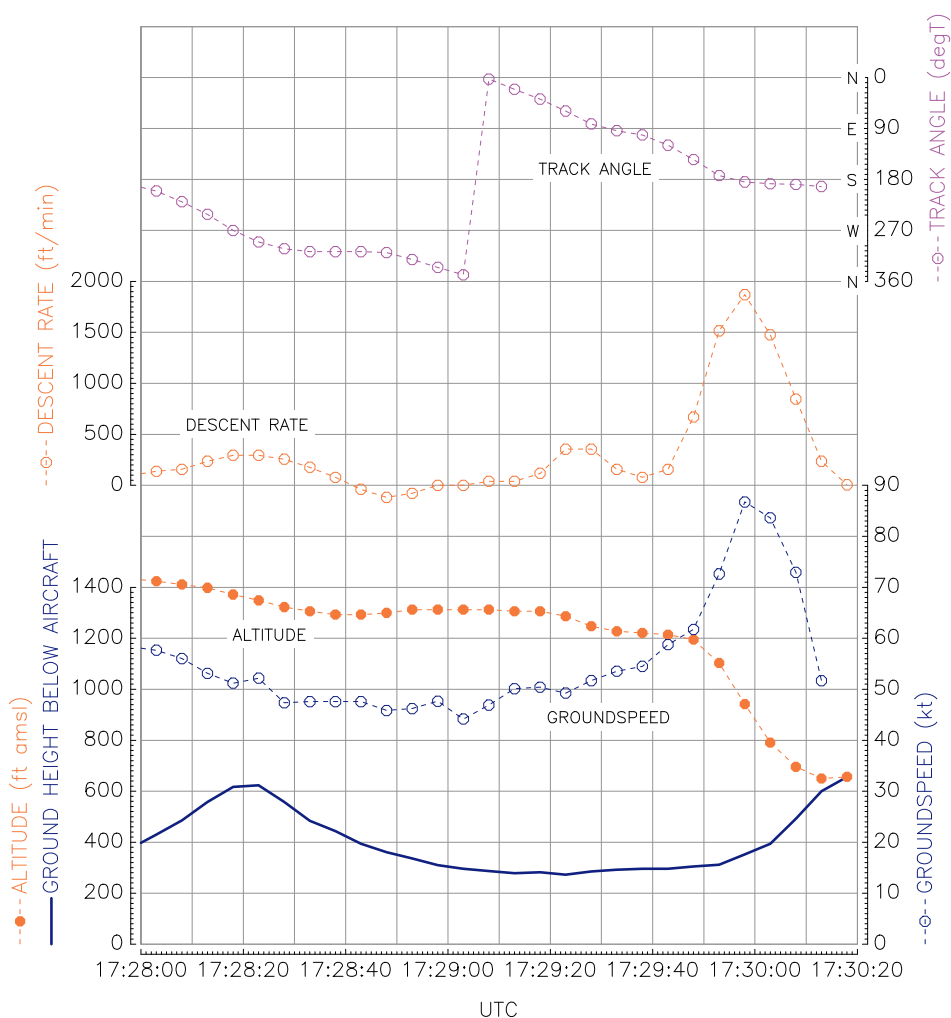
Figure 4 plots the track angle, groundspeed and vertical speed, derived from the flight path data in the IGC file, together with the altitude and ground height below the glider, for the last part of the flight as the glider circled and descended toward the landing field. The circuit was at about 1,300 ft amsl (between 800 and 1,000 ft agl over undulating terrain). The descent started from 1,200 ft amsl (about 550 ft higher than the accident site elevation), during which the vertical decent rate peaked at about 1,900 ft/min before reducing to about zero, and the groundspeed from just under 90 kt to about 50 kt.

IGC recorded/derived data for circuit and descent to field
