**ACCIDENT**

<b>Aircraft Type and Registration:</b>	Pegasus Quik, G-CGRR	
<b>No &amp; Type of Engines:</b>	1 Rotax 912-UL piston engine	
<b>Year of Manufacture:</b>	2010 (Serial no: 8541)	
<b>Date &amp; Time (UTC):</b>	6 August 2022 at 1355 hrs	
<b>Location:</b>	Harringe Court Farm, Ashford, Kent	
<b>Type of Flight:</b>	Private	
<b>Persons on Board:</b>	Crew - 1	Passengers - None
<b>Injuries:</b>	Crew - 1 (Serious)	Passengers - N/A
<b>Nature of Damage:</b>	Minor damage to trike, wing damaged beyond repair	
<b>Commander's Licence:</b>	National Private Pilot's Licence	
<b>Commander's Age:</b>	62 years	
<b>Commander's Flying Experience:</b>	306 hours (of which 90 were on type) Last 90 days - 2 hours Last 28 days - 1 hour	
<b>Information Source:</b>	AAIB Field Investigation

**Synopsis**

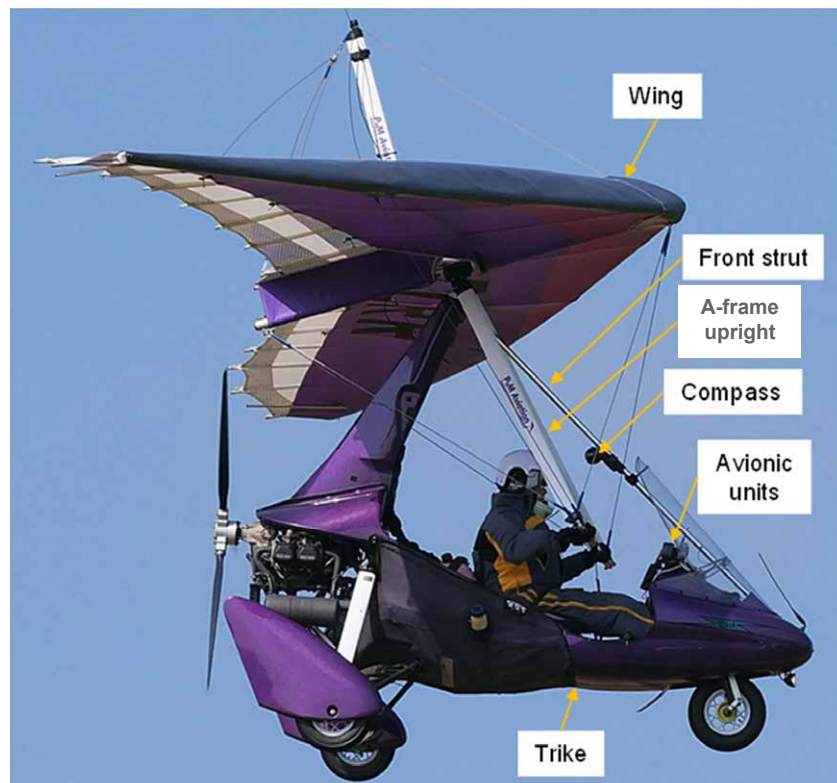
**Figure 1**

The pilot's helmet and damaged headset were located next to the trike; the visor was located 20 m away from the right side of the aircraft. The compass was found next to the cockpit and had detached from its mounted position on the front strut. Although the front seat lap strap buckle had been released, there were no anomalies found with the operation of the buckle or the strap. The front seat shoulder strap had been rolled up and secured with a plastic tie-wrap close to the pylon behind the rear seat. Two avionic units were mounted on the top of the cockpit coaming directly in front of the pilot (Figure 1).

G-CGRR pictured in flight showing significant features  
(Image used with permission)

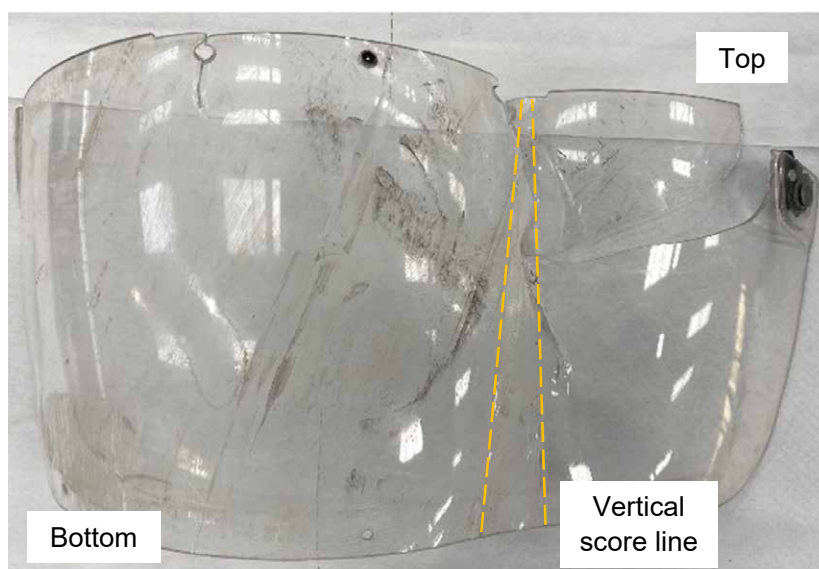
**Figure 2**  
Damaged helmet visor

on its right side. The visor had been badly damaged with multiple scrape marks and a wide vertical line scored from top to bottom to the left of the visor's centre line. The distortion of the visor along the vertical line matched the profile of the front strut. The horizontal curved profile of the visor had bent inwards along this vertical line (Figure 2). A large piece of the visor had broken away from the upper left quarter.

Although the possibility of the visor being damaged as a result of contact with the right A-frame upright was considered, the curved profile of the vertical line could only have been formed by impact between the visor and the front strut. As the pilot had not worn the shoulder strap, his upper torso would not have been restrained during the impact and the visor on his helmet would only have provided limited protection to his face. It is probable that both these facts resulted in the pilot sustaining serious facial injuries during the impact.
