# Derailment of a tram near Highbury Vale tram stop, Nottingham, 30 September 2022

## Summary of the accident

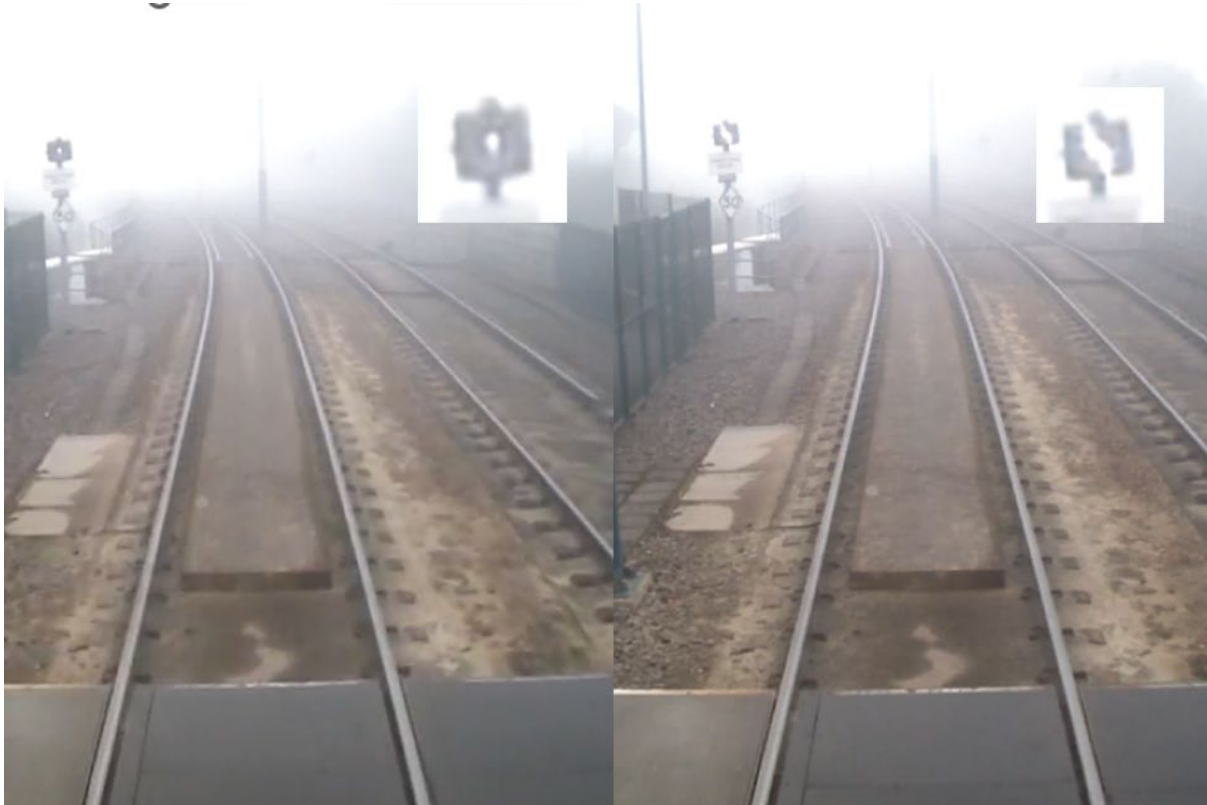
At 07:14:39 hrs, tram 219 arrived at David Lane tram stop. The driver saw that the points position indicator (PPI) repeater (located at David Lane tram stop) for HVP3 points indicated that the points were in an intermediate position. Having heard the earlier control room broadcast, the driver correctly attributed this to the maintenance team. He expected to find the team working on the points, which are approximately 700 metres north of David Lane tram stop.

**Image taken from the forward-facing CCTV of tram 219 as it arrived at David Lane tram stop with the points position indicator (repeater) for HVP3 points showing them to be in an intermediate position (left image) and later set for Phoenix Park (right image).**

After the driver had selected the route to Phoenix Park, the technicians working on the failure used the points controller adjacent to HVP3 points to 'swing' the points between various positions. Between 07:14:57 and 07:15:08 they did this four times, with the PPI repeater showing the positions briefly during this time. However, when tram 219 departed David Lane tram stop at 07:16:17 hrs, forward-facing CCTV (FFCCTV) images confirm that the PPI repeater at the tram stop was showing that HVP3 points were set for the route to Phoenix Park and that it had been doing so for over a minute before the tram departed.

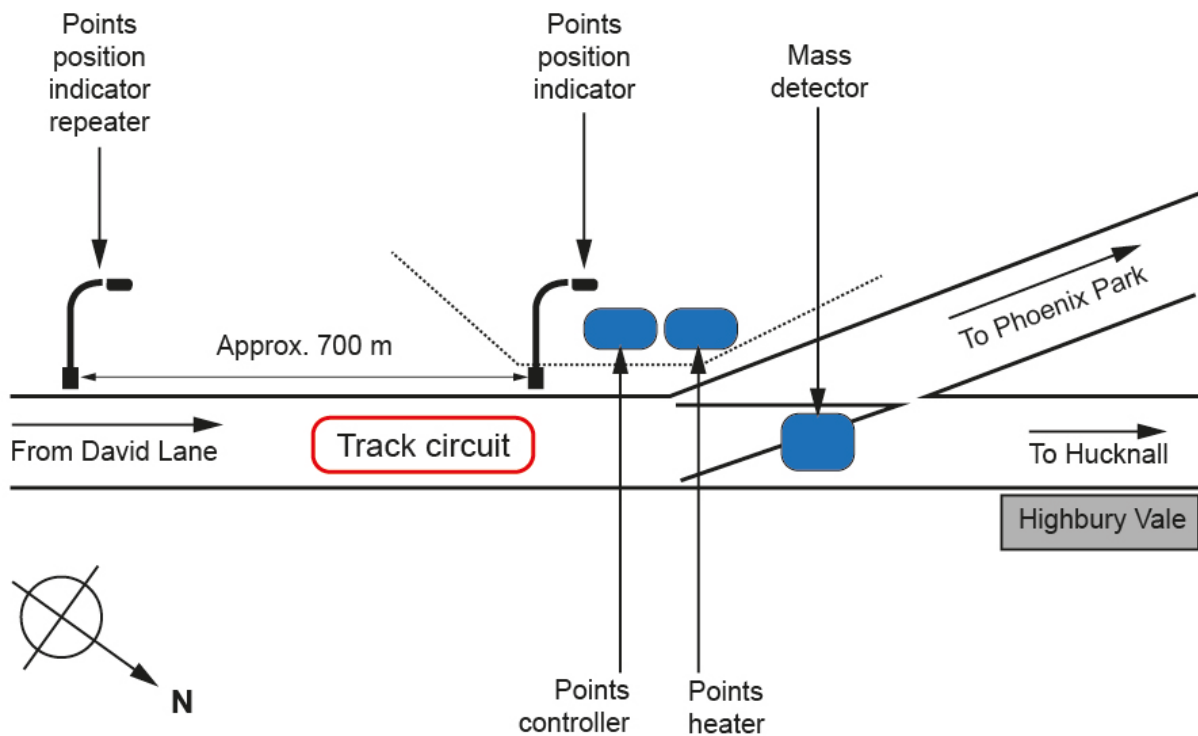
In normal operation, trams travelling north towards HVP3 points from David Lane are detected by a track circuit located on the approach to the points. Trams are then subsequently detected by a mass detector located at the junction. This detection should inhibit further operation of the points and ensure that they are not moved while a tram is passing over them. Once trams clear the track circuit and then the mass detector (in the correct sequence) the points are released to accept a new route for following trams.

**Sketch map showing layout of the accident location and relevant infrastructure.**

Investigations showed that before the accident, the track circuit on approach to HVP3 points had not been operating correctly. This meant that the points control system was registering the presence of a tram through the mass detector without the track circuit having first detected the tram's approach. As this was contrary to the expected sequence, the control system generated an 'out of sequence' alarm and prevented the points from moving as a 'fail-safe' measure.
