Rail Accident Investigation Branch

# Rail Accident Report

**Pedestrian struck by a train at Lady Howard  
footpath and bridleway crossing, Surrey,  
21 April 2022**

Report 01/2023  
v2 February 2024

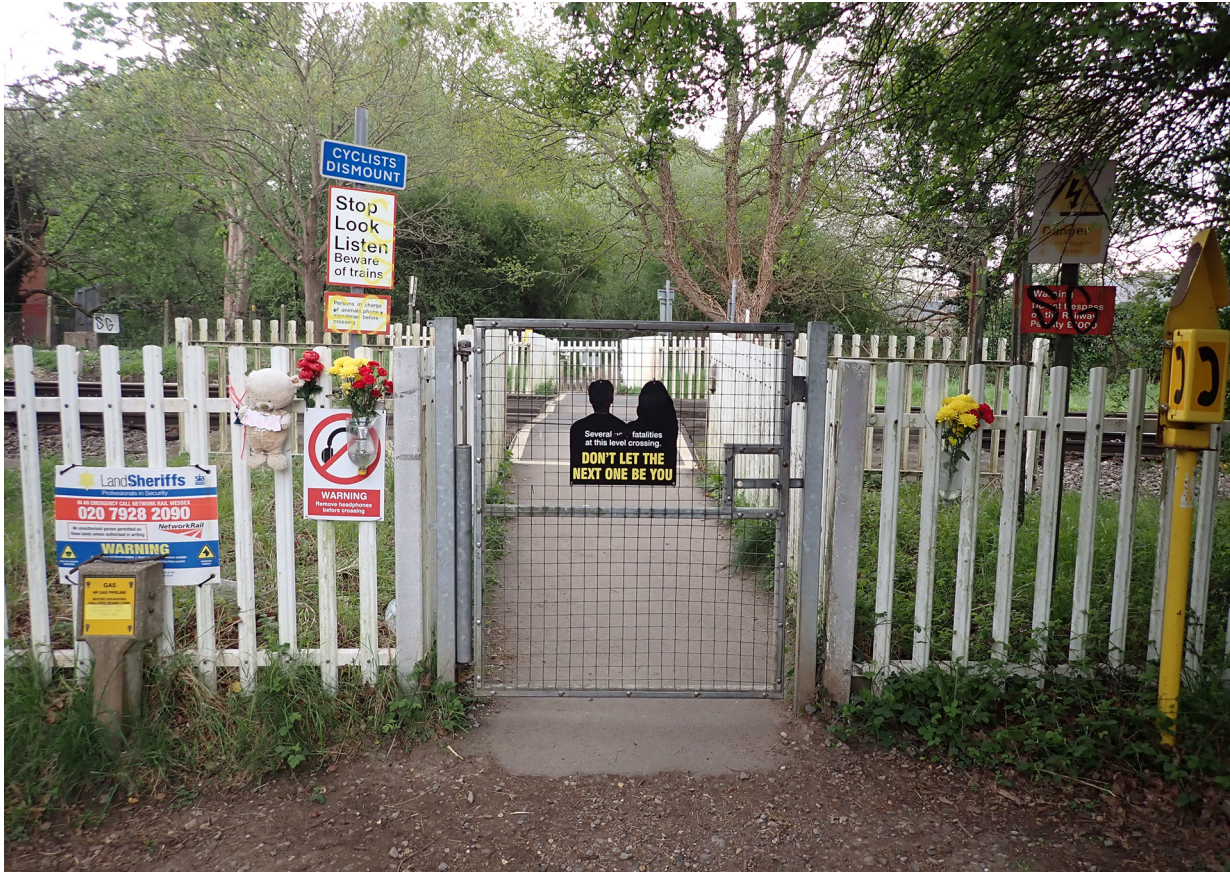
At the time of the accident, some of these signs had been painted with graffiti (figure 3).

Figure 3: The entrance to Lady Howard crossing, approaching from Ashted Common (the direction of the pedestrian at the time of the accident).

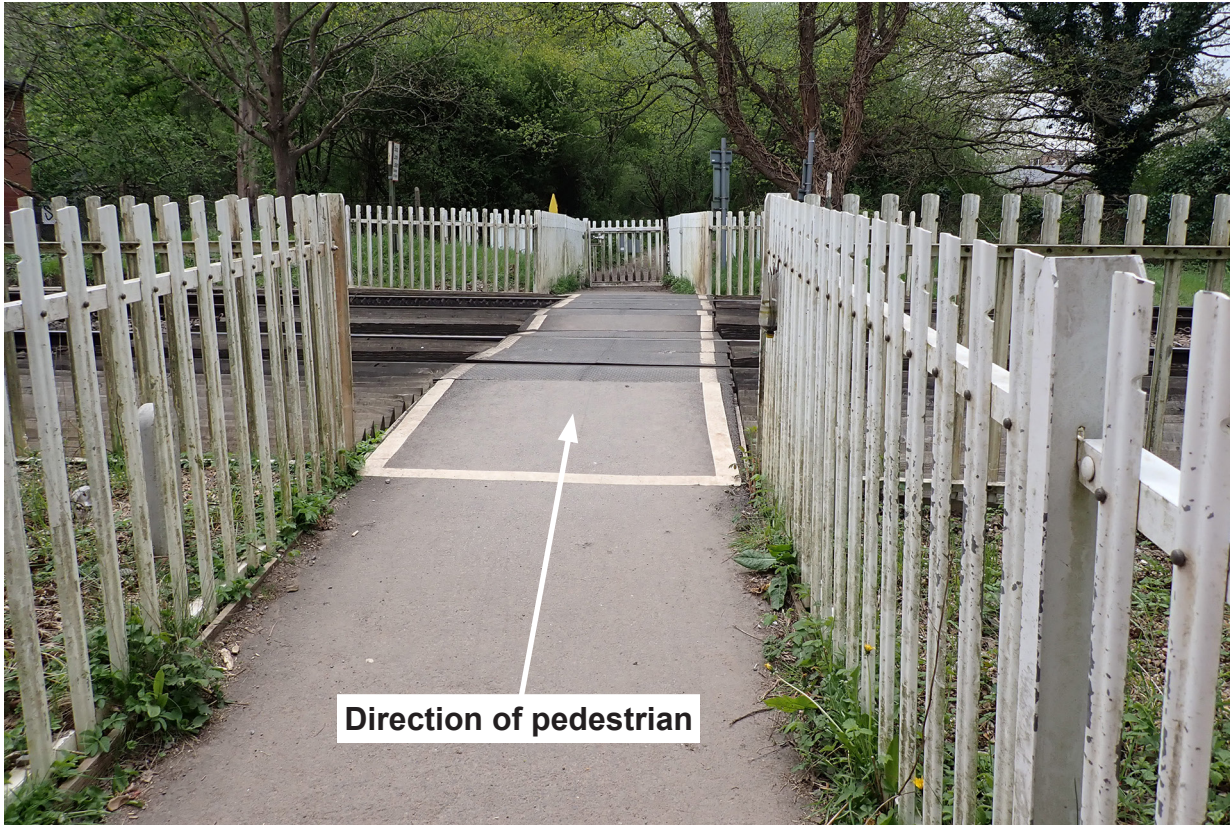
- 15 RAIB measured the fenced corridor inside the gate on the Ashted Common side of the crossing (the approach used by the pedestrian involved in the accident) to be 4.5 metres long. This ends with a white line painted on the asphalt surface 2 metres from the nearest rail of the up Portsmouth line (figure 4). This white line, known as the 'decision point', is the notional point at which users on foot are expected to make a decision as to whether or not it is safe to cross the railway. For crossing users with horses, Network Rail uses a decision point 3 metres from the nearest rail, although this point is not marked on the ground.

Figure 4: Inside the gate at Lady Howard crossing showing the decision point, approaching from Ashted Common.

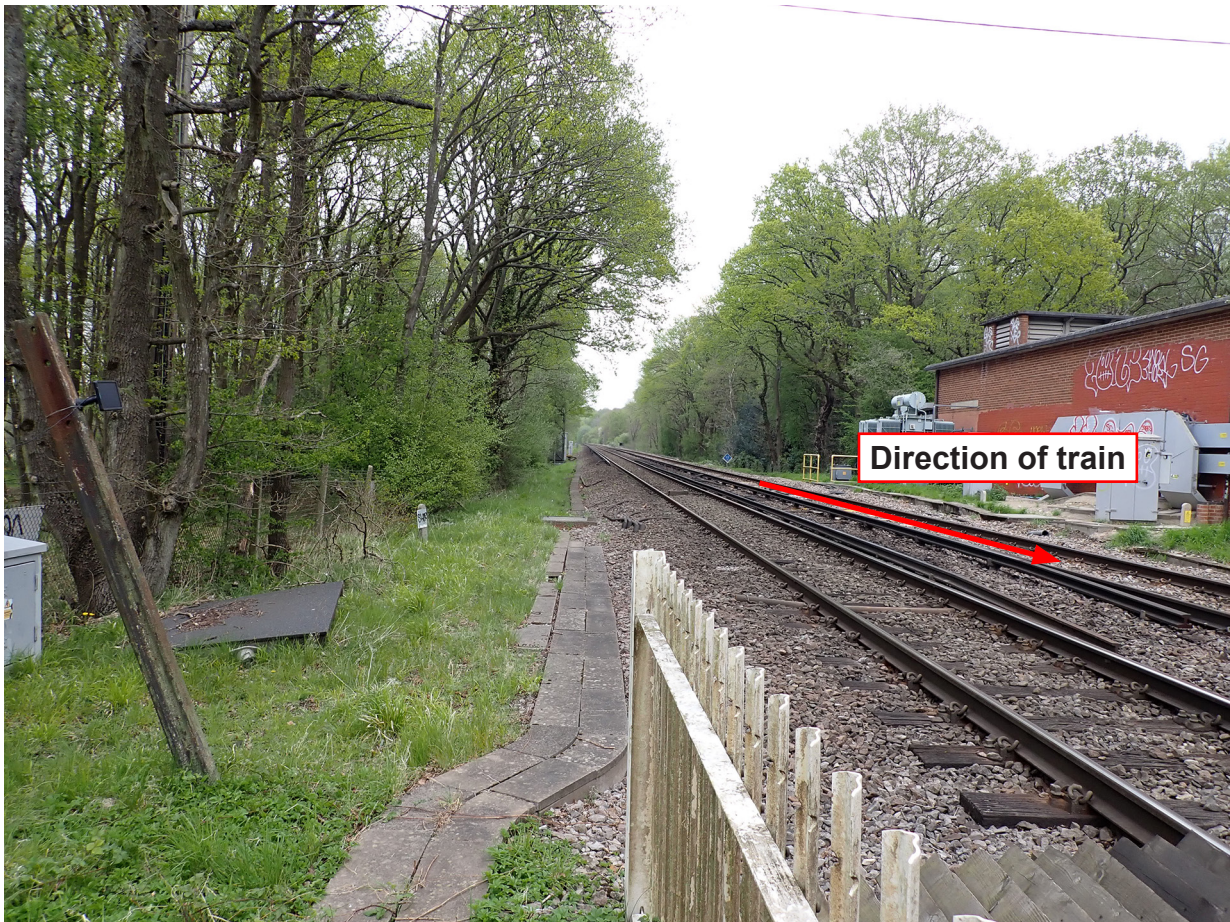
- 16 At the marked decision point, the metal fencing opens out in both directions along the railway. RAIB measured the sighting distances (the distances at which approaching trains can be seen by crossing users) in each direction at this point. On the Ashted Common side, a user standing at the decision point can see for around 440 metres in the direction towards Epsom (the direction from which the train involved in the accident approached). Beyond this point the railway curves to the left from the observer's point of view (figure 5 and figure 6). In the other direction, the railway is straight and users can see for at least 1000 metres to Ashted station.

Figure 5: View from the decision point on the Ashted Common side of Lady Howard crossing, looking towards Epsom.

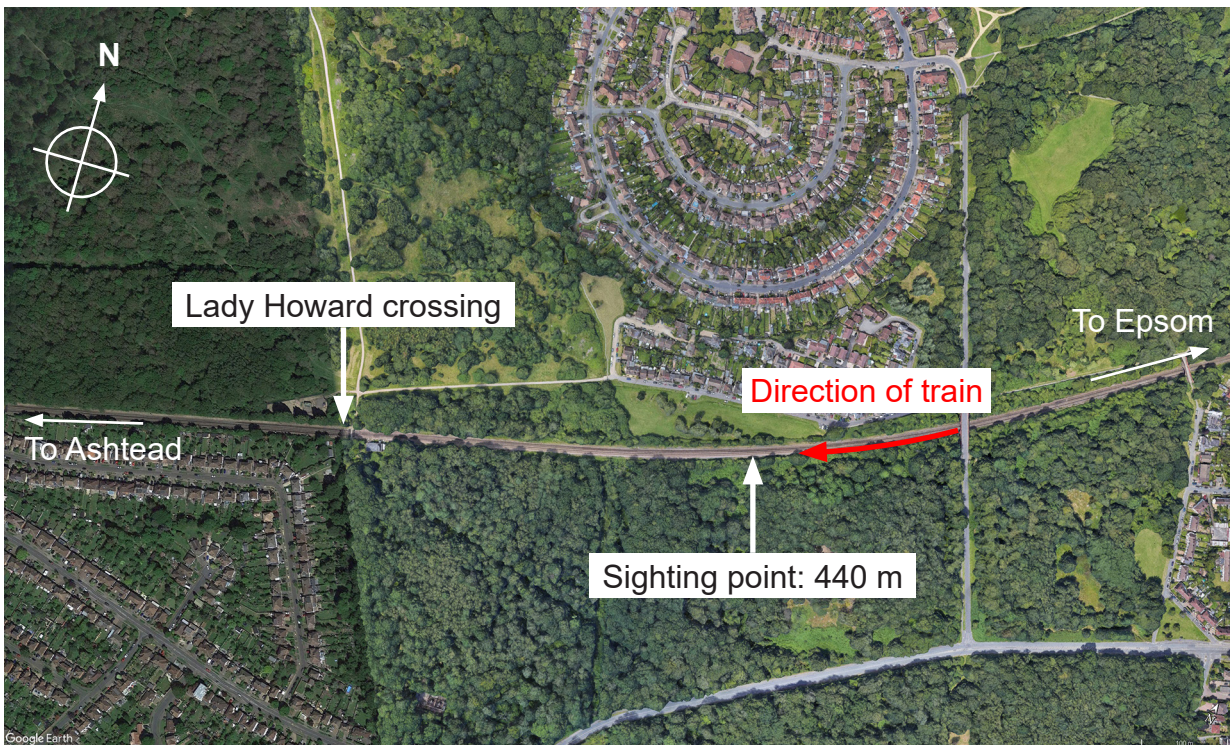
Figure 6: Google Earth view of the location, showing the crossing and the left-hand curve in the direction towards Epsom.

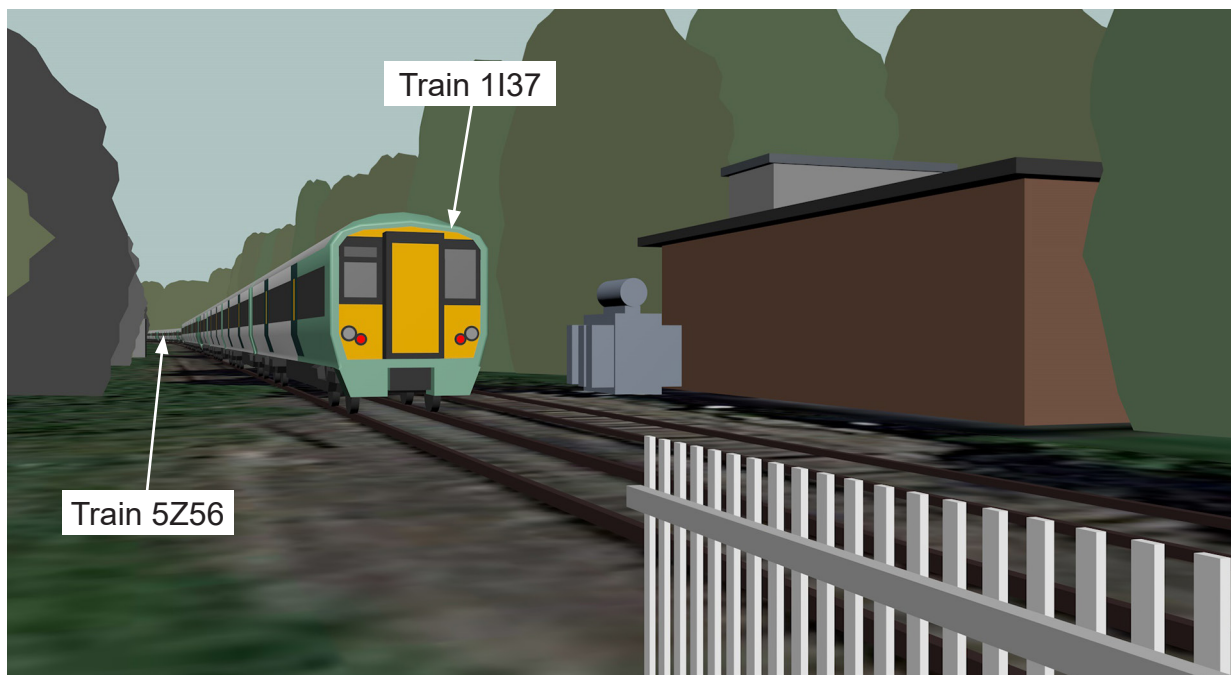
- 45 When the pedestrian looked twice to the left, the front end of train 5Z56 (which is the most conspicuous part of the train, being painted yellow and displaying headlights) was hidden behind train 1137, which was receding from the crossing. The front end of train 5Z56 did not re-emerge from behind 1137 until after the pedestrian had started to cross. Although it may have been possible for the pedestrian to have seen the side of train 5Z56 in the gap beyond train 1137 and before the railway curved to the left out of view, it would have appeared very small at that distance and not particularly conspicuous (figure 7). This is in part because the green and white painted livery of the train would have provided relatively low contrast against the background of green vegetation.

- 46 The pedestrian was wearing prescription sunglasses and had been facing towards Ashted just before crossing, in the direction of the approaching train 1137. In that position and at that time of day, she was almost directly facing the sun. When she turned to look towards the left, there may have been some after-effects of facing the sun that could have reduced her sensitivity to contrast, and this may have been further attenuated by the sunglasses. However, the predominant factor affecting the pedestrian's ability to see the oncoming train 5Z56 was the presence of train 1137 as it moved away from the crossing. This would have been much more conspicuous and largely hid the approaching train, 5Z56, from view.

Figure 7: Computer-generated reconstruction of the view from the pedestrian's perspective looking to her left as she started moving towards the crossing.

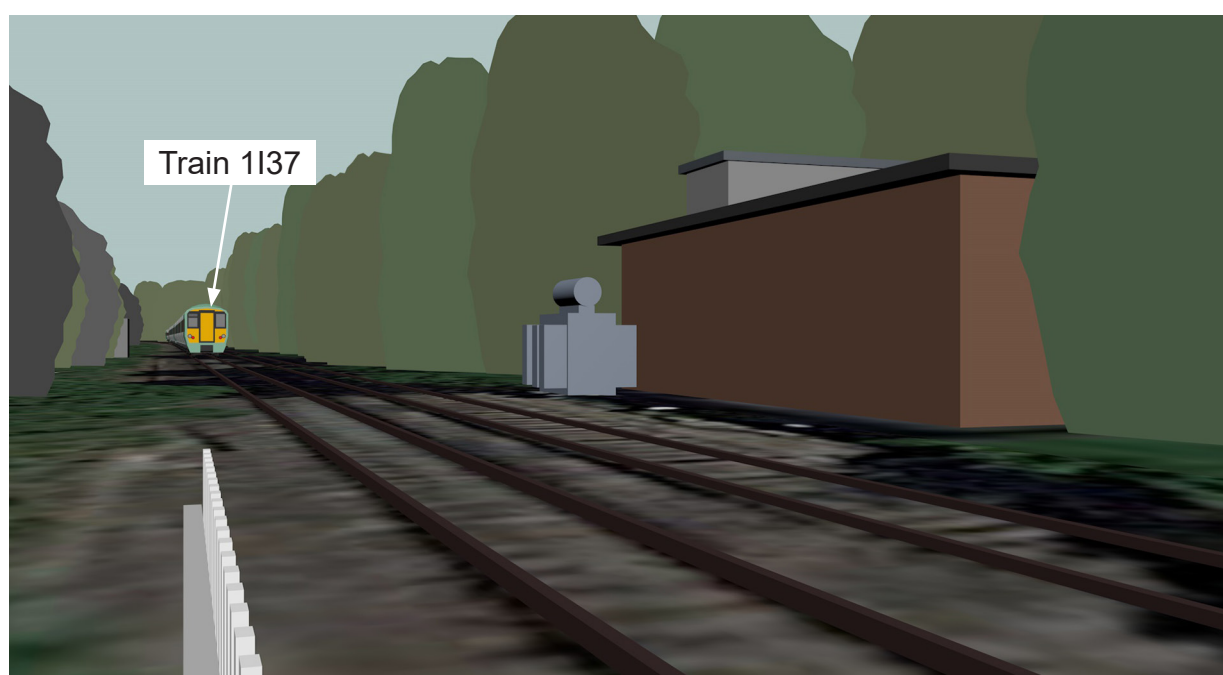
50 When the pedestrian took the second glance, as she passed the decision point, RAIB calculated that the rear of train 1137 was around 100 metres beyond the crossing. RAIB has also concluded that, at that point, it is more likely than not that the pedestrian would have been looking towards her left for oncoming trains on the down Portsmouth line to the right of, rather than beyond the front of train 1137 and into the diminishing gap between it and the curve of the railway line.

51 Visibility past the trailing end of train 1137 towards the down Portsmouth line would have been greater than 100 metres (figure 8). Given the extent of the visibility available to the pedestrian, it is possible that she decided that this was sufficient distance to be able to safely traverse the crossing, not realising that a train travelling at the maximum permitted speed of 60 mph (97 km/h or 27 m/s) could cover the visible distance in around 4 seconds. At the time of the accident, there were no warnings at the crossing to alert users to this risk.

Figure 8: Computer-generated reconstruction of the view from the pedestrian's perspective looking to her left as she crossed the decision point.

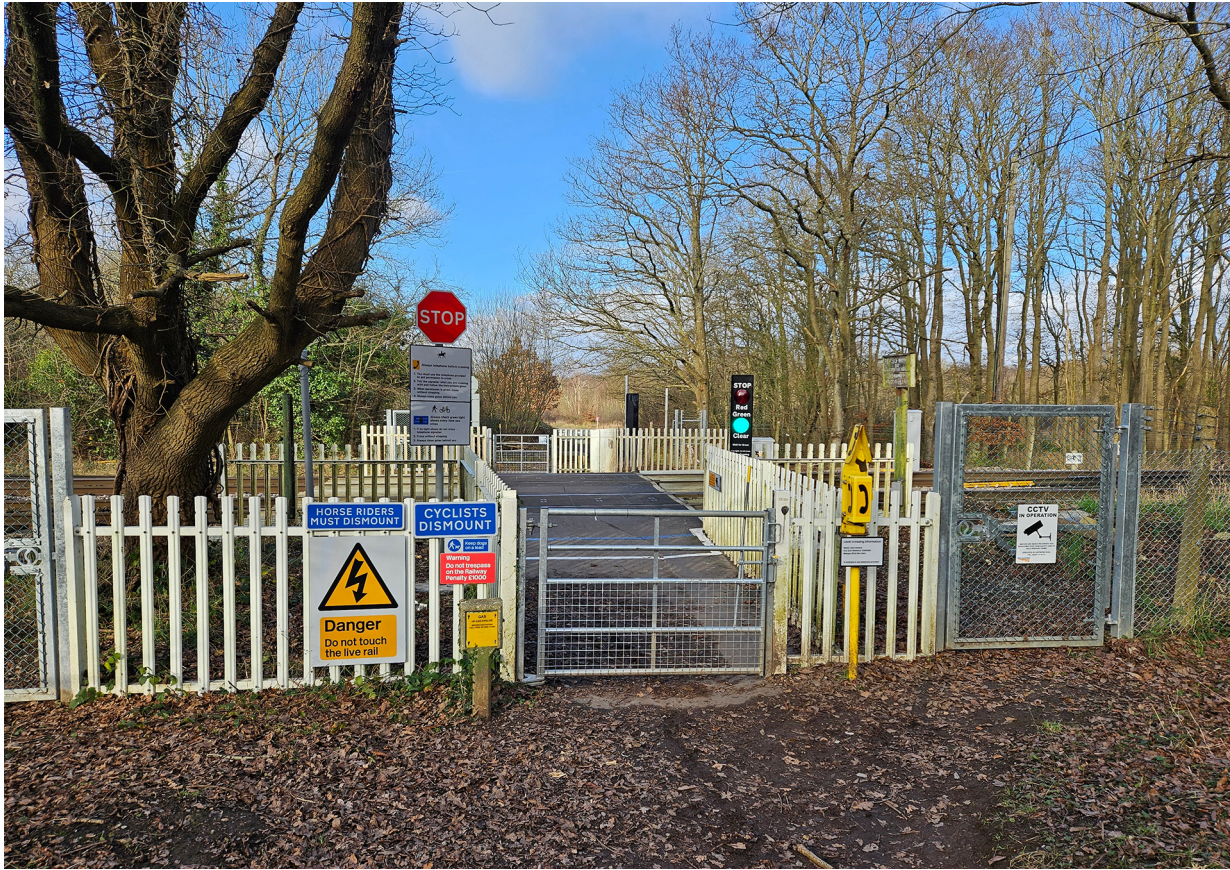
Figure 11: Lady Howard crossing, fitted with overlay MSLs (courtesy of Network Rail).

- 105 Network Rail’s Wessex route applied for and received a derogation from the standard which has allowed it to fit overlay MSLs at Lady Howard crossing. MSL equipment was brought into use at the crossing in January 2024 (figure 11).
