**ACCIDENT**

<b>Aircraft Type and Registration:</b>	Nord NC856A, G-CGWR	
<b>No &amp; Type of Engines:</b>	1 Snecma Regnier 4L08 piston engine	
<b>Year of Manufacture:</b>	1955 (Serial no: 54)	
<b>Date &amp; Time (UTC):</b>	23 September 2022 at 1625 hrs	
<b>Location:</b>	Field near Spanhoe Airfield, Laxton, Northamptonshire	
<b>Type of Flight:</b>	Private	
<b>Persons on Board:</b>	Crew - 1	Passengers - None
<b>Injuries:</b>	Crew - None	Passengers - N/A
<b>Nature of Damage:</b>	Aircraft caught fire and was destroyed	
<b>Commander's Licence:</b>	Private Pilot's Licence	
<b>Commander's Age:</b>	54 years	
<b>Commander's Flying Experience:</b>	1,175 hours (of which 23 were on type) Last 90 days - 27 hours Last 28 days - 13 hours	
<b>Information Source:</b>	Aircraft Accident Report Form submitted by the pilot

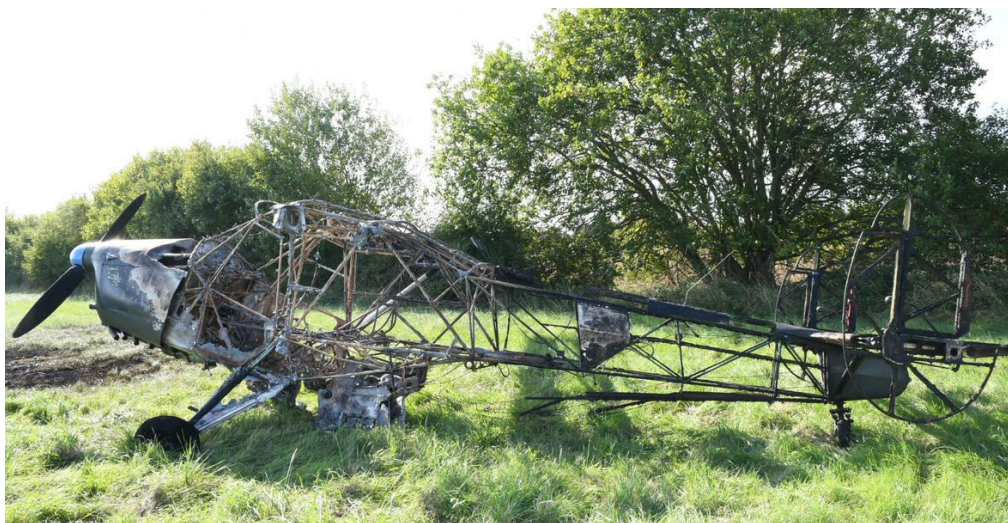
**Figure 1**

G-CGWR post-fire damage (used with permission)

All the pre-takeoff engine oil, temperature and power checks had been normal. On previous flights fuel consumption and performance were also as expected. There had been no disturbance of the engine or fuel system since the last annual Permit to Fly checks were undertaken. Whilst the investigation could not definitively establish the cause of the fire it is likely a failure of the fuel system in the engine bay enabled Avgas to be ignited on hot engine surfaces, causing a fuel fed fire which then rapidly consumed the aircraft.
