AAIB Bulletin

3/2023

Published 9 March 2023

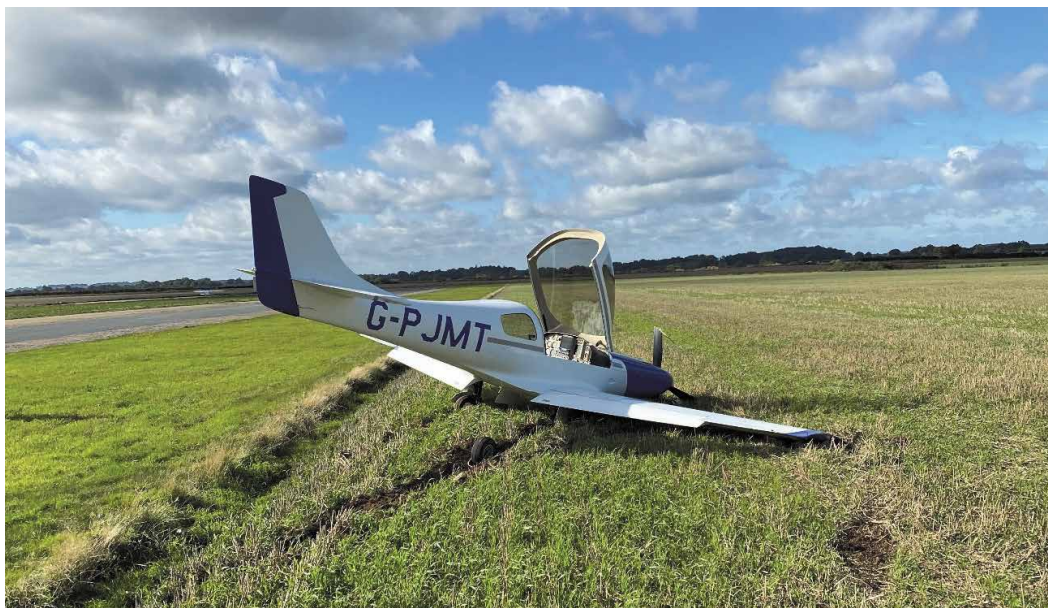
Figure 1

During pre-landing checks the pilot observed that the right main landing gear had not locked down. Despite the use of emergency procedures, it remained retracted, and the pilot landed the aircraft on the nose and left landing gear. As the aircraft slowed, it slewed off the runway and sustained damage to the wing tip, propeller and nose landing gear. The pilot and passenger were uninjured. Examination of the aircraft found the right landing gear shock absorber had discharged and prevented the strut from extending as its wheel left the ground. In this condition the tyre caught on the edge of the wheel bay and prevented the gear from lowering.

Aircraft accident site

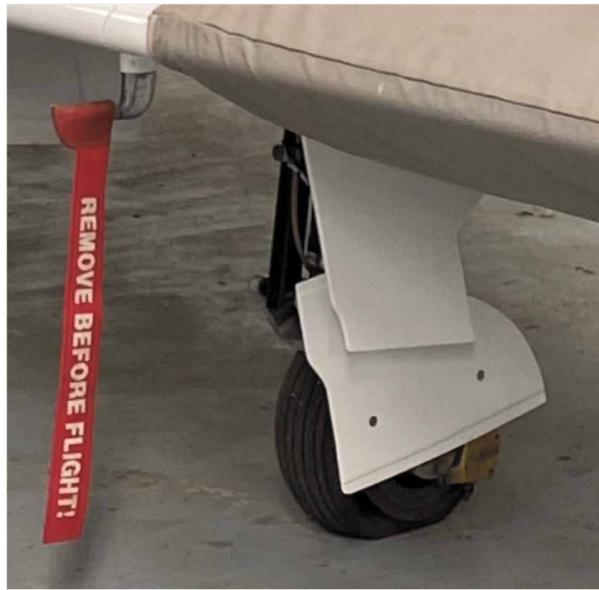
The aircraft was fitted with tricycle landing gear with hydraulic extension and retraction. Fairings are attached to the landing gear struts to ensure an aerodynamic surface on the underside of the wing when the gear is retracted. The main landing gear lifts and folds inwards towards the fuselage. Figure 2 shows the general arrangement of the main landing gear assembly.

Figure 2
Main landing gear general arrangement

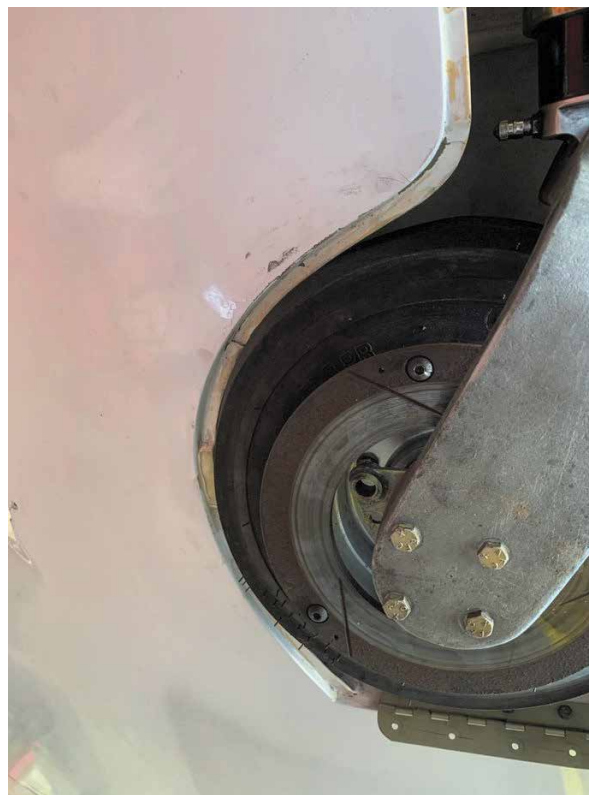
During the lifting process as the aircraft was recovered, the right main gear lowered of its own accord. Later examination by the aircraft maintenance organisation found the right main air-shock absorber was discharged. This had resulted in the landing gear strut articulated link not fully extending as the weight came off the wheel after takeoff. In this position the tyre had caught on the edge of the wheel well and prevented the gear from lowering (Figure 3). With the tyre impinging on the edge of the wheel well, the hydraulic actuator does not have a mechanical advantage and could not overcome the restriction.

Figure 3
Landing gear tyre and wheel well impingement (fairings removed)

Further examination found the left main landing gear shock absorber was also partially discharged, although to a lesser extent. When the pilot did his pre-flight checks the discharged state of both shock absorbers caused minimal difference between the height above ground of each wing tip, so went unnoticed. The cause of the discharged condition of the shock absorbers is not known but the pilot is of the opinion they gradually discharged over time and therefore had not drawn attention to the problem.

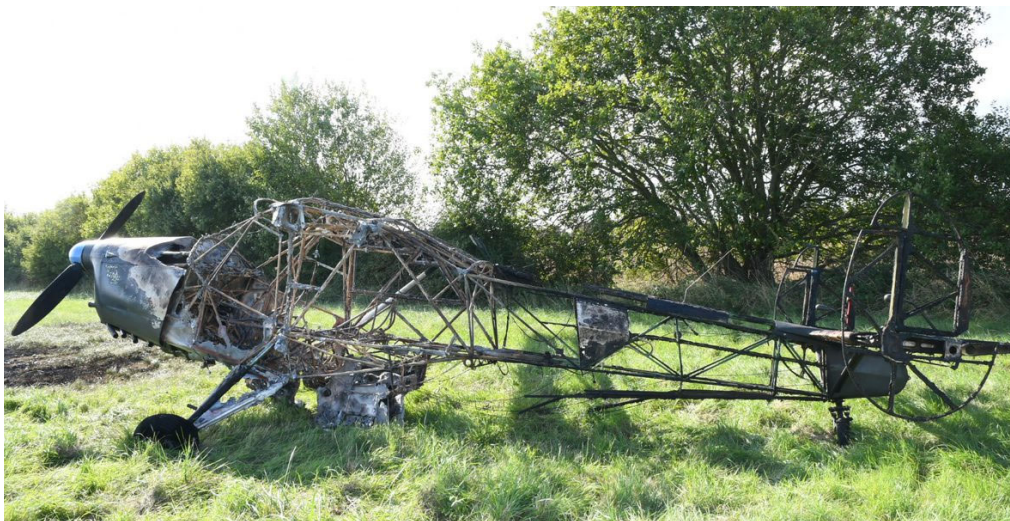
Figure 1

Following a routine takeoff and initial climb the engine misfired and suddenly lost power. Smelling fuel, the pilot immediately executed a successful emergency landing stopping just off the runway and within the airfield boundary. As the aircraft came to a halt there was a flash fire on the port side of the aircraft and the pilot evacuated the aircraft without injury. Despite the efforts of airport staff with fire extinguishers, the aircraft was rapidly destroyed by the fire.

G-CGWR post-fire damage (used with permission)

All the pre-takeoff engine oil, temperature and power checks had been normal. On previous flights fuel consumption and performance were also as expected. There had been no disturbance of the engine or fuel system since the last annual Permit to Fly checks were undertaken. Whilst the investigation could not definitively establish the cause of the fire it is likely a failure of the fuel system in the engine bay enabled Avgas to be ignited on hot engine surfaces, causing a fuel fed fire which then rapidly consumed the aircraft.

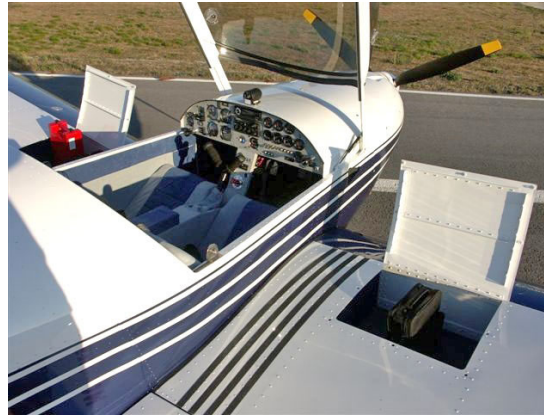
Figure 1

Shortly after takeoff, the aircraft rolled to the right and required greater than normal control input to maintain a climb. The pilot declared a PAN. A joining aircraft acknowledged the call and remained clear. The pilot observed that the right-wing locker door had opened and was protruding up at an approximate angle of 45° to the top surface of the wing, disrupting the airflow (Figure 1). They were able to control the aircraft, using significant left rudder, and positioned the aircraft to land. The aircraft landed without further incident.

The pilot commented that they were aware that a parachute aircraft was inbound to overhead the airfield and had rushed to prepare the aircraft for departure. In the end they decided to wait for the parachutists to land before departing but had forgotten to check the wing locker was securely closed.

Open wing baggage lockers on a similar aircraft
(Image used with permission)

- Do not rush to expedite takeoff, the self-imposed time pressure is likely to have been the root cause of not checking the wing locker.
- Add 'wing lockers' to the '*hatches and harness*' check to the pre-flight check list.

Taking the time to ensure all hatches and external panels are properly secure before departure is equally important on all types of aircraft. In this case, once airborne, the pilot rightly focused on maintaining control of the aircraft to ensure a safe landing.
