Rail Accident Investigation Branch

# Rail Accident Report

**Track damage between Pencoed and Llanharan,  
South Wales  
6 March 2021**

Report 03/2023  
February 2023

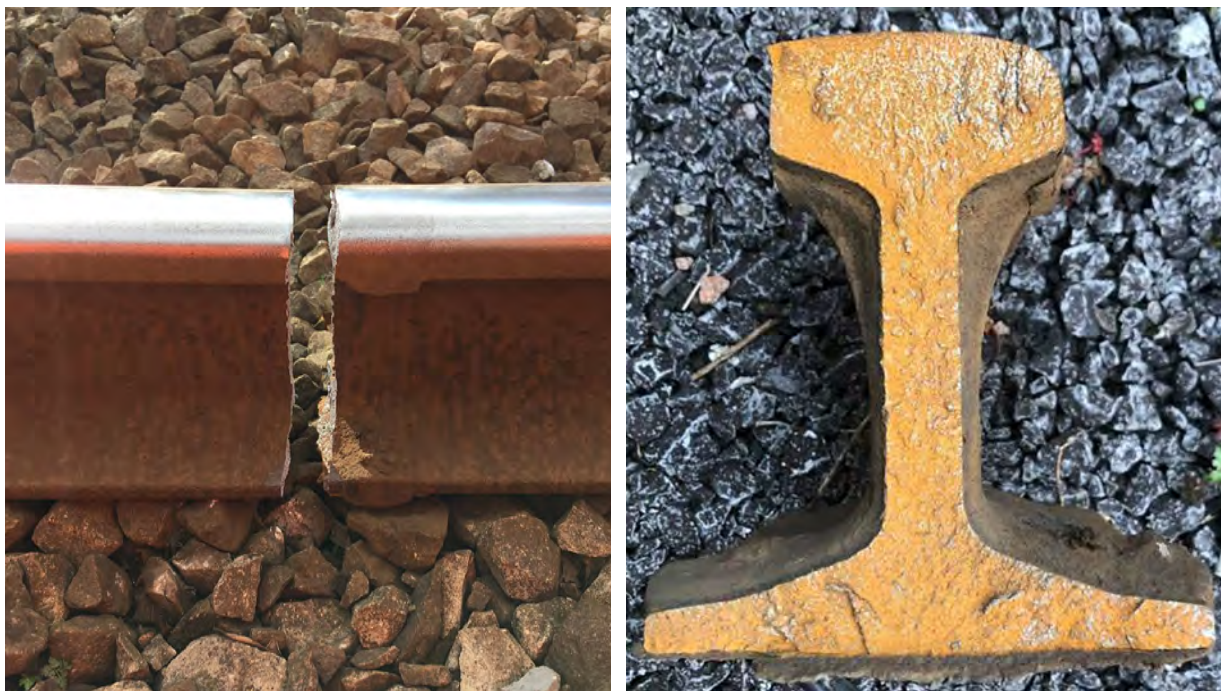
- 43 At 02:45 hrs, in accordance with the Rule Book, the Port Talbot signaller had arranged for the line to be examined by the next train passing through the Pencoed and Llanharan area. At 03:31 hrs, the driver of the examining train reported that there was no issue with the line. The Port Talbot signaller started to allow drivers of subsequent trains to pass the signals being held at red by the track circuit failures. Subsequent investigation by Network Rail identified at 09:32 hrs that the track circuit faults observed by the Port Talbot signaller were the results of two rail breaks (figure 8) and the line was closed at this point.

Figure 8: The rail break at Pencoed, in-situ (left-hand image) and its fracture face (right-hand image) (photos courtesy of Network Rail).

**50 The damage to the infrastructure between Pencoed and Llanharan was caused by impact loading from the rotation of a wheelset with severe wheel flats on train 6A11.**

- 52 The high impact forces generated by a rotating wheelset with a wheel flat is a known cause of rail breaks, particularly if the impact occurs near a rail joint, where the strength of the rail is reduced. The repeated impact on the track of a wheel flat also produces a characteristic noise that can be heard as a train passes. The sound is generated as the edges of the wheel flat impact on the rail and is cyclic in nature.

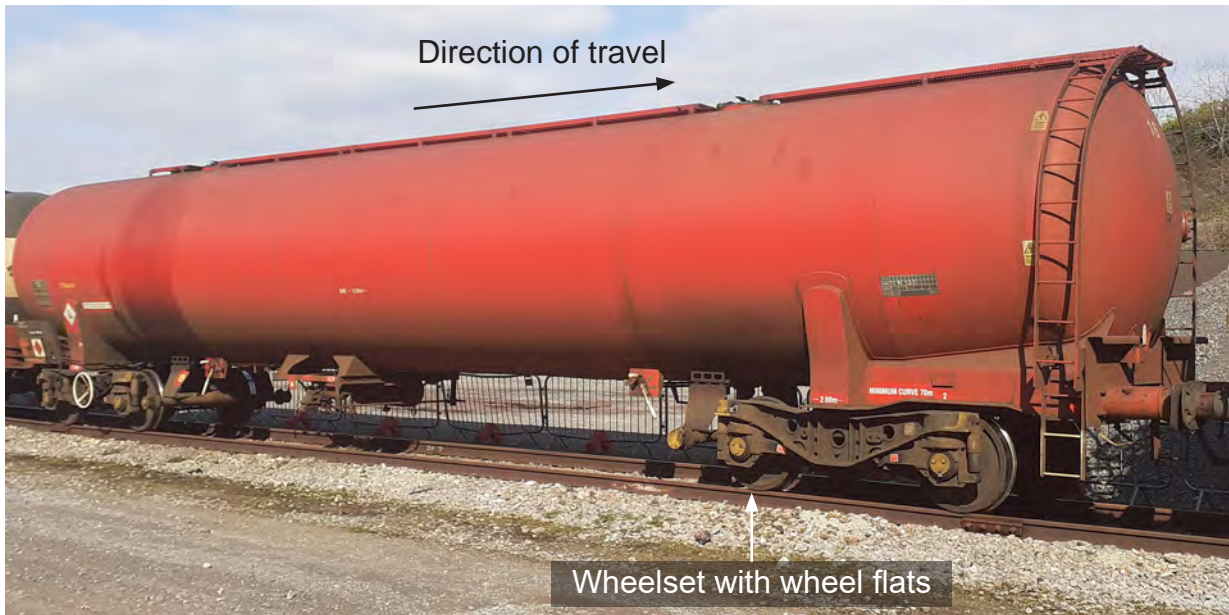
- 44 The inspection of train 6A11 at Bristol East depot took place on 11 March 2021 (figure 9). Wagon GERS89016 was inspected, and the accident wheelset was found to have flats measuring about 185 mm in length on both wheels.
- 45 As well as damage to the trailing wheelset of the leading bogie of wagon GERS89016 (figure 10), wheelset damage was also identified on another eight wagons, as described in table 1. Figure 10 shows the damage witnessed on wagon GERS89016 as well as wagon VTG88111 (the fifth wagon from the front of the train) and wagon 7077920143 (the seventeenth wagon).

Figure 9: Wagon GERS89016 at Bristol East depot after the accident (photo courtesy of DB Cargo).

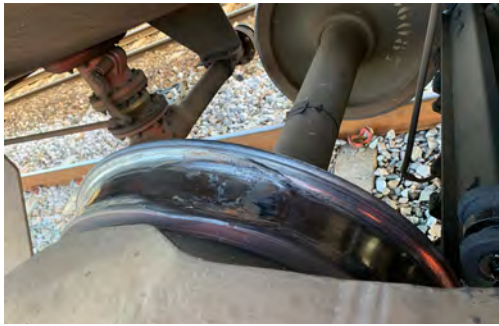
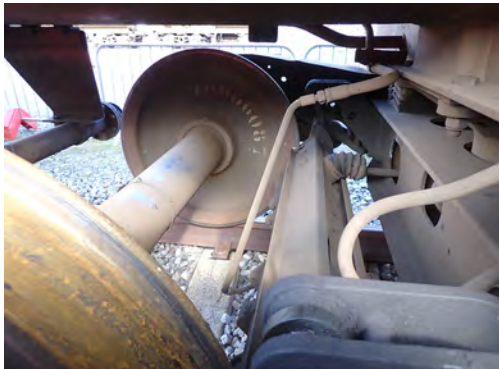
Wagon GERS89016  
Trailing wheelset of  
leading bogie

- 5 The train did not derail because of the rail fractures, and no one was injured in the accident. However, some damage was caused to the bogie-mounted braking equipment and wheelset involved (figure 10).

Figure 10: Example of wheelset damage on train 6A11 (photos courtesy of DB Cargo).

- 53 The subsequent inspection at Bristol East depot identified damage to the wheels of several vehicles of train 6A11, including the presence of severe wheel flats on the trailing wheelset of the leading bogie of wagon GERS89016 (paragraph 44). RAIB has concluded that the damage to the infrastructure between Pencoed and Llanharan was caused by impact loading from these severe wheel flats.

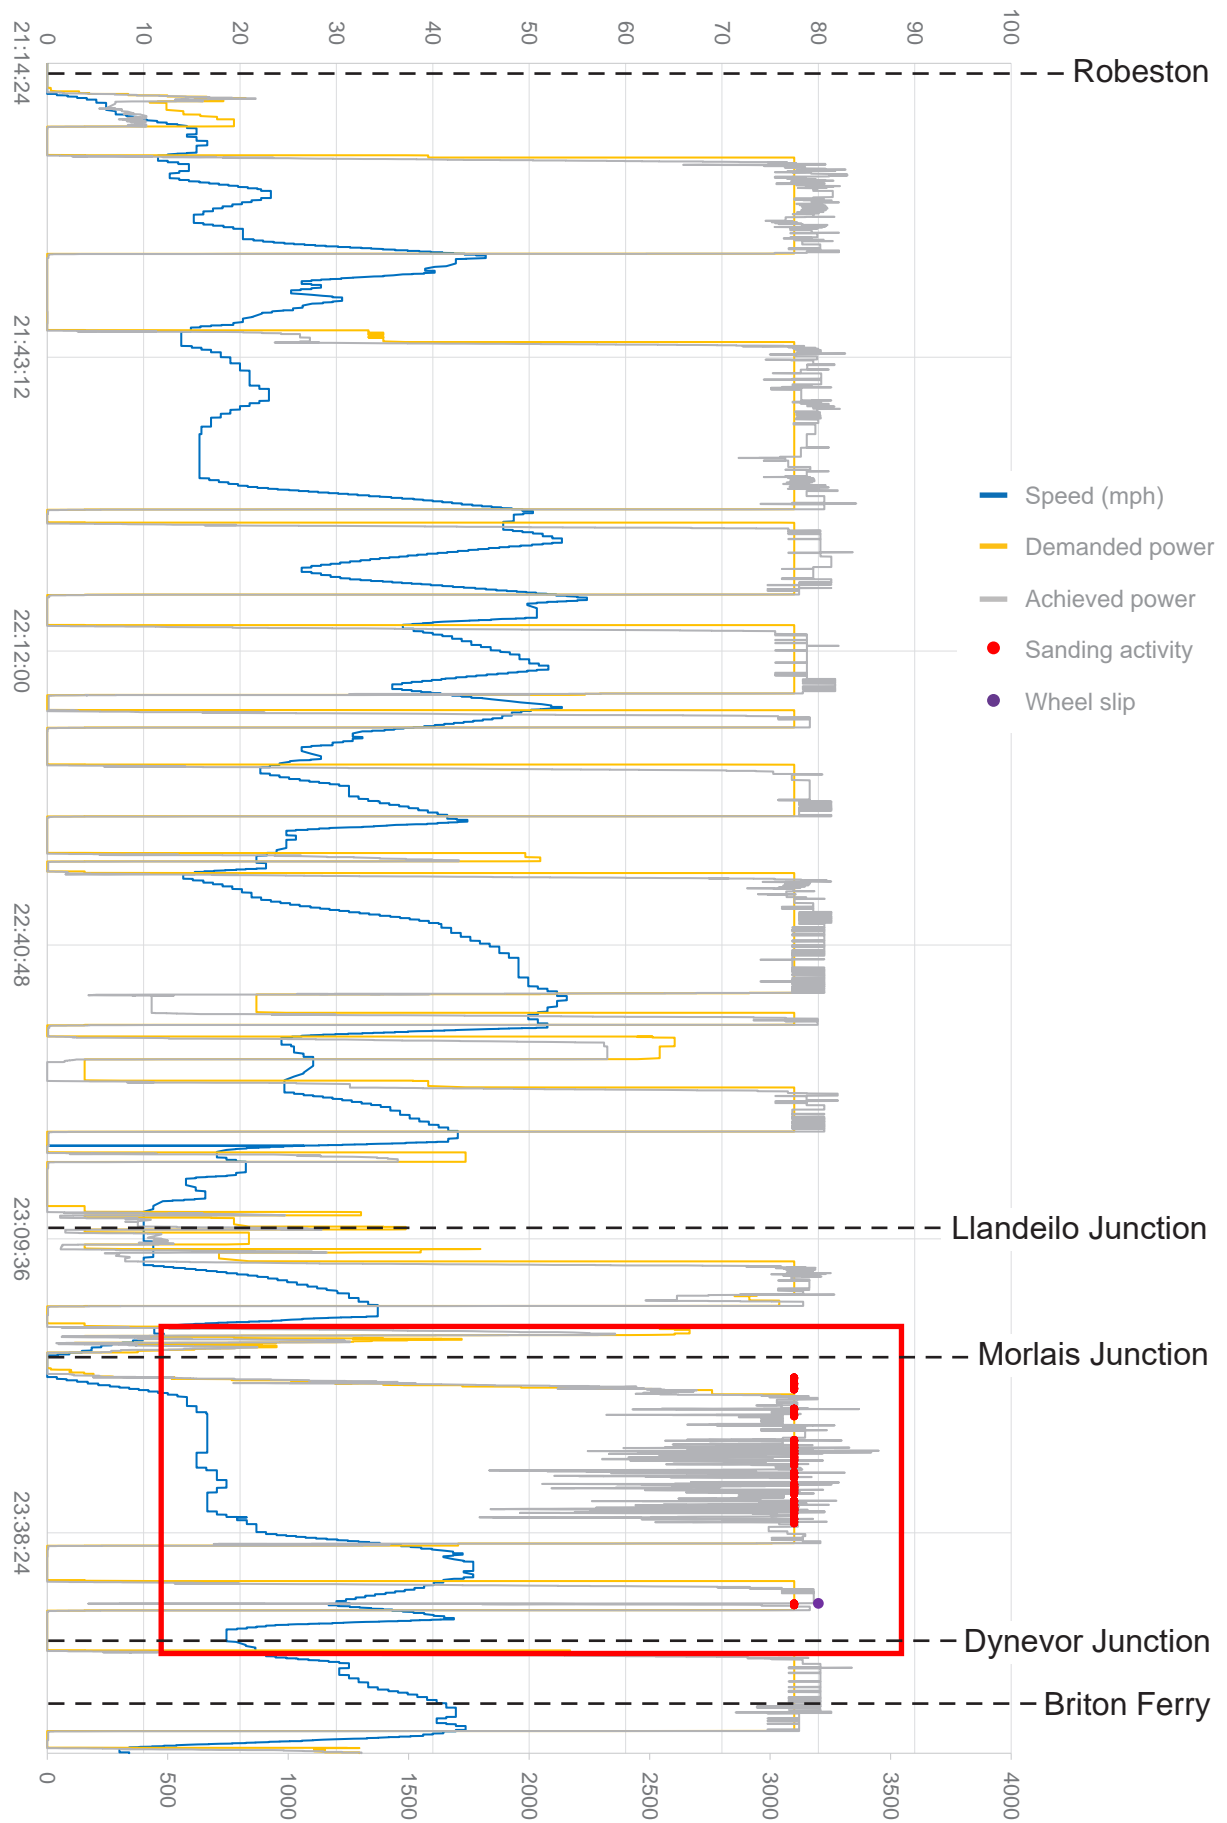
- 85 Figure 14 shows the OTDR data as recorded on locomotive 60015 on 5 March 2021 for the trip from Robeston to Margam. Figure 14 shows:
- the speed trace in mph

Figure 14: OTDR data for locomotive 60015 on 5 March 2021.

- 88 From Morlais Junction to Llangyfelach Tunnel, the driver commanded full traction on the locomotive but train 6A11 initially struggled to increase its speed on the rising gradient and the anti-slip function of the traction control system had to intervene. OTDR data (identified by the red box on figure 14) showed that the torque applied to the wheelset was repeatedly reduced to match the available adhesion and that sanding was automatically activated.

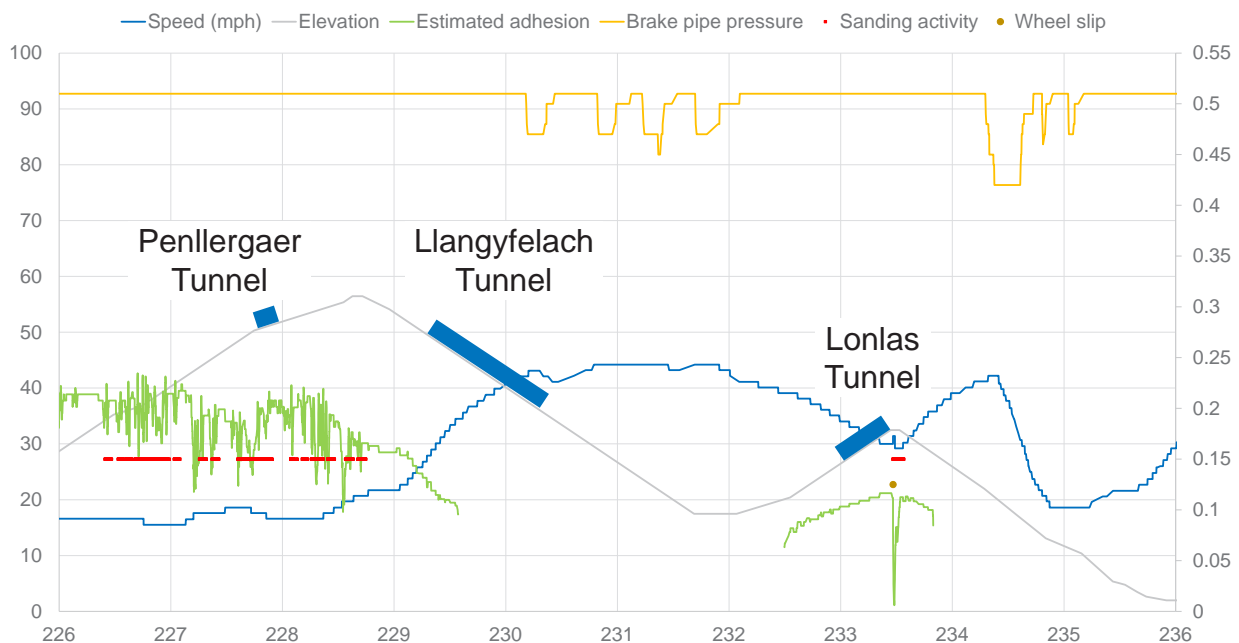
Figure 15: Results of analysis of the OTDR data for locomotive 60015 on 5 March 2021 to estimate adhesion.

- 90 This analysis found that the estimated level of adhesion along the stretch of line from Morlais Junction to the start of the descent towards Llangyfelach Tunnel was between 0.15 and 0.2 (figure 15). This was a time when the locomotive was repeatedly depositing sand on the rails and hence this estimated level of adhesion accounts for the effects of sand. A detailed examination of the adhesion curve (figure 16) shows that some of the lowest points of the adhesion curve occur immediately before sanding takes place. These lowest points of the adhesion curve give an instantaneous estimate of the adhesion that was present before sanding, and indicate that adhesion was as low as 0.1 along the stretch of line from Morlais Junction to the start of the descent towards Llangyfelach Tunnel.

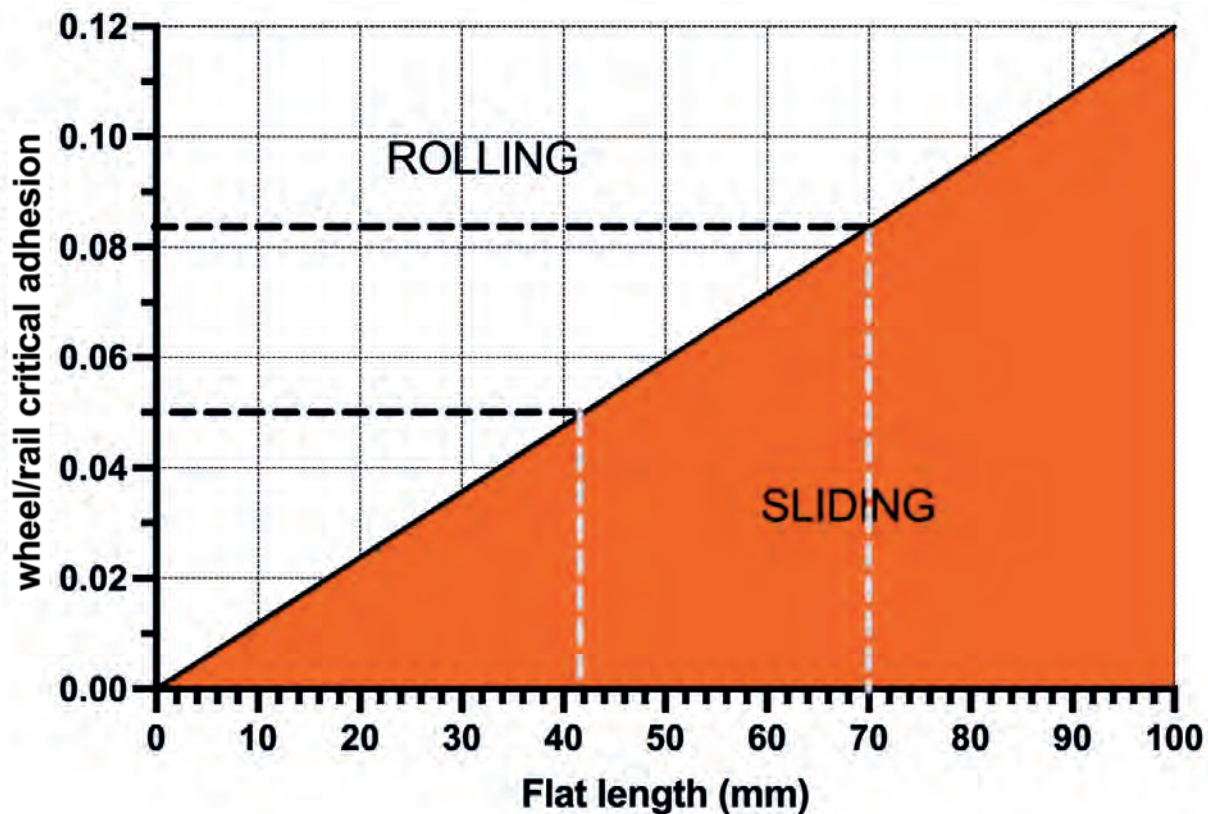
95 The study commissioned by RAIB (paragraph 80) calculated that the wheel flats would have grown to around 70 mm in length by the end of the brake application from Lonlas Tunnel towards Dynevor Junction. Figure 17, developed as part of the study, shows that with a wheel flat length of 70 mm, adhesion would have needed to be greater than 0.08 to get the wheelset to start rotating after the brakes were released. This suggests that the wheelset involved would have stayed locked after the brakes were released, assuming that the adhesion levels remained in a similar range, and that the wheel flats would have continued to grow.<sup>14</sup>

Figure 17: Plot showing the relation between wheel/rail critical adhesion and the flat length.

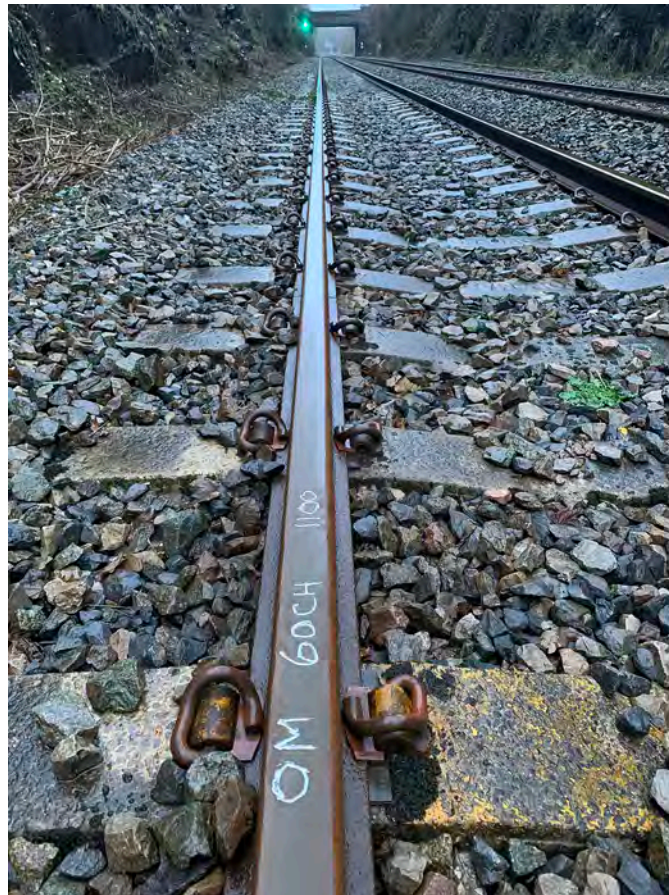
- 104 The Swansea District line is also fitted with traction gel applicators. Traction gel applicators are designed to increase the adhesion on the top of the railhead by applying a traction enhancing material. However, Network Rail only uses them on this line during leaf fall season and the accident took place outside of that season (see paragraph 113).
- 105 Network Rail undertook a visual inspection of the line on 14 March 2021 to assess its condition. This was nine days after the accident involving train 6A11. Figure 18 shows the condition of the railhead on that day at a location between Lonlas Tunnel and Dynevor Junction. The photograph shows a lack of a running band (where the repeated passage of trains normally leaves a shiny band on the railhead as shown, for example, on figure 8). Where the running band would normally be located, the photograph shows rust.

*Figure 18: Railhead condition on the line between Lonlas Tunnel and Dynevor Junction (courtesy Network Rail).*

- 106 Results from analysis of swabs of the railhead taken by Network Rail during the 14 March 2021 track inspection showed:
- evidence of large amounts of brown dirt/debris and a trace of metallic particles (this is to be expected from a railhead surface but is also consistent with the presence of rust)
