AAIB Bulletin S1/2023

SPECIAL

SERIOUS INCIDENT

Aircraft Type and Registration:	Bombardier CL-600-2B16 (604), D-AAAY
No & Type of Engines:	2 General Electric CF34-3B turbofan engines
Year of Manufacture:	2004 (Serial no: 5602)
Date & Time (UTC):	10 August 2022 at 1640 hrs
Location:	In the climb after departing Farnborough Airport, Hampshire
Type of Flight:	Commercial Air Transport (Passenger)
Persons on Board:	Crew - 3 Passengers - 7
Injuries:	Crew - None Passengers - None
Nature of Damage:	Damaged contact in number 1 system flap retract relay
Commander's Licence:	Airline Transport Pilot's Licence
Commander's Age:	56 years
Commander's Flying Experience:	13,091 hours (of which 5,655 were on type) Last 90 days - 102 hours Last 28 days - 41 hours
Information Source:	AAIB Field Investigation

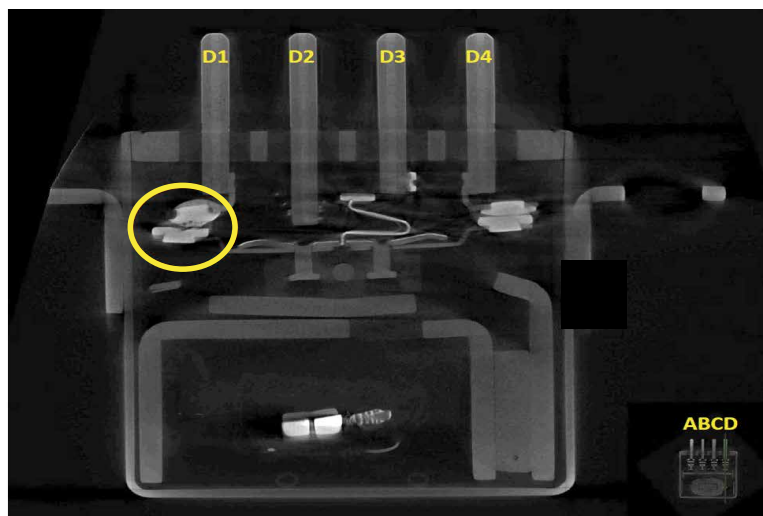
Figure 3

The scans identified anomalies with the D contacts of relays K1CE, K2CE and K3CE. The contacts in relay K4CE appeared normal. An example of an image from the K3CE scan is shown in Figure 3.

Relay K3CE showing D1 contact damage, circled in yellow

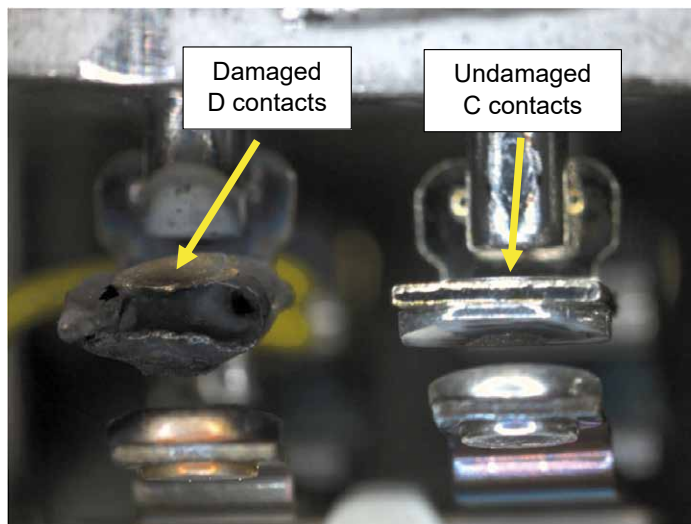
Figure 6

Prior to full disassembly, the contacts were examined using an optical microscope and significant damage was found on the D contacts on relays K1CE, K2CE and K3CE. The damage to the D1 contact on relay K3CE is shown in Figure 6.

K3CE relay showing contact damage

Scanning Electron Microscopy inspection and Energy Dispersive X-ray analysis was conducted on a selection of contact pads which showed evidence of welding and pulling apart.

The failure of the relays on these three aircraft was caused by damage to the D contacts which switch electrical power to the BDUs. The damage was consistent with arcing between the contacts, which caused metal transfer and the welding of the contacts. As all the contacts in the relay are mounted on a common shaft, the welding of the D contacts would stop the other three sets of contacts from working properly. Examination of relays provided to the investigation, which had not failed in-service, also had damage to the D contacts showing that the damage had accumulated over a period of time.

It is recommended that Bombardier Aviation introduce a modification on the Challenger 600 series of aircraft to protect the D contacts within the extend and retract relays of the flap operating system from unsuppressed back-EMF electrical arcing.

It is recommended that Bombardier Aviation introduce a life policy for the flap operating system relays on the Challenger 600 series of aircraft, which takes account of the component's specified life and is sufficient to ensure that any in-service damage on the D contacts on the extend and retract relays remains acceptable for continued operation.

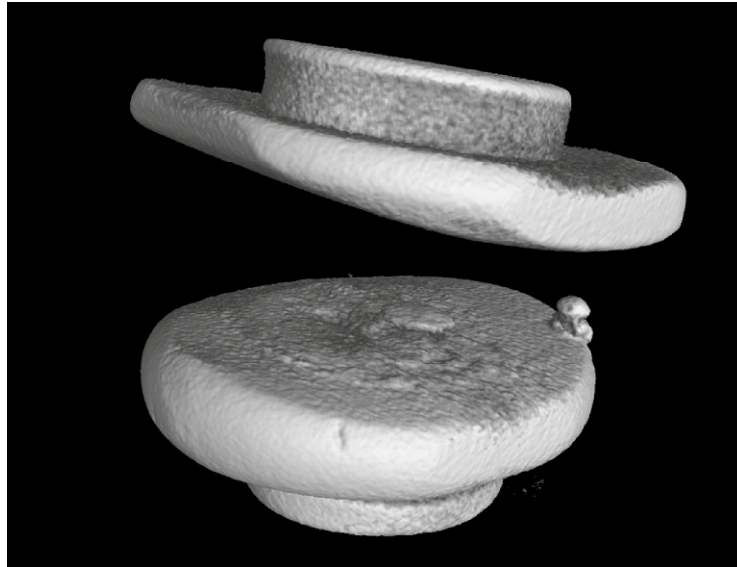
Figure 7

The K2CE relay, which had not failed, and was replaced in 2018, was CT scanned and the D1 and D2 contacts were found to show signs of erosion and material transfer (Figure 7). This relay had been in-service for approximately 2,700 flight hours and 1,371 flight cycles.

Aircraft 2, relay K2CE, contacts D1 and D2 showing surface degradation and material transfer

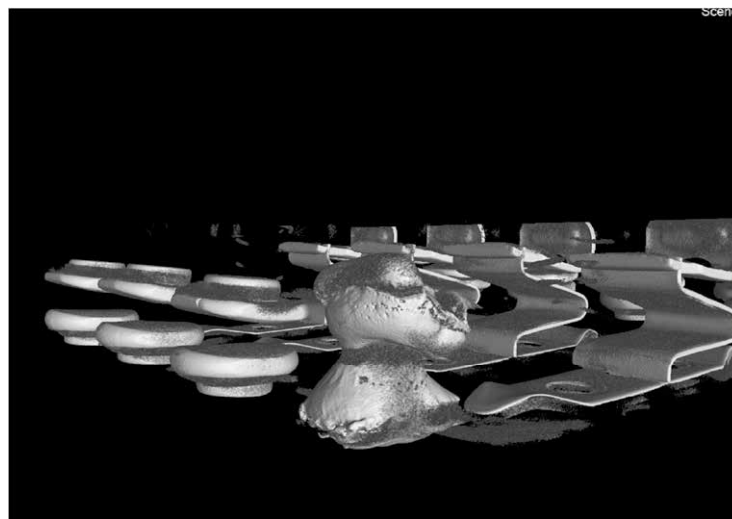
Figure 8

The K2CE relay from Aircraft 3 was found to have the D1 and D2 contacts welded together. When in the de-energised condition; the contacts should have been open. The D2 and D3 contacts were also closed; this would be their normal position with the relay de-energised (Figure 8). In this condition, if the uncommanded flap movement arrest system was activated, rather than the flap movement being arrested, the flaps would retract.

Aircraft 3, relay K2CE, showing welded D1 and D2 contacts

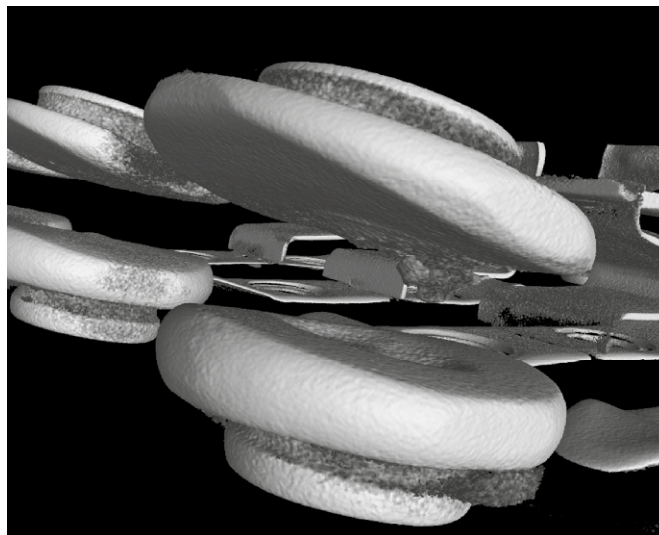
Aircraft 4, which had passed the SB flap movement timing test, also had degraded D1 and D2 contacts on relay K3CE. Figure 9 shows erosion and metal transfer between the contacts.

Aircraft 4, relay K3CE, showing erosion and metal transfer on contacts D1 and D2

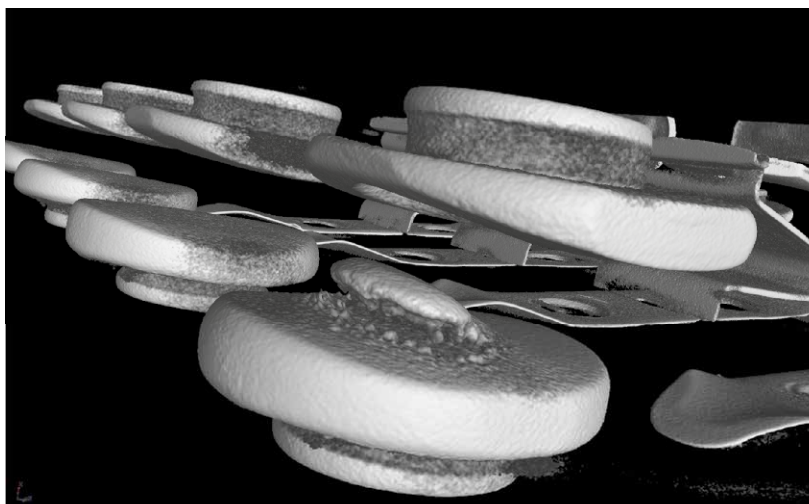
In most of the relays examined, metal erosion and metal transfer were visible on the D contacts to varying degrees. Figure 10 shows damage to the D1 and D2 contacts on relay K1CE from Aircraft 2, where the flaps initially extended at half speed before the fault cleared.

Aircraft 2, relay K1CE, showing erosion and metal transfer on contacts D1 and D2

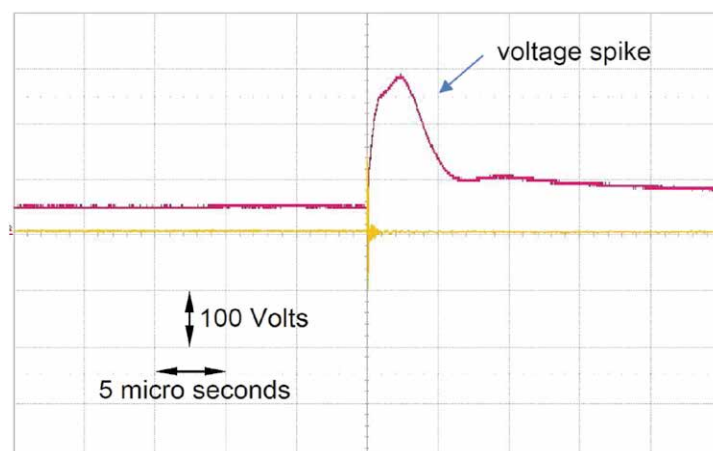
Figure 12

Laboratory testing of the BDU coil resistance indicated they were within specification. The current and voltage during solenoid switching was measured using an oscilloscope (Figure 12). When the solenoid was de-energised a transient voltage spike of up to approximately 300 V was seen, and this spike regularly exceeded 150 V during repeated switching. The voltage spike is likely to be the back electro motive force (EMF) which is a known feature of inductive loads and is caused by the current to the solenoid coil decaying and inducing the EMF after the electrical supply has been switched off. There was no protection or suppression provided within the flap operating system to prevent or reduce this back-EMF.

Oscilloscope output showing typical voltage spike after de-energising the BDU coil

During laboratory testing, when the BDU solenoids were de-energised, a transient voltage spike was seen to peak at up to 300 V and regularly exceeded 150 V. This spike is caused by a back-EMF, which could cause arcing across the D contacts. There is no protection within the electrical system to suppress this back-EMF.
