ACCIDENT

Aircraft Type and Registration:	Reims Cessna FRA150M, G-BDNR	
No & Type of Engines:	1 Rolls Royce O-240-E piston engine	
Year of Manufacture:	1976 (Serial no: 284)	
Date & Time (UTC):	1 August 2021 at 1426 hrs	
Location:	Approx 4 miles NNE of Retford Gamston Airport, Nottinghamshire	
Type of Flight:	Training	
Persons on Board:	Crew - 1	Passengers - 1
Injuries:	Crew - None	Passengers - 1 (Minor)
Nature of Damage:	Nose leg collapsed, prop bent and engine cowling damaged. Subsequent engineering inspection found number 3 cylinder and piston had detached in flight	
Commander's Licence:	Commercial Pilot's Licence	
Commander's Age:	21 years	
Commander's Flying Experience:	534 hours (of which 300 were on type) Last 90 days - 223 hours Last 28 days - 59 hours	
Information Source:	AAIB Field Investigation

Synopsis

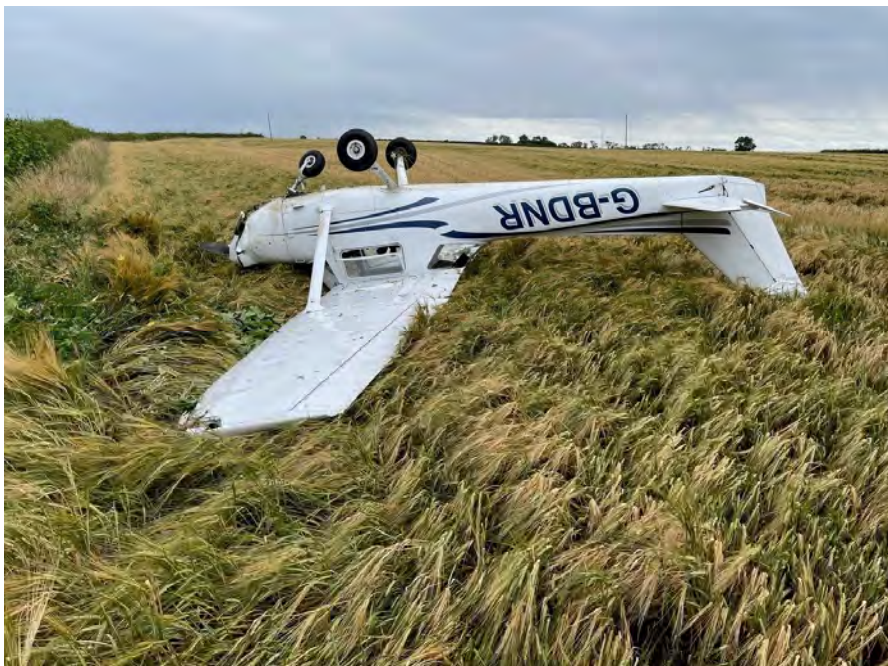
Figure 1

After hitting a hedge, the aircraft came to rest upside down

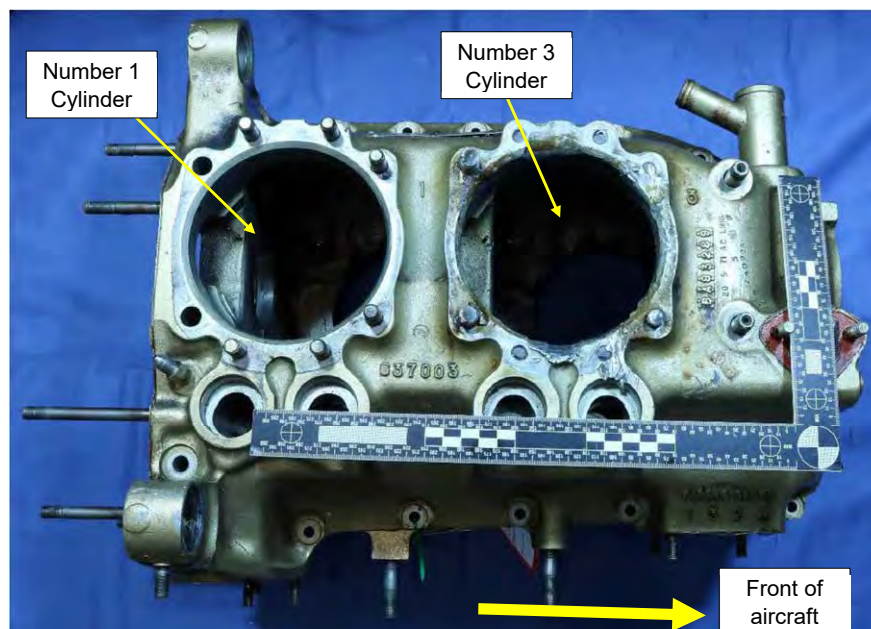
Figure 2

After removing the engine from the aircraft, examination of the engine crankcase revealed that the six engine cylinder base studs and two crankcase through-studs which attach the number 3 cylinder to the crankcase had failed (Figure 2).

Closer inspection of the fractured ends of the studs revealed crack growth marks and fatigue failures. The engine crankcase was sent for metallurgical and fatigue analysis including comparison to the manufacturer's material specifications. A second engine crankcase, serial number 40R-116, which was unrelated to G-BDNR but with a similar failure mode to cylinder 3 was also sent for comparative analysis.

Crankcase right side showing numbers 1 (intact) and 3 (failed) cylinder studs

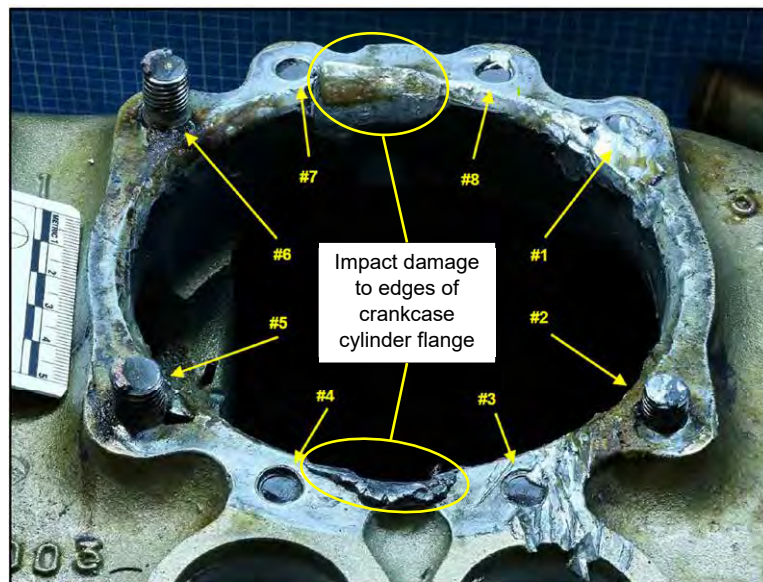
Figure 3

For ease of reference, the cylinder 3 crankcase base studs from G-BDNR's engine, 40R-079, were arbitrarily numbered #1 to #8 (Figure 3).

Studs #2, #5 and #6 had failed just above the cylinder mounting face. The remaining studs had failed just beneath the cylinder mounting face. Studs #5 and #6 were through studs to help bolt the two halves of the crankcase together.

Close inspection of number 3 cylinder mounting surface

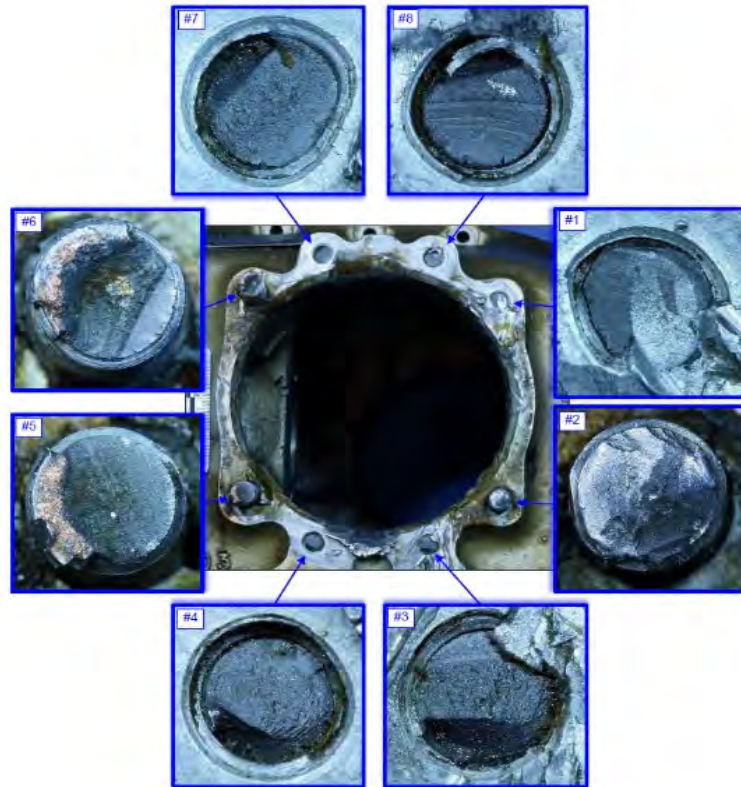
Figure 4

Closer views of the in-situ stud fracture surfaces show signs of post fracture damage (Figure 4). Crack progression markings on each of the fracture surfaces appear to show fatigue failures. The directions and extent of stable fatigue crack growth are shown in Figure 5.

A closer view of the in-situ stud fracture surfaces

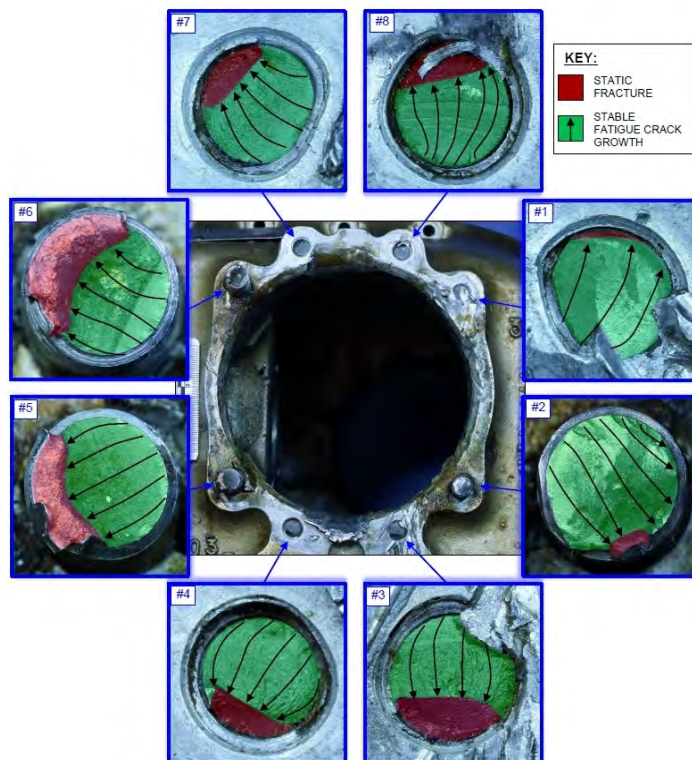
Figure 5

On studs #1 and #2, fatigue cracks had propagated across almost the entire stud diameter, with only a small region of static fracture. This was consistent with a relatively low magnitude of stress repeated for a high number of cycles. In comparison, the remaining studs show larger regions of static fracture consistent with a greater magnitude of stress, repeated for fewer cycles. These findings indicate that the fatigue cracks on studs #1 and #2 had initiated first and would have accelerated the remaining stud failures. In each case, the fatigue crack fronts had initiated from multiple sites within the inside edge of the thread roots nearest the cylinder and propagated outwards.

Directions and extent of fatigue crack growth

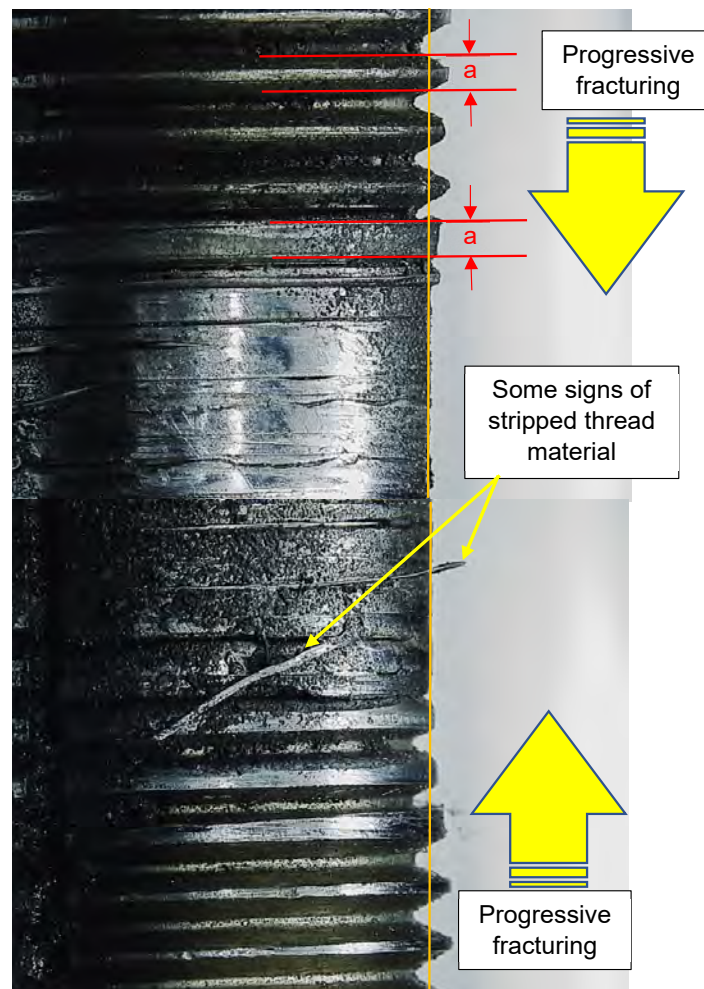
Figure 6

Closer examination of the threaded and damaged sections of the studs revealed that the threads had been stripped. The crests of the threads appeared to have been progressively fractured by the nut as it was torqued, and the fractured crests pushed into the thread roots. This created a flat region around the circumference of the stud causing the nut to lose torque. There was also some evidence of stripped spiral thread material which could be remains from the nut thread (Figure 6).

Test 3 - Stud with progressively fractured thread crests (a) and flattened section to half the depth of the intact threads

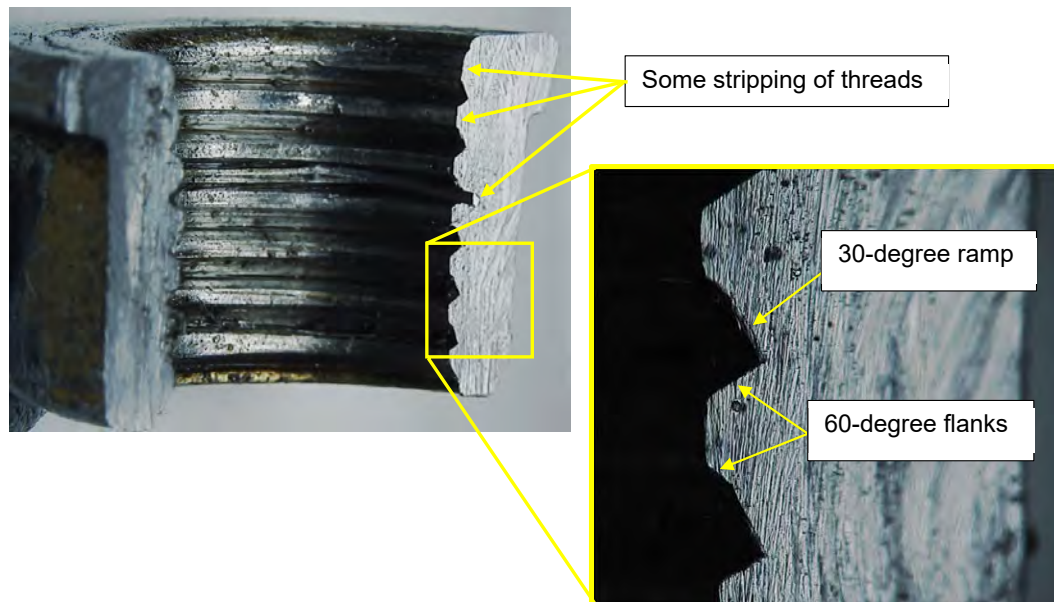
Figure 7

Two types of TCH nuts were used during the tests; one of the samples from Test 3 used a nut employing Spirallock⁶ technology (Figure 7) where a 30° ramp had been manufactured between the thread roots which was designed to resist loosening (See Spirallock section below).

Test 3 - Section of Continental Spirallock nut showing stripped threads (left) and 30° Spirallock ramp (right)

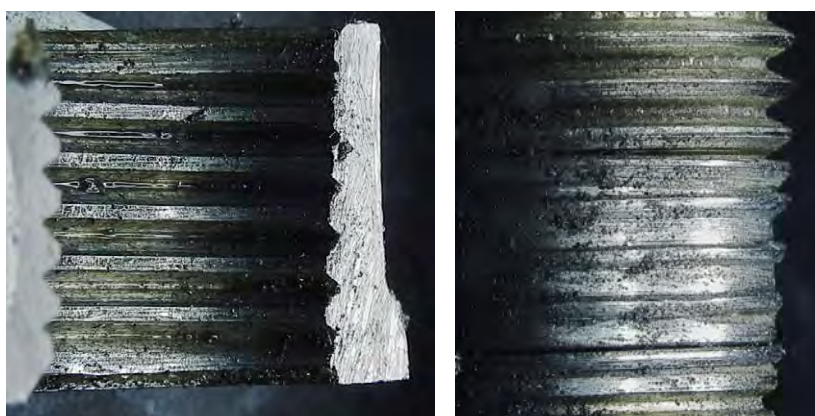
Figure 8

Test 4 used legacy nuts from an old RR O-240 engine which had a standard 60° thread profile (Figure 8). All TCH nut types tested resulted in similar stud failures when torqued.

Test 4 - Section of Continental legacy nut showing some thread stripping (left) and distorted threads on the associated stud (right)

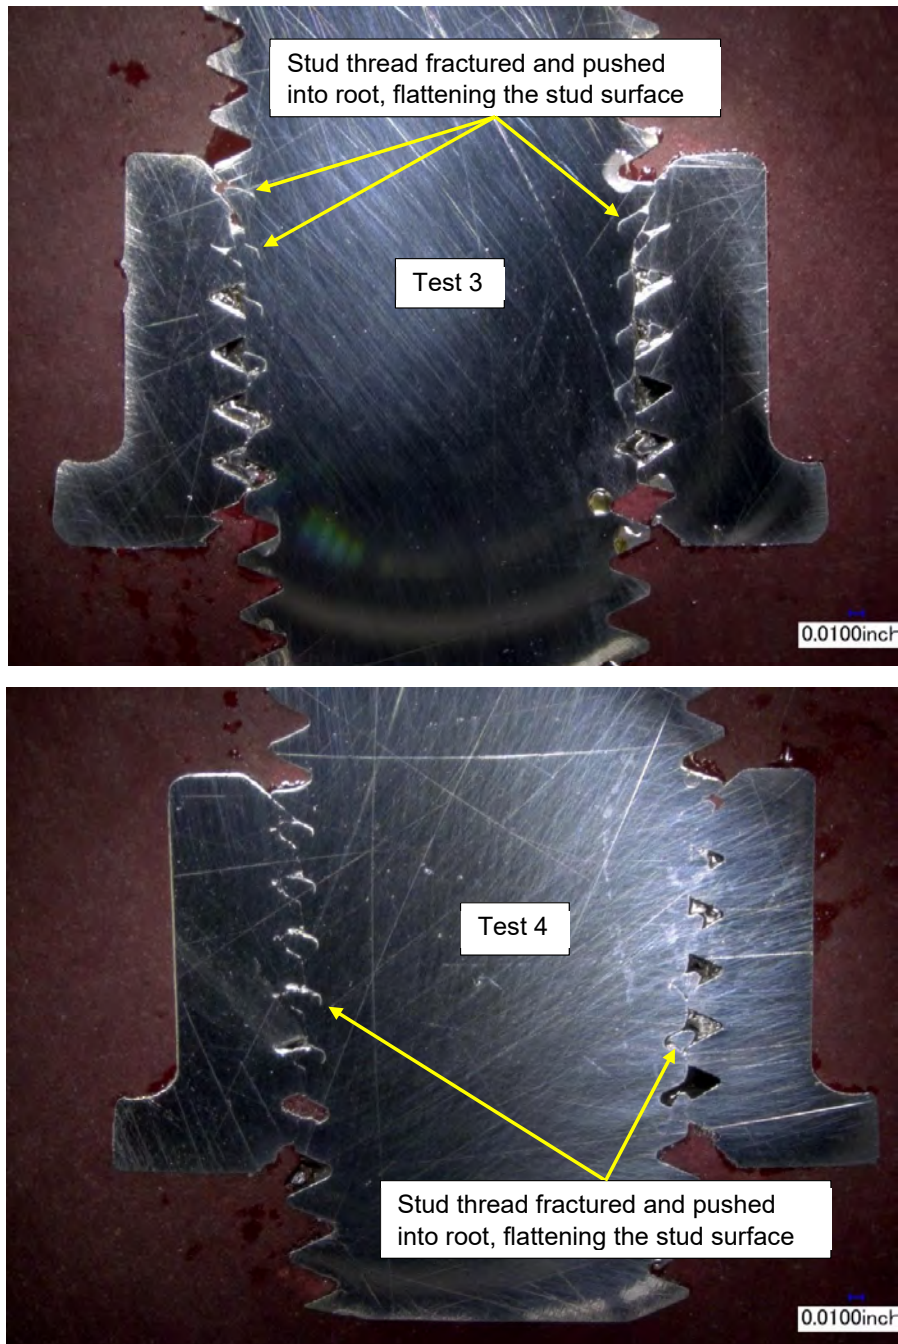
Figure 10

Sectioned samples from Tests 3 and 4 showing failure mechanism
Images used with permission

The manufacturer sectioned and examined some of the failed nuts and studs from Table 2 (Test samples 3 and 4), and the results can be seen in Figure 10. They show the stud threads had been damaged by the nuts in both samples. The broken thread crowns were pushed into their roots creating a flat section around the stud's circumference which caused the nuts to lose torque. Note both samples sectioned had not used Spirallock nuts.

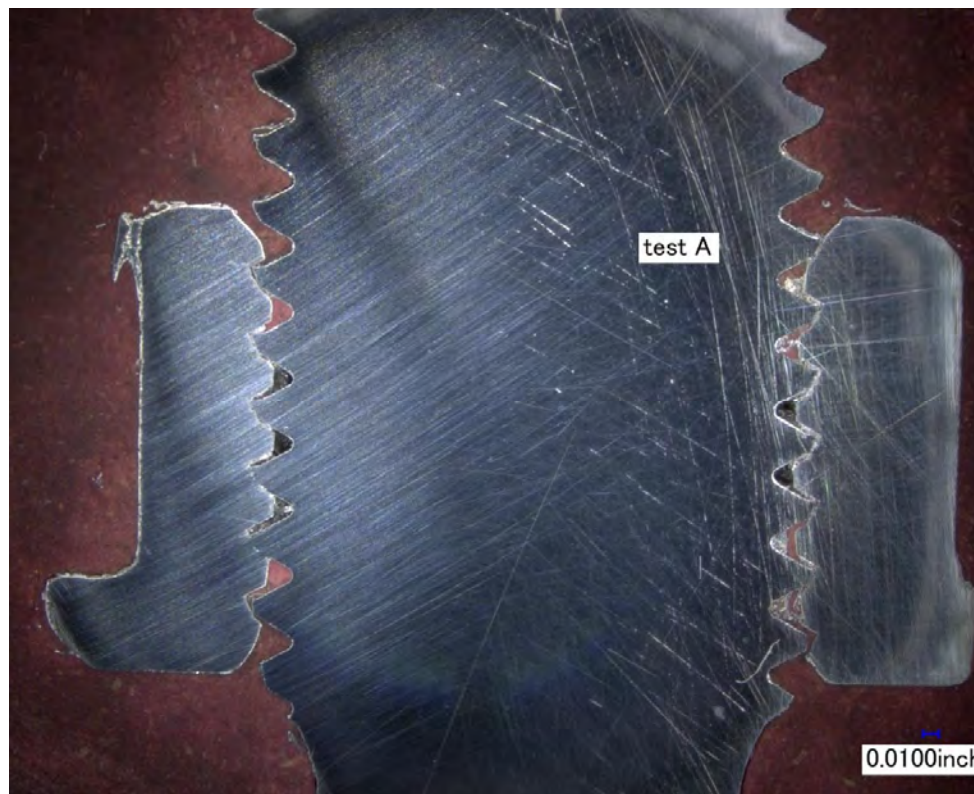
Figure 11 shows that the crowns of the nut threads do not appear to extend fully into the roots of the stud. As a result, only approximately half the flank of the nut threads is in contact with the flanks of the stud threads. With only half the flanks in contact, the shear load is effectively increased which may have contributed significantly to the thread stripping. In addition, it is possible that with nut threads that fully engage with the stud thread flanks, the stud is more likely to fail in tension at high torque values than to strip the threads, as observed when the AM nuts were used.

AM stud with matching tensile strength to Spirallock nut
Image used with permission

The manufacturer found that the base nuts had a higher tensile strength of 180 Ksi⁹ than the studs, 140 Ksi. This mismatch of tensile strength allowed the nuts to fracture the crown of the stud threads creating a flat surface around the circumference, which probably contributed significantly to the torque failures. When an AM stud was used with a matching tensile strength to the nut, the nut torqued up to 55 ft/lbs before failure, 53% above the maximum torque value (Figure 11).

In this example, the nut threads do not extend fully into the roots of the stud threads which increases the axial shear forces for a given surface area of thread contact.
