ACCIDENT

Aircraft Type and Registration:	Piper PA-28-140, G-BCJN
No & Type of Engines:	1 Lycoming O-320-E3D piston engine
Year of Manufacture:	1974 (Serial no: 28-7425350)
Date & Time (UTC):	4 August 2022 at 0935 hrs
Location:	Cotswold Airport, Gloucestershire
Type of Flight:	Training
Persons on Board:	Crew - 1 Passengers - 1
Injuries:	Crew - 1 (Minor) Passengers - 1 (Minor)
Nature of Damage:	Beyond economic repair
Commander's Licence:	Commercial Pilot's Licence
Commander's Age:	24 years
Commander's Flying Experience:	526 hours (of which 230 were on type) Last 90 days - 71 hours Last 28 days - 32 hours
Information Source:	AAIB Field Investigation

Synopsis

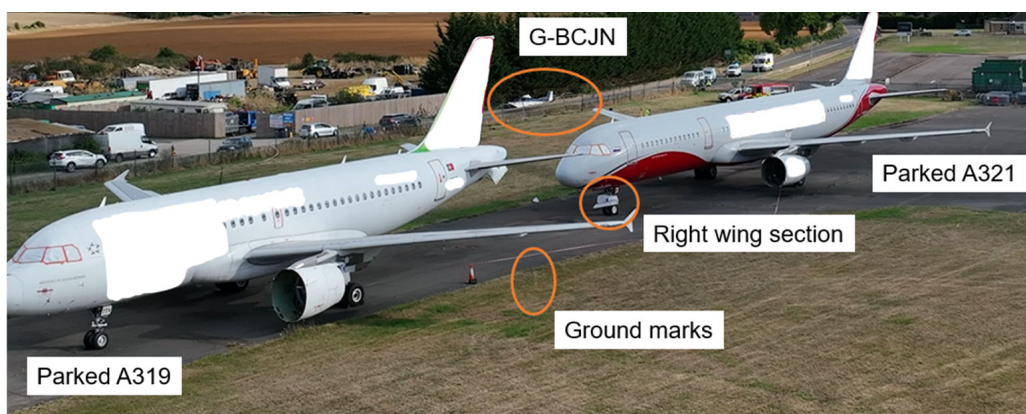
Figure 3
Accident site

The accident site was located at the south-east corner of the airfield where several airliners were parked on Taxiway C. The first ground marks were made by the G-BCJN’s left landing gear tyre as it touched the grass under the left wing of the A319 (Figure 3). There was a section of outboard right wing from G-BCJN attached to the nose landing gear of the A321 and several pieces of fairing scattered just beyond. There were ground marks from both G-BCJN’s main landing gear tyres across the grass until the airfield perimeter fence, which had four posts knocked over.

As the aircraft passed between the two airliners, its right wing struck the nose landing gear leg of one of them, the A321. The outer portion of G-BCJN's right wing was severed but the aircraft continued across the grass, running on its wheels. Neither pilot recalled closing the throttle and it is likely that the aircraft remained under power at this point. The aircraft's speed was nonetheless quite low, and it was further reduced by the collision with the airfield perimeter fence. As a result, the energy of the collision with the trees surrounding the vehicle yard was quite low and allowed the pilots to escape with only minor injuries. It was fortuitous that the aircraft encountered no traffic as it crossed the road.

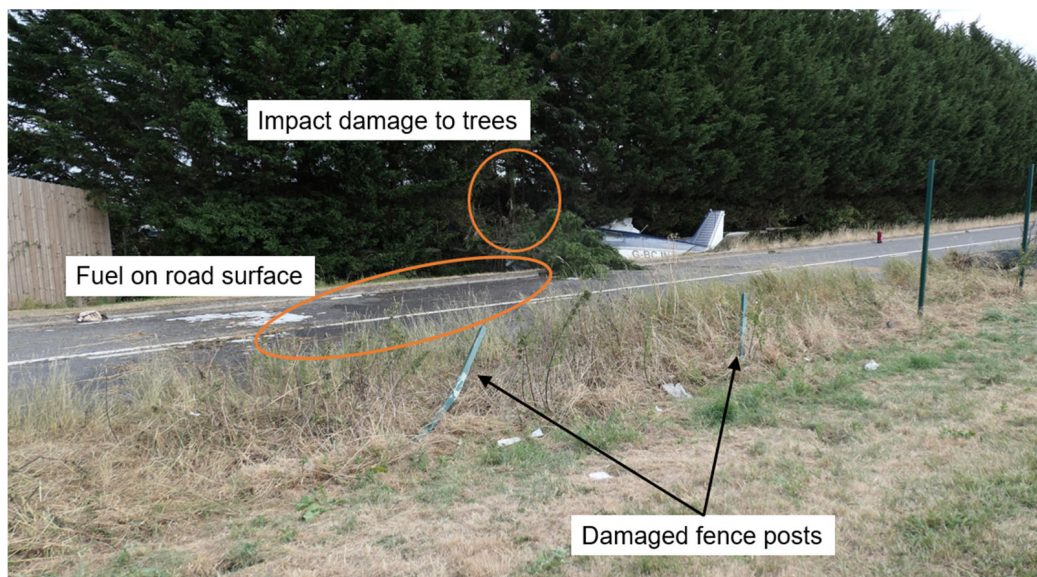
Figure 4
Accident site

The wire link fence was lying over towards the A429 road and there was evidence of fuel from the left fuel tank of G-BCJN across the road surface (Figure 4). G-BCJN had come to rest in a drainage ditch on the far side of the road with its right wing bent upwards and its left wing pointing forwards. There were marks on the tall fir trees from an impact with the nose of the aircraft.

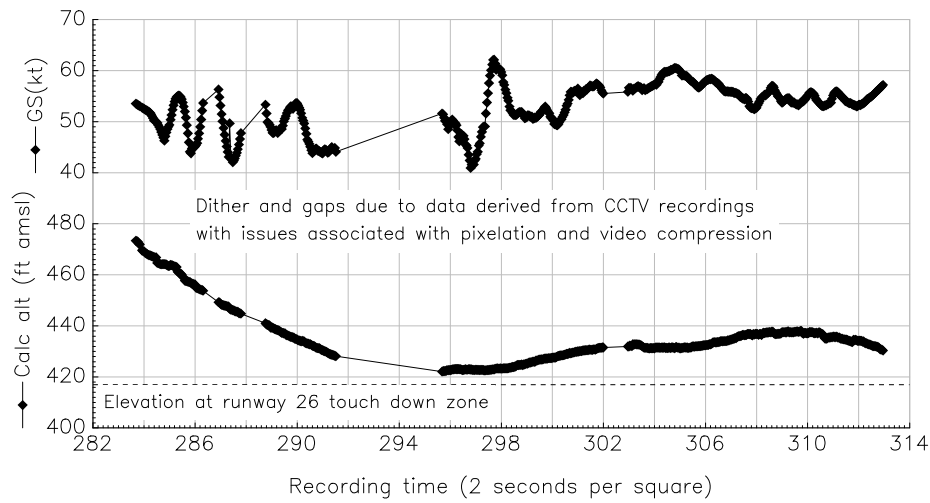
Figure 5

A number of airfield CCTV cameras captured various stages of the approach, landing and attempted go-around. This was the best available source of information to track the aircraft movements from just prior to touch down through to the final aircraft position. The aircraft was small and pixelated in the CCTV recordings and suffered from video compression processes; this meant it was not always possible to track the aircraft accurately. CCTV recordings of the aircraft from different locations on the airfield enabled photogrammetry techniques to be used to determine the flight path and ground speed of the aircraft (Figure 2), albeit with errors and breaks in the data due to the quality issues. The altitude and groundspeed associated with this period are shown in Figure 5.

Altitude and ground speed derived from CCTV recordings

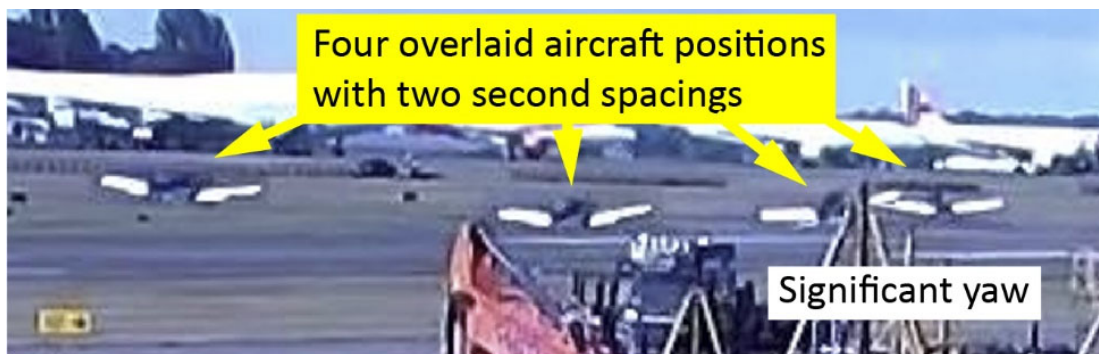
The recordings gave an impression of pitch attitude and heading but would not support calculation of orientation without significant errors. Figure 6 shows a significant change in heading over the space of 6 seconds. This period possibly included a brief touch down. After that, the pitch appears to have been held relatively high.

Four cropped CCTV images, two seconds apart, overlaid to show change in heading

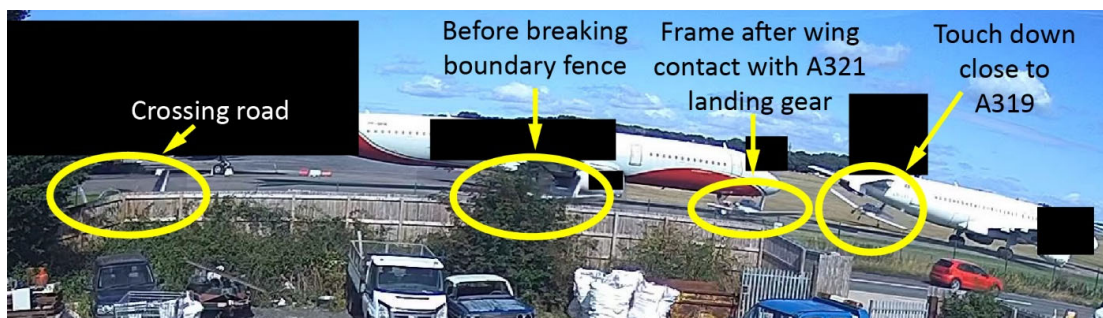
A CCTV recording was provided from a business situated across the A429 road from the airport. Figure 7 shows the aircraft touching down close to the parked A319 on Taxiway C, striking the nose landing gear of the A321 parked behind the A319, and crossing the road.

Four cropped CCTV images, one second apart, overlaid to show the final touch down, contact with a parked aircraft and the crossing of the A429 road

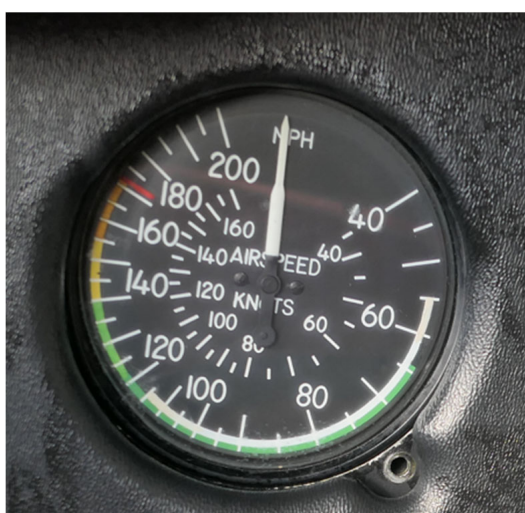
Figure 8
G-BCJN ASI

The student had flown the accident aircraft three times previously, but it is fitted with a different ASI to the other aircraft he had flown in his limited experience. The aircraft's ASI (Figure 8) has two concentric scales with mph on the outer scale and kt on the much smaller inner scale.

The student had difficulty with speed control in a previous sortie and had discussed this with the instructor, who had suggested that the student was focusing his attention on the outer scale and thus using speeds which were too low.

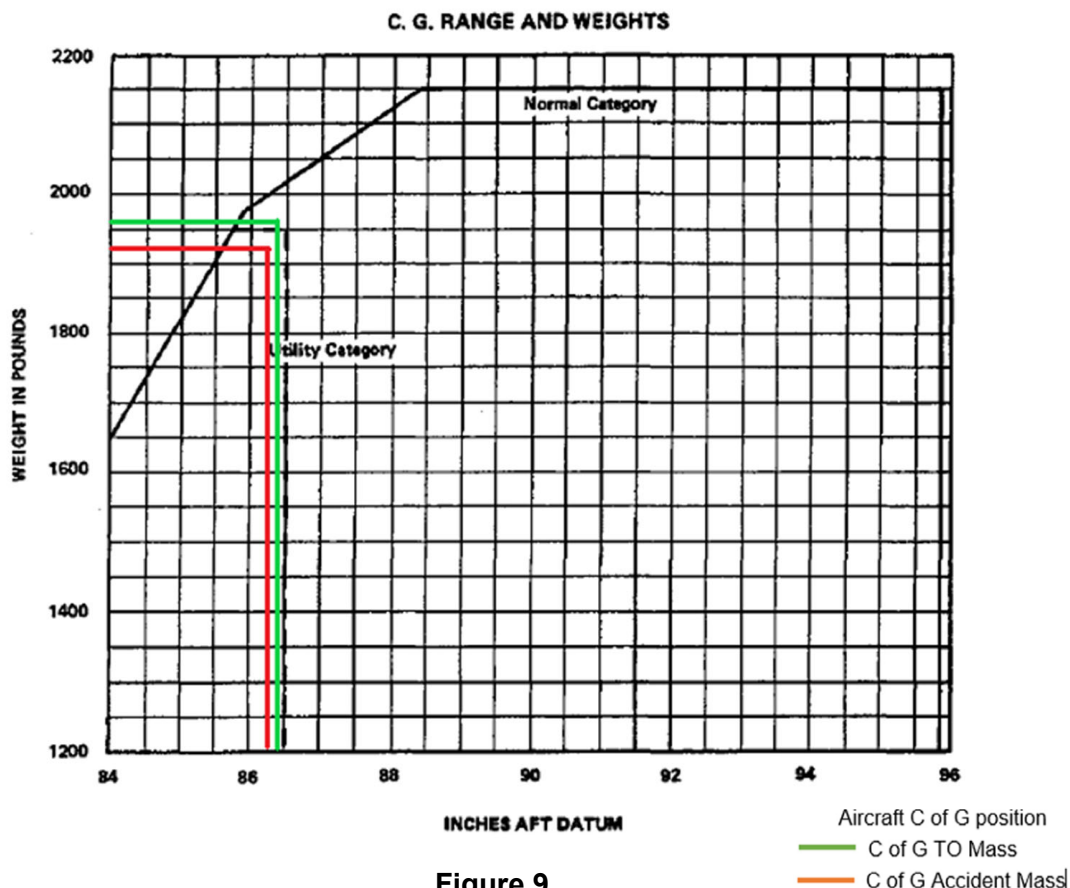
The aircraft departed Bristol with a fuel load of 50 US gallons. The weight and CG position were calculated for takeoff and for the time of the accident (Figure 9). The aircraft was within the CG envelope throughout the flight.

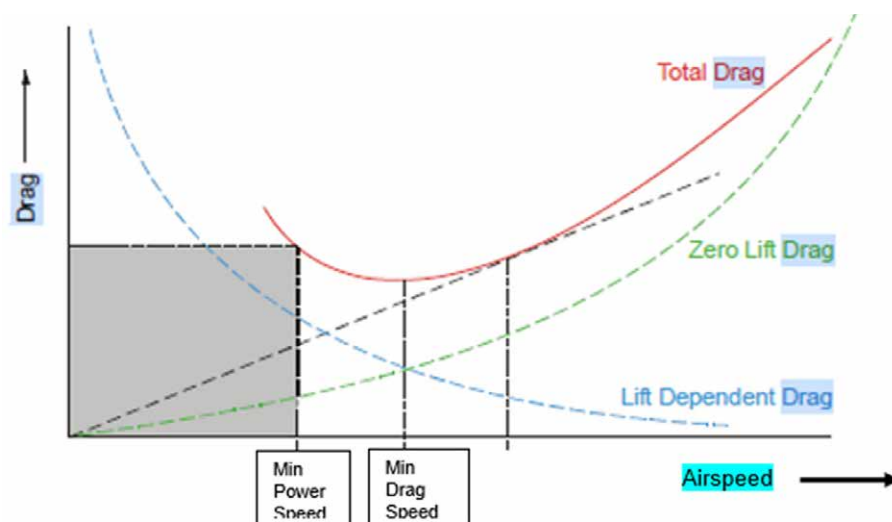
Figure 10
Typical Drag diagram

The aerodynamic drag on an aircraft is made up of components of zero lift drag and lift dependant drag. Both components vary with airspeed and a typical total drag diagram is shown in Figure 10. Minimum drag speed is the point at which the lowest total drag is achieved. It coincides with the speed for best lift/drag ratio.

If an aircraft slows below minimum drag speed, then the total drag on the aircraft is increasing. The shaded area is the minimum product of drag and airspeed at any point on the total drag curve, and it occurs at the minimum power speed. If the aircraft slows below this speed, then the power required to remain in level flight will increase. The minimum power speed for a PA-28 is not identified in the Pilots Operating Handbook. When the power required to remain in level flight equates to the maximum power available the aircraft will not be able to accelerate without descending to increase airspeed.

The aircraft touched the runway left wheel first causing it to yaw left. As the left wheel exited the runway onto the grass, the drag on the wheel caused the aircraft to yaw further left. It then became airborne at low speed and continued to fly across the grass at low speed and low height in a significantly nose-up attitude. With the flaps at 25° and at very low airspeed the aircraft was likely below the minimum power speed and therefore did not have sufficient performance to either accelerate or to climb.
