ACCIDENT

Aircraft Type and Registration:	Extra EA 300/L, G-ZXEL
No & Type of Engines:	1 Lycoming AEIO-540-L1B5 piston engine
Year of Manufacture:	2006 (Serial no: 1224)
Date & Time (UTC):	19 June 2022 at 1555 hrs
Location:	Near Duxford Airfield, Cambridgeshire
Type of Flight:	Private
Persons on Board:	Crew - 1 Passengers - None
Injuries:	Crew - None Passengers - N/A
Nature of Damage:	Damage to vertical tail, rudder and elevator
Commander's Licence:	Commercial Pilot's Licence
Commander's Age:	46 years
Commander's Flying Experience:	4,641 hours (of which 524 were on type) Last 90 days - 39 hours Last 28 days - 22 hours
Information Source:	Aircraft Accident Report Form submitted by the pilot and further enquiries by the AAIB

Synopsis

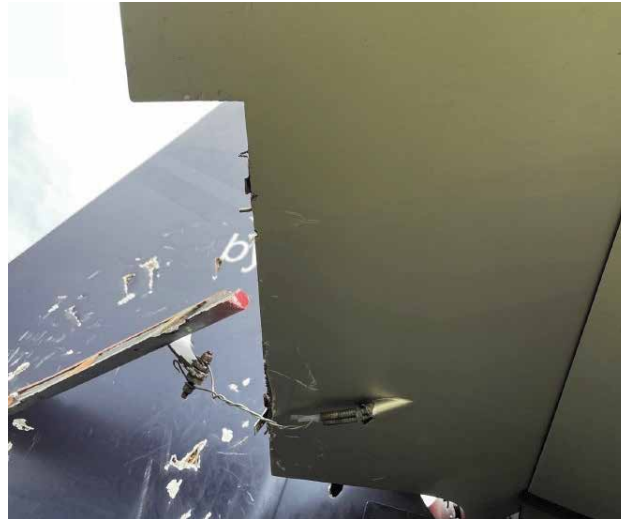
Figure 2

The elevator trim tab on G-ZXEL was found to have detached from the elevator at the hinge points, but it was still attached to the aircraft via the cables; this had allowed the tab to flap in the slipstream, repeatedly strike the side of the rudder, and pull the elevator up and down. The flapping stopped when the trim tab tip became lodged in the side of the rudder (Figures 2 and 3).

G-ZXEL lower side of right elevator showing trim tab detached at the hinge points but still connected via the control cables

The top half of the trim tab had detached in flight and was not recovered. The inboard hinge had de-bonded from the wooden tab structure, while the outboard hinge had snapped and was not recovered.

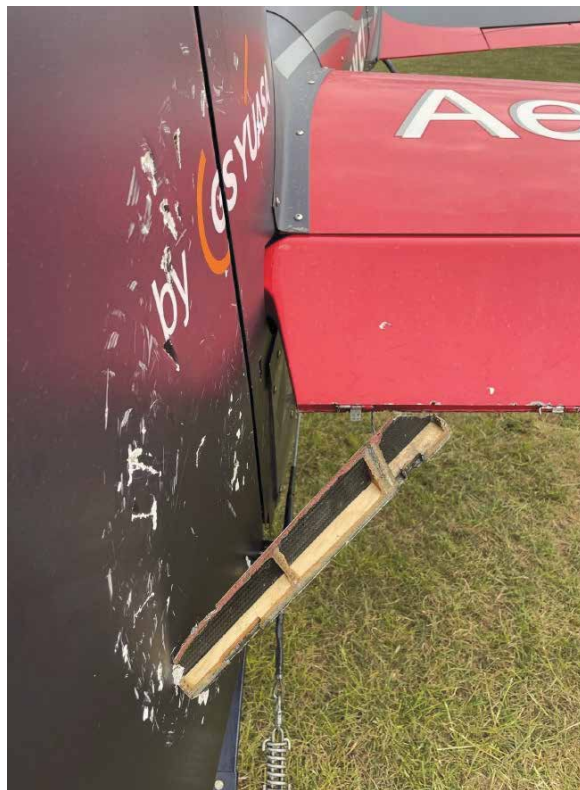
Figure 3

G-ZXEL damage to the rudder and vertical tail

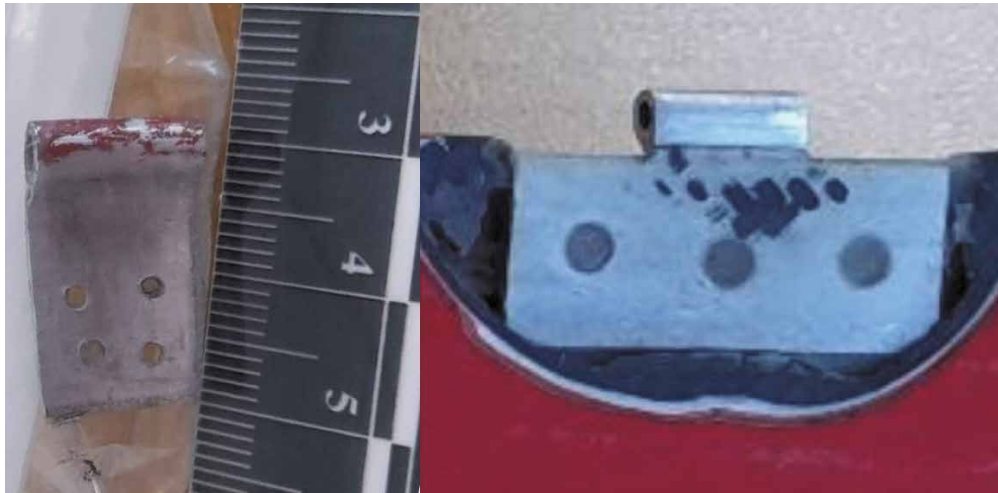
Figure 4

The trim tab and the inboard hinge were sent to the aircraft manufacturer for examination. They determined that the inboard hinge was the incorrect size, with only one third of the glue bonding area compared to the type of hinge that should have been fitted (Figure 4). The correct hinge has part number EA-33203.1. The fitted hinge could not be identified. The aircraft manufacturer stated that it was not a part used in any of their aircraft.

Left: inboard hinge found on G-ZXEL. Right: correct size and shape hinge

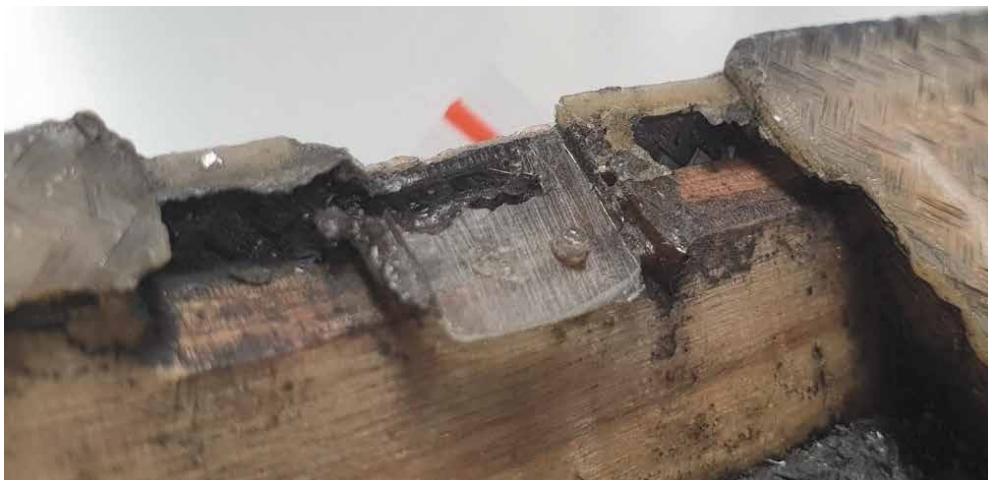
Figure 5

The inboard hinge bonding surface revealed the remains of the glue that had been bonded to the incorrect sized hinge, but it also revealed the presence of glue on either side which showed that the correct sized hinge had been previously fitted (Figure 5). There was also evidence of dirt or soot in the bonding surfaces.

G-ZXEL trim tab bonding surface of the inboard hinge

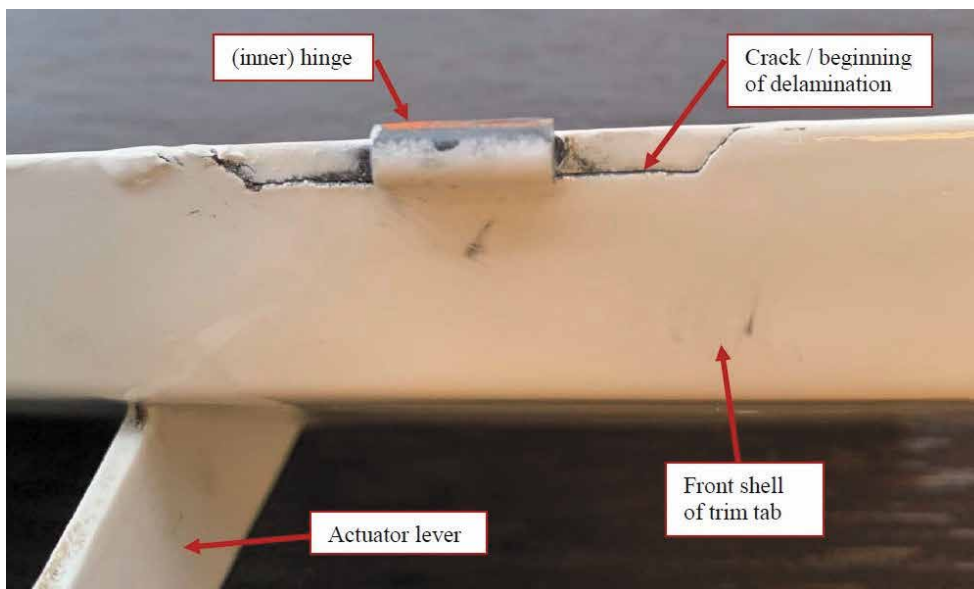
Figure 6

Cracked tab inner hinge from G-OFFO

All the failed and cracked trim tabs identified in this report were visually examined by the aircraft manufacturer in conjunction with an investigator from the German Federal Bureau of Aircraft Accident Investigation². The tabs from G-ZEXL and G-GEJS were also taken apart to assess the bonding areas. The bonding surfaces of these revealed the use of insufficient glue resulting in a reduced bonding area.

As a result of this accident, the aircraft manufacturer published Mandatory Service Bulletin SB-300-2-22³ on 10 August 2022 which explains the issues identified during this investigation and requires a detailed visual inspection of the elevator trim tab hinges within 25 hours, and a recurring detailed visual inspection as part of the normal 50-hour inspection programme.

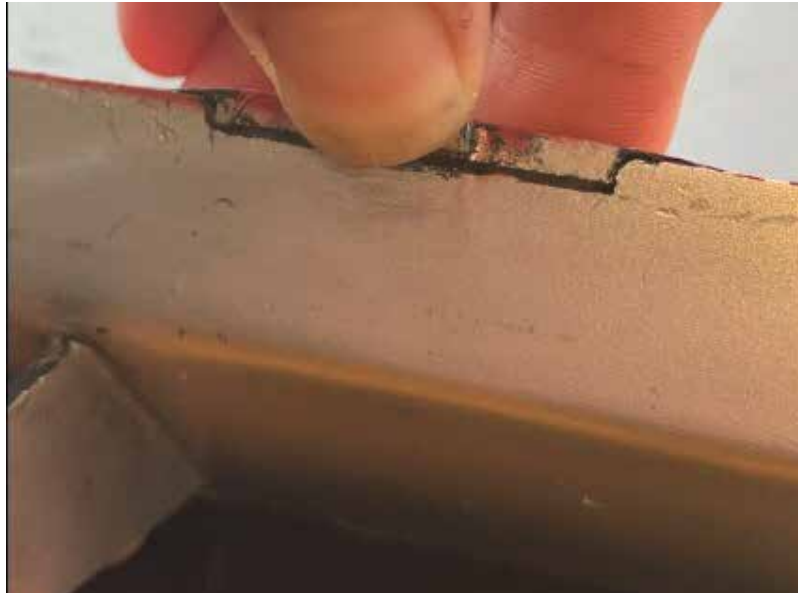
Figure 7

Cracked tab inner hinge from G-ZEXL
– shown with pressure applied to lift the hinge

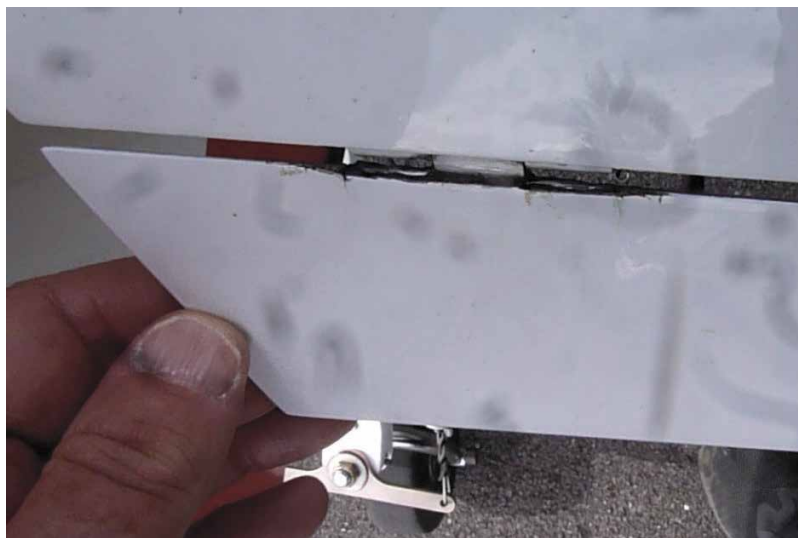
Figure 8

Cracked and loose tab inner hinge from G-GEJS
– shown with aft pressure applied to tab

In the case of G-GEJS both the lower and upper bonding surfaces had failed, but the tab was still able to take load due to three remaining glue joints which pass through the three holes in the hinge bonding surface.
