# ***AAIB Bulletin***

***4/2023***

Bombardier CL-600-2B16 (604 variant)	D-AAAY	10-Aug-22	3
--------------------------------------	--------	-----------	---

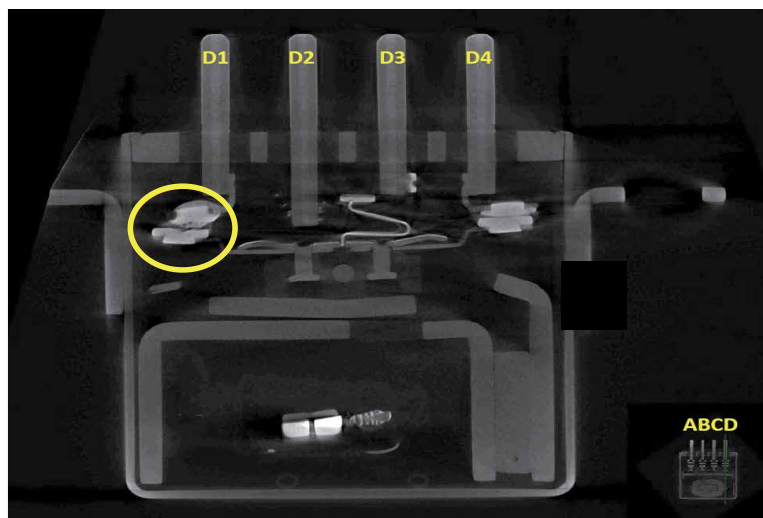
**Figure 3**

The scans identified anomalies with the D contacts of relays K1CE, K2CE and K3CE. The contacts in relay K4CE appeared normal. An example of an image from the K3CE scan is shown in Figure 3.

Relay K3CE showing D1 contact damage, circled in yellow

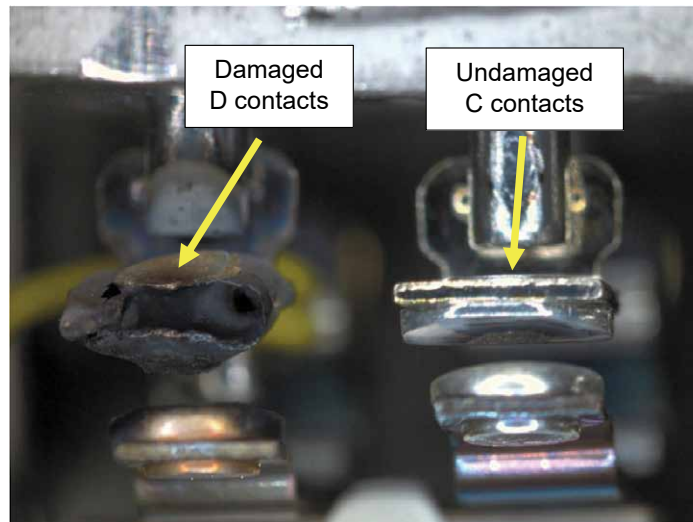
**Figure 6**

Prior to full disassembly, the contacts were examined using an optical microscope and significant damage was found on the D contacts on relays K1CE, K2CE and K3CE. The damage to the D1 contact on relay K3CE is shown in Figure 6.

K3CE relay showing contact damage

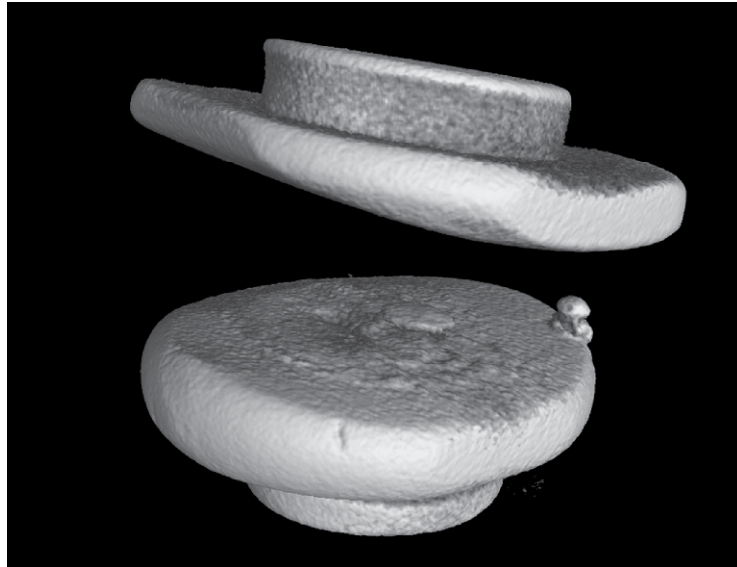
**Figure 7**

The K2CE relay, which had not failed, and was replaced in 2018, was CT scanned and the D1 and D2 contacts were found to show signs of erosion and material transfer (Figure 7). This relay had been in-service for approximately 2,700 flight hours and 1,371 flight cycles.

Aircraft 2, relay K2CE, contacts D1 and D2 showing surface degradation and material transfer

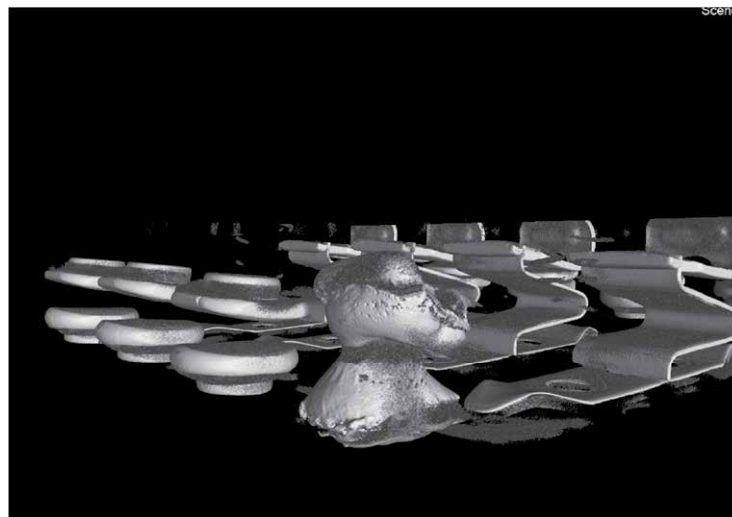
**Figure 8**

The K2CE relay from Aircraft 3 was found to have the D1 and D2 contacts welded together. When in the de-energised condition; the contacts should have been open. The D2 and D3 contacts were also closed; this would be their normal position with the relay de-energised (Figure 8). In this condition, if the uncommanded flap movement arrest system was activated, rather than the flap movement being arrested, the flaps would retract.

Aircraft 3, relay K2CE, showing welded D1 and D2 contacts

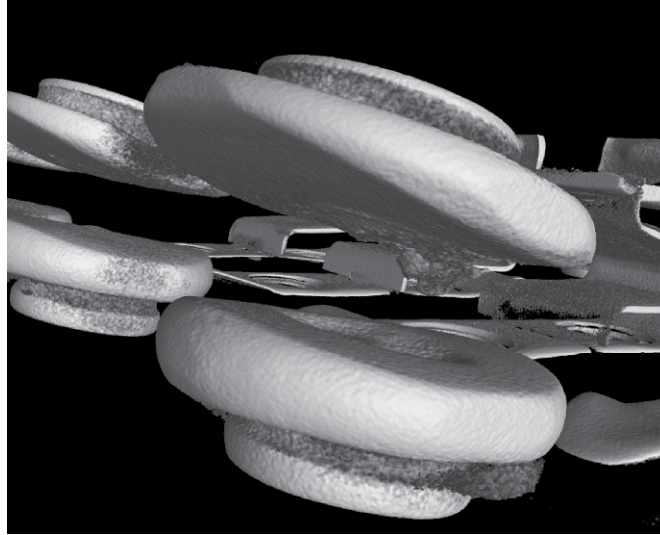
**Figure 9**

Aircraft 4, which had passed the SB flap movement timing test, also had degraded D1 and D2 contacts on relay K3CE. Figure 9 shows erosion and metal transfer between the contacts.

Aircraft 4, relay K3CE, showing erosion and metal transfer on contacts D1 and D2

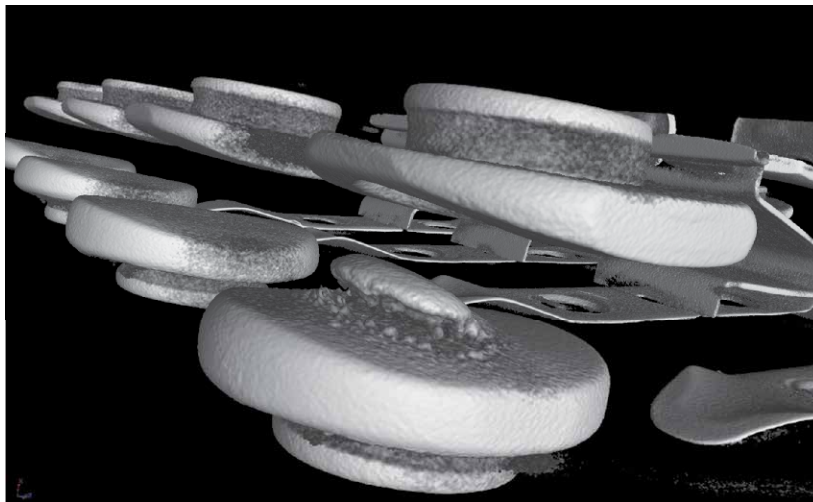
**Figure 10**

In most of the relays examined, metal erosion and metal transfer were visible on the D contacts to varying degrees. Figure 10 shows damage to the D1 and D2 contacts on relay K1CE from Aircraft 2, which did not exhibit any faults during the testing carried out as part of the SB.

Aircraft 2, relay K1CE, showing erosion and metal transfer on contacts D1 and D2

The failure of the relays on these three aircraft was caused by damage to the D contacts which switch electrical power to the BDUs. The damage was consistent with arcing between the contacts, which caused metal transfer and the welding of the contacts. As all the contacts in the relay are mounted on a common shaft, the welding of the D contacts would stop the other three sets of contacts from working properly. Examination of relays provided to the investigation, which had not failed in-service, also had damage to the D contacts showing that the damage had accumulated over a period of time.

It is recommended that Bombardier Aviation introduce a modification on the Challenger 600 series of aircraft to protect the D contacts within the extend and retract relays of the flap operating system from unsuppressed back-EMF electrical arcing.

It is recommended that Bombardier Aviation introduce a life policy for the flap operating system relays on the Challenger 600 series of aircraft, which takes account of the component's specified life and is sufficient to ensure that any in-service damage on the D contacts on the extend and retract relays remains acceptable for continued operation.

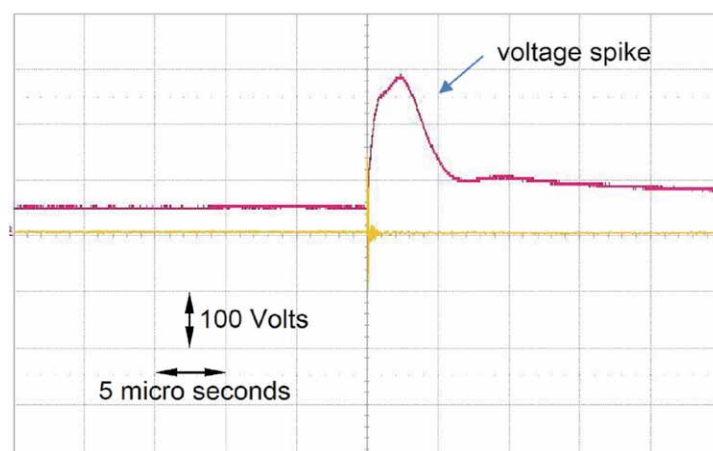
**Figure 12**

Laboratory testing of the BDU coil resistance indicated they were within specification. The current and voltage during solenoid switching was measured using an oscilloscope (Figure 12). When the solenoid was de-energised a transient voltage spike of up to approximately 300 V was seen, and this spike regularly exceeded 150 V during repeated switching. The voltage spike is likely to be the back electro motive force (EMF) which is a known feature of inductive loads and is caused by the current to the solenoid coil decaying and inducing the EMF after the electrical supply has been switched off. There was no protection or suppression provided within the flap operating system to prevent or reduce this back-EMF.

Oscilloscope output showing typical voltage spike after de-energising the BDU coil

During laboratory testing, when the BDU solenoids were de-energised, a transient voltage spike was seen to peak at up to 300 V and regularly exceeded 150 V. This spike is caused by a back-EMF, which could cause arcing across the D contacts. There is no protection within the electrical system to suppress this back-EMF.

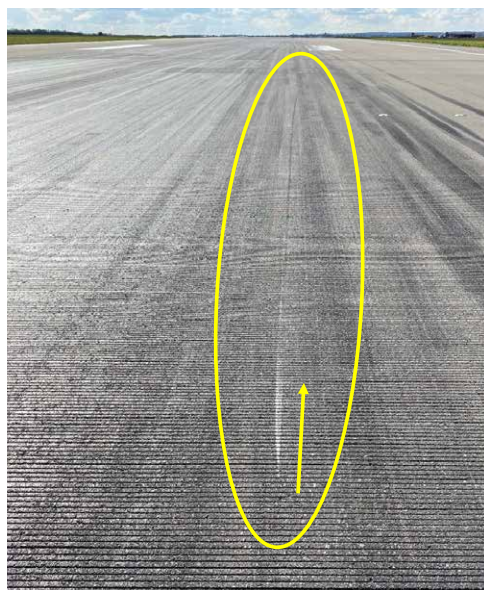
**Figure 1**

The aircraft had touched down on Runway 25 at Luton around the normal touchdown markers. There were marks visible from the right wing contacting the ground from around 390 m from the threshold of the runway for 18 m as shown in Figure 1.

Markings on Runway 25 with the arrow indicating the direction of landing

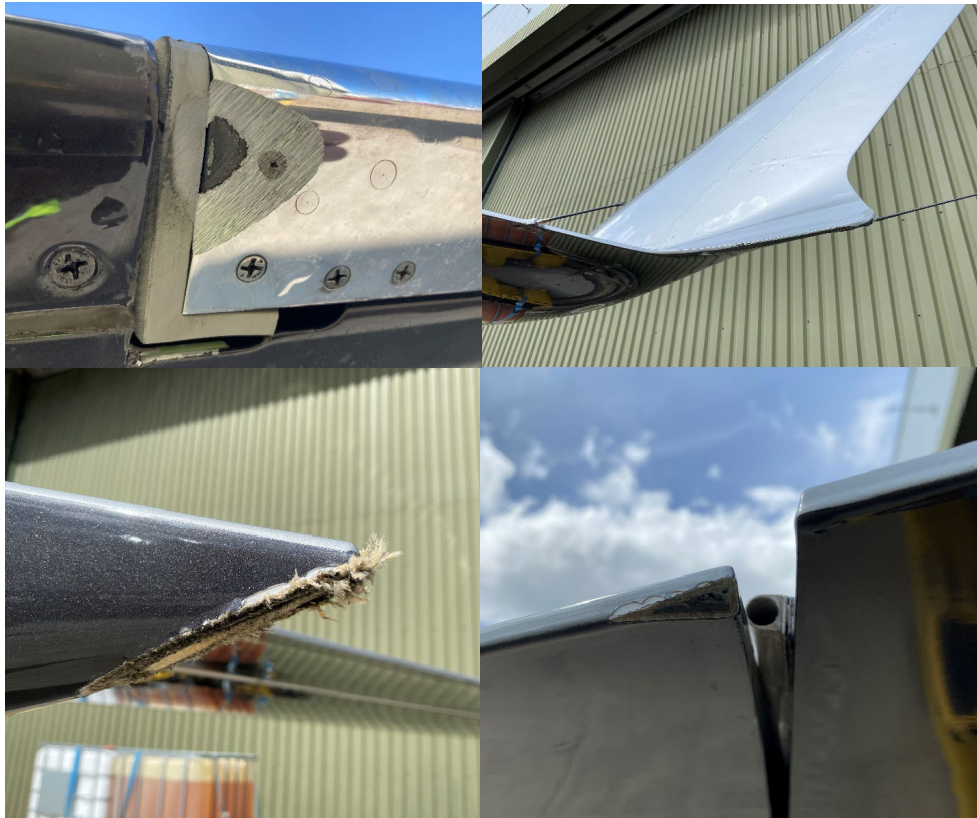
**Figure 2**

The winglet damage consisted of trailing edge and outboard skin damage. The flap fairing, which was composite construction, had been partly worn away. The outboard leading edge slat outer skin was damaged down to the second inner skin layer, and the aileron trailing edge lower outboard skin had been shaved off. Three of the static discharge wicks on the right aileron also required replacement. The damage is shown in Figure 2.

Damage to LX-NST Clockwise from top left – slat, winglet, aileron, flap fairing

Repairs were made to the flap fairing and winglet trailing edge.

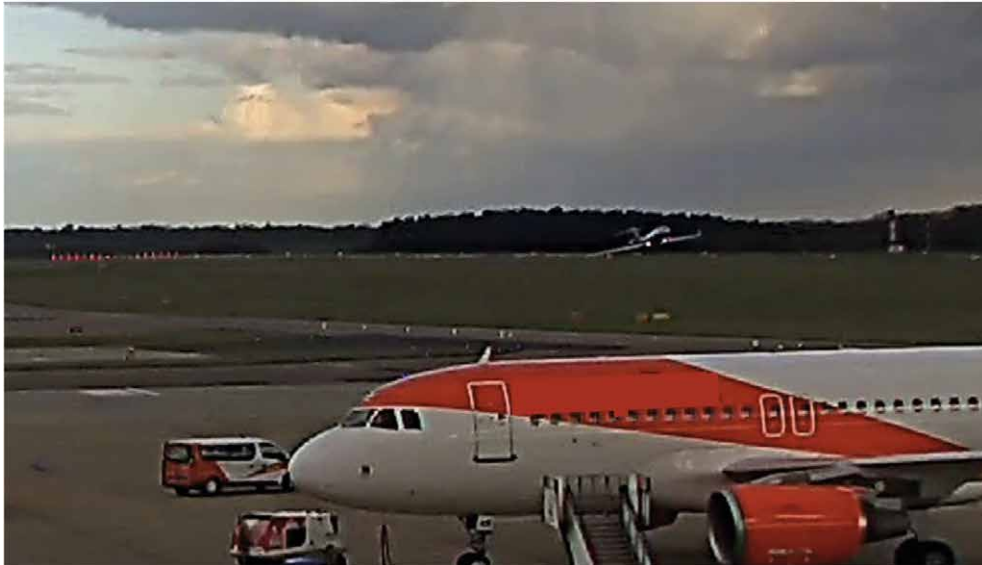
**Figure 3**

LX-NST's baulked landing was recorded on the airport's CCTV system. Figure 3 shows the moment the right wing contacted the ground.

Redacted CCTV image of LX-NST's wing contacting the ground

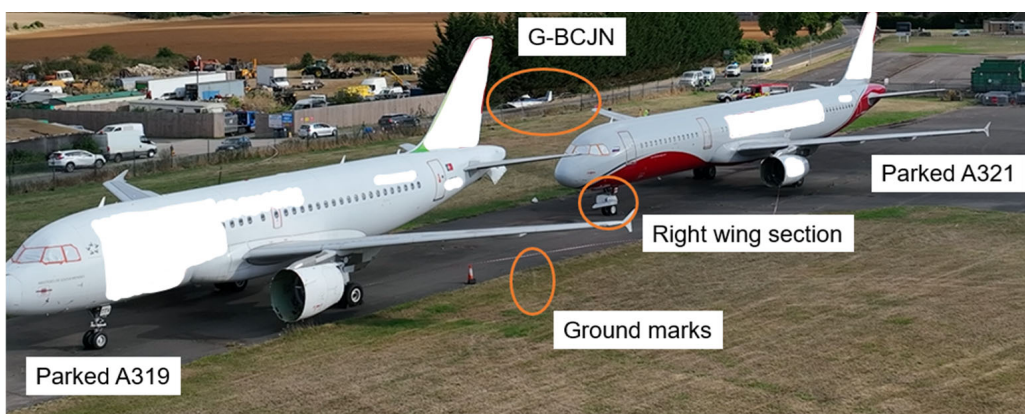
**Figure 3**  
Accident site

The accident site was located at the south-east corner of the airfield where several airliners were parked on Taxiway C. The first ground marks were made by the G-BCJN’s left landing gear tyre as it touched the grass under the left wing of the A319 (Figure 3). There was a section of outboard right wing from G-BCJN attached to the nose landing gear of the A321 and several pieces of fairing scattered just beyond. There were ground marks from both G-BCJN’s main landing gear tyres across the grass until the airfield perimeter fence, which had four posts knocked over.

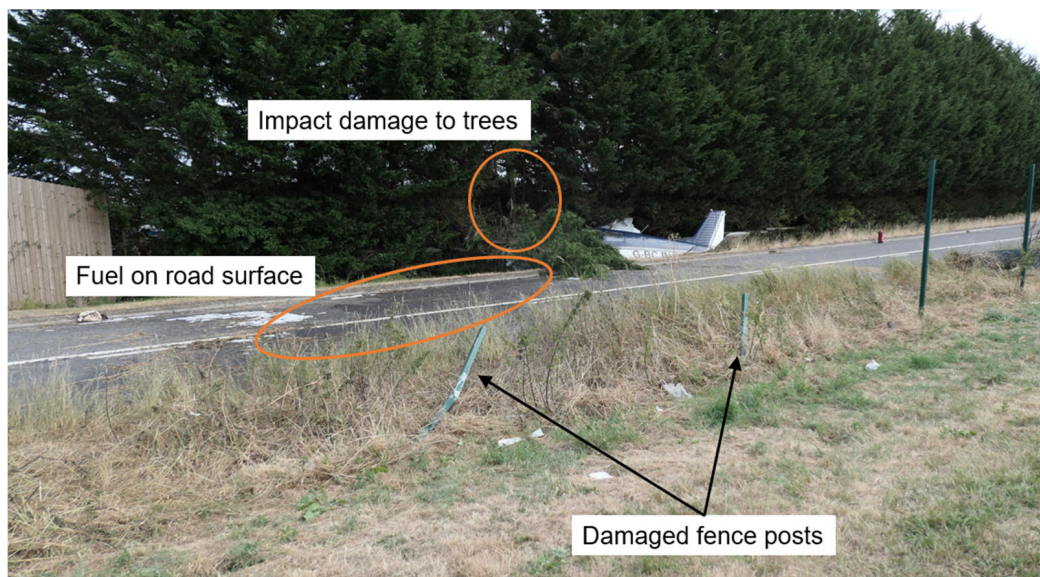
**Figure 4**

The wire link fence was lying over towards the A429 road and there was evidence of fuel from the left fuel tank of G-BCJN across the road surface (Figure 4). G-BCJN had come to rest in a drainage ditch on the far side of the road with its right wing bent upwards and its left wing pointing forwards. There were marks on the tall fir trees from an impact with the nose of the aircraft.

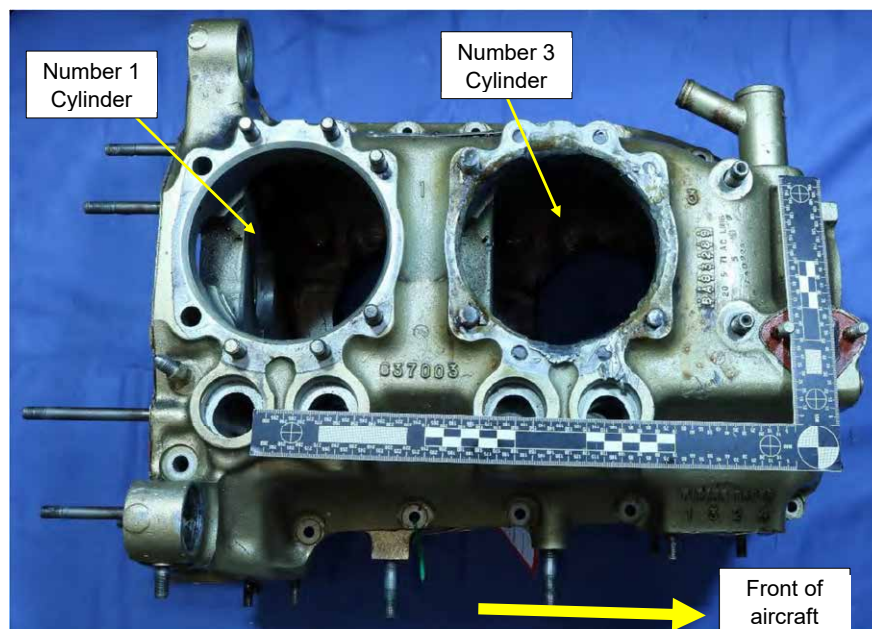
**Figure 2**

Closer inspection of the fractured ends of the studs revealed crack growth marks and fatigue failures. The engine crankcase was sent for metallurgical and fatigue analysis including comparison to the manufacturer's material specifications. A second engine crankcase, serial number 40R-116, which was unrelated to G-BDNR but with a similar failure mode to cylinder 3 was also sent for comparative analysis.

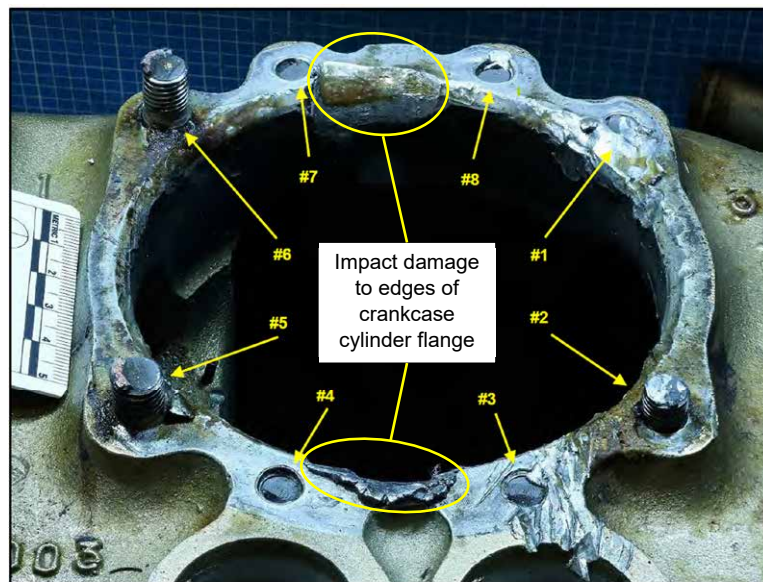
**Figure 3**

Studs #2, #5 and #6 had failed just above the cylinder mounting face. The remaining studs had failed just beneath the cylinder mounting face. Studs #5 and #6 were through studs to help bolt the two halves of the crankcase together.

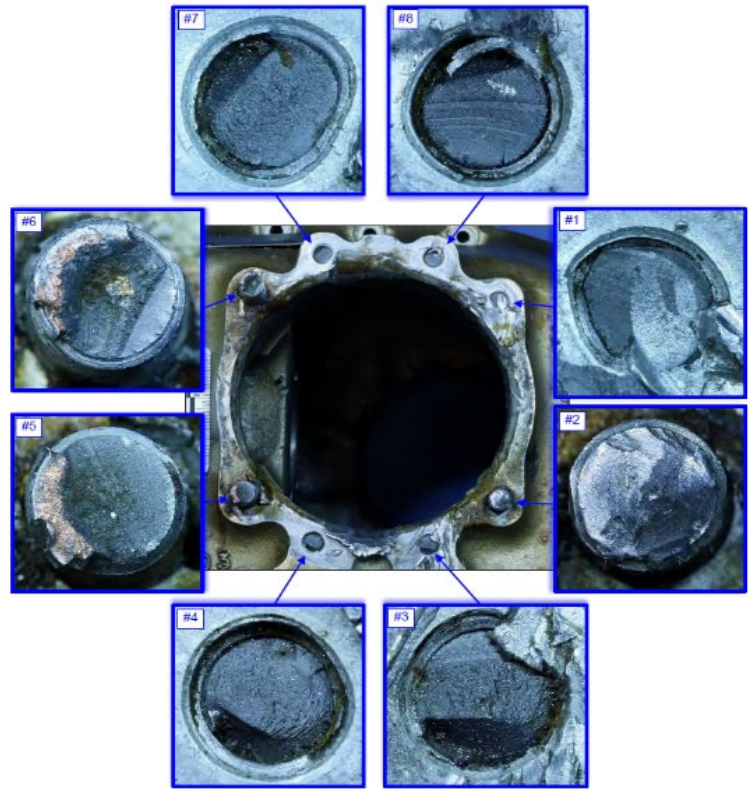
**Figure 4**

Evidence from the scanning electron microscope revealed that fatigue striations could just be resolved in places around the edges of the studs. Their fine spacing was consistent with a high frequency vibration load spectrum. There was no evidence of corrosion pitting or pre-existing material or mechanical defects associated with crack initiation.

A closer view of the in-situ stud fracture surfaces

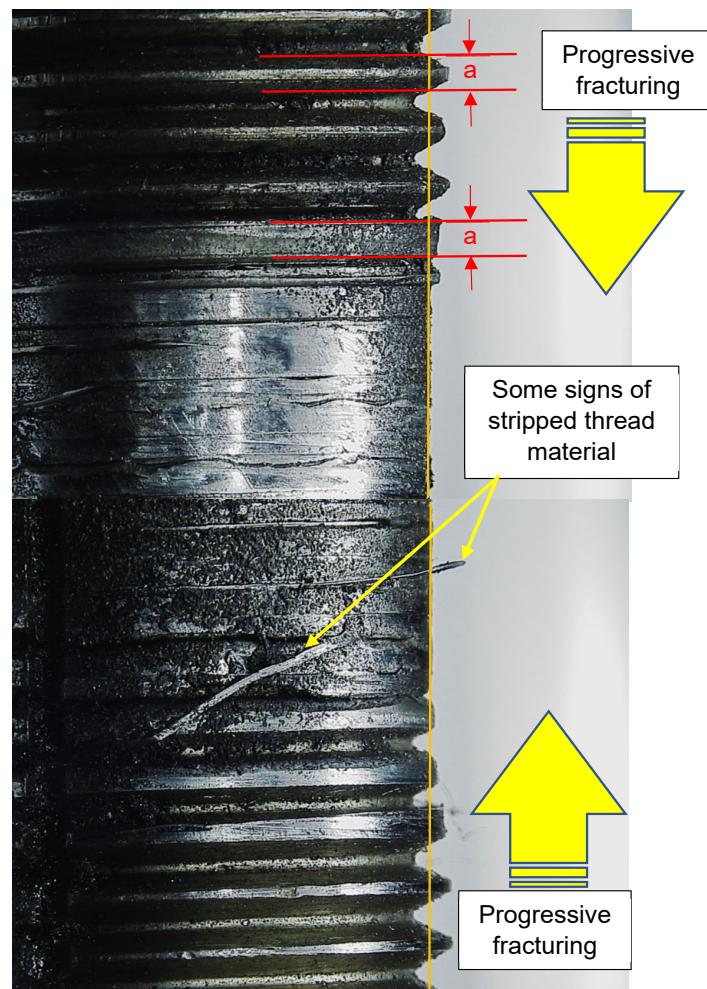
**Figure 6**

Closer examination of the threaded and damaged sections of the studs revealed that the threads had been stripped. The crests of the threads appeared to have been progressively fractured by the nut as it was torqued, and the fractured crests pushed into the thread roots. This created a flat region around the circumference of the stud causing the nut to lose torque. There was also some evidence of stripped spiral thread material which could be remains from the nut thread (Figure 6).

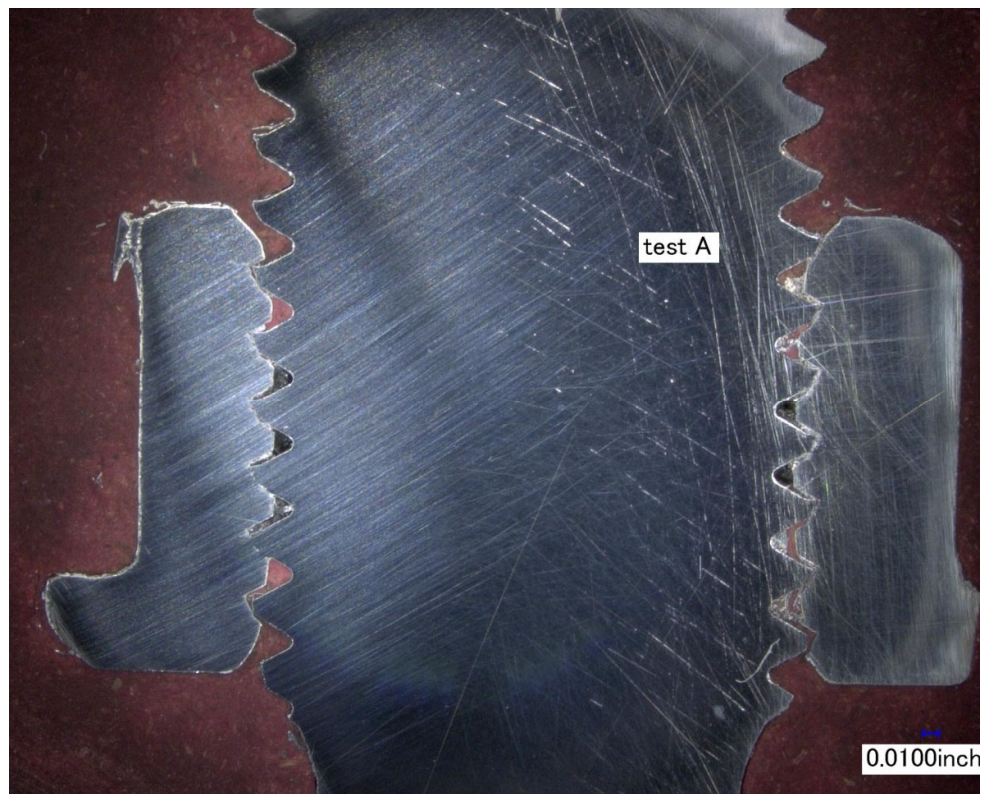
**Figure 11**

Figure 11 shows that the crowns of the nut threads do not appear to extend fully into the roots of the stud. As a result, only approximately half the flank of the nut threads is in contact with the flanks of the stud threads. With only half the flanks in contact, the shear load is effectively increased which may have contributed significantly to the thread stripping. In addition, it is possible that with nut threads that fully engage with the stud thread flanks, the stud is more likely to fail in tension at high torque values than to strip the threads, as observed when the AM nuts were used.

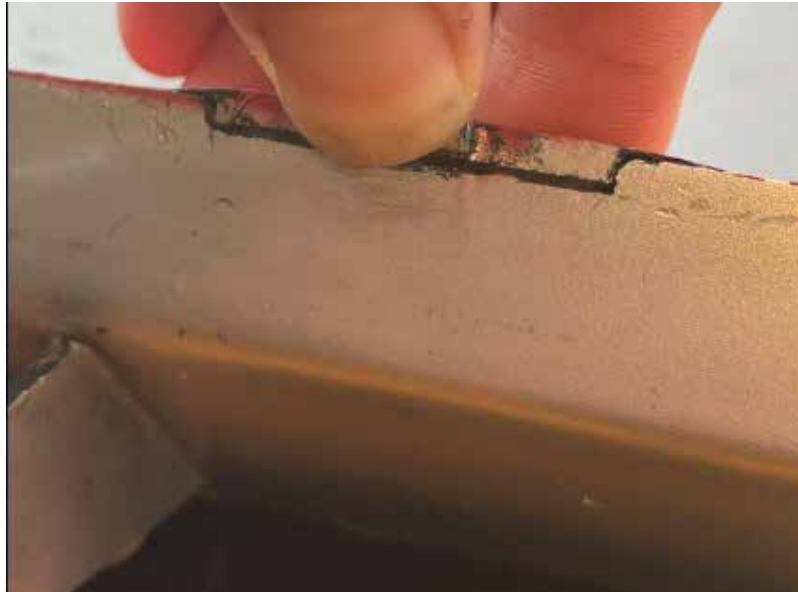
**Figure 7**

Cracked tab inner hinge from G-ZEXL  
– shown with pressure applied to lift the hinge
