7. The safe management of weather-related events which affect train operation

Purpose of this summary

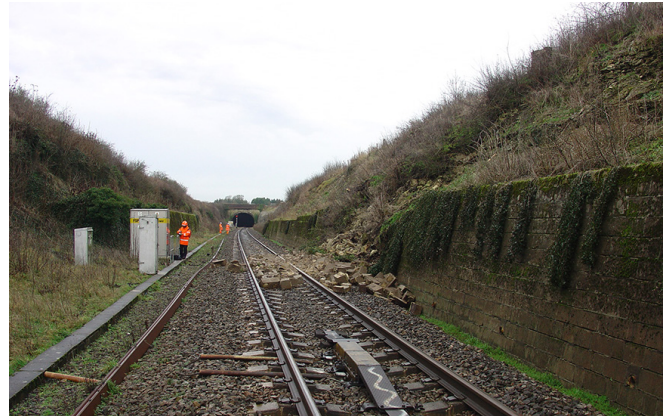
Following RAIB investigations of derailments at Oubeck ([report 19/2006](#)) and Moy ([report 22/2006](#)) in November 2005, and at Kemble in January 2007 ([report 07/2008](#)), which seemed to have some features in common, RAIB carried out a class investigation during 2008 into Network Rail's management of earthworks ([report 25/2008](#)). This found that, while Network Rail's approach to earthworks management was comparable to or better than other industries with similar earthworks, the practical understanding of climate change and its effect on railway infrastructure was limited, and there was inconsistency in the application of earthworks management systems across Network Rail. We recommended that Network Rail should take various actions to improve its knowledge of its assets and its performance in managing them. Since then, subsequent investigations have found that Network Rail has put a lot of effort into improving its performance in this area, but the stress put on the infrastructure from weather events has also increased. RAIB has also investigated incidents in which structural failure has occurred as a result of deterioration over time, rather than extreme weather events. These are not discussed further in this document, but they reinforce the need for an effective system for managing the condition of structures.

Collapsed wall following landslip at Kemble.

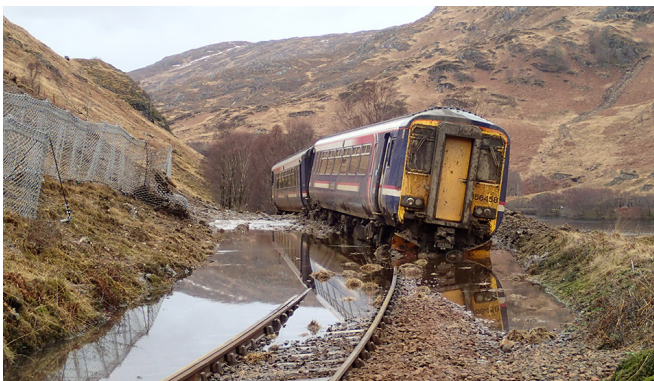
Accidents related to earthworks may involve landslips or washouts. In both cases a risk of derailment is created, as trains may run into debris, as at Gillingham tunnel in 2009 ([report 19/2010](#)), Watford tunnel in 2016 ([report 11/2017](#)) and Corby in 2019 ([report 04/2020](#)), or onto inadequately supported track, as at Knockmore in 2012 ([report 14/2013](#)) and at Baildon in 2016 ([report 03/2017](#)). Structural failures are often related to the effects of heavy rain, either by itself, as at Dryclough Junction in 2011 ([report 17/2011](#)) and Loch Eilt in 2018 ([report 10/2018](#)) or as the cause of floods as at Lamington in 2015 ([report 22/2016](#)) when larger than normal water flows create additional scour risk around the supports of bridges. Responding to these pressures may require the railway to work with owners of adjacent land to ensure that drains are adequate to deal with the flows of water, and to recognise when changes in land use will result in additional water flow onto the railway. The data and analysis needed to prompt such work is not always available.

Derailed train following landslip at Loch Eilt.

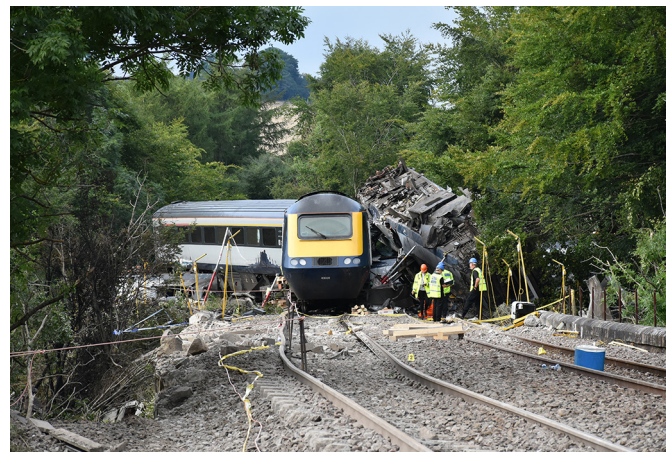
At around 09:37 hrs on Wednesday 12 August 2020, a passenger train derailed near Carmont, Aberdeenshire ([report 02/2022](#)). The train, reporting number 1T08, was the 06:38 hrs service from Aberdeen to Glasgow, which was returning towards Aberdeen due to a blockage that had been reported on the line ahead. It was travelling at 73 mph (117 km/h), just under the normal speed for the line concerned. After derailing, the train deviated to the left, before striking a bridge parapet which caused the vehicles to scatter.

Train following derailment at Carmont.

Tragically, three people died as a result of the accident and the remaining six people on the train were injured. The Carmont derailment resulted from gravel being washed out from a drainage trench, onto the track below, during intense rainfall. RAIB's investigation found that route controllers did not have the information, procedures or training that they needed to effectively manage a widespread and potentially dangerous weather event of this type. Consequently, no instruction was given to train 1T08 to reduce its speed on its return journey north. RAIB also found that, before this derailment, Network Rail's approach to the management of risk to its infrastructure from extreme rainfall was primarily focused on those assets known to be at risk. There were no standard procedures in place to address the more general risk to assets during the most severe type of storms.

RAIB has recommended improved operational responses to extreme rainfall events, exploiting the full capability of modern technology, and based on a detailed understanding of the risk associated with extreme rainfall. It has also recommended improved training for operational decision-makers so as to enhance their capability to respond to this type of event.

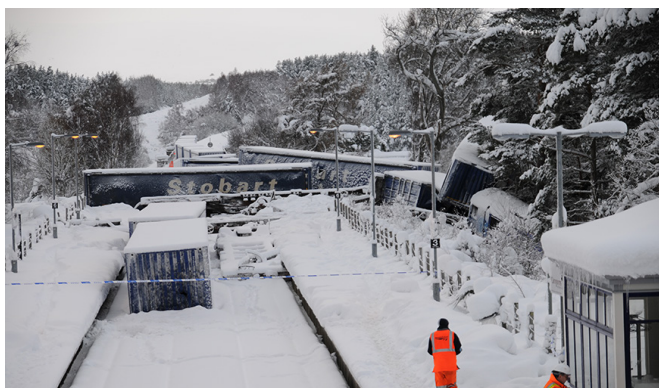
Wagons following derailment at Carrbridge.

Winter weather can bring particular hazards to the railway. While ice and snow are recognised as disruptive, it is possible for them to create significant safety risks. RAIB's investigations into an incident at Carstairs ([report 02/2011](#)) and an accident at Carrbridge ([report 03/2011](#)), which both occurred in Scotland during the winter of 2009-10, found that a build-up of snow on rail vehicles, occurring during a journey, could lead to impaired braking performance affecting the trains' ability to stop safely. As

well as changes to the operating rules to improve the effectiveness of brake tests carried out by train drivers, there was also a need for the extreme weather actions described above to include measures to deal with risks from wintry weather. Failure to implement a strategy for risk mitigation in wintry weather was also a factor in the accident in Summit tunnel, West Yorkshire, in 2010 ([report 16/2011](#)), when a train derailed after hitting a pile of ice which had fallen onto the track. When train operations are disrupted by adverse weather conditions, the situation needs to be properly managed. We have commented on this in [Summary of Learning number 4](#) covering the management of abnormal train operating events.

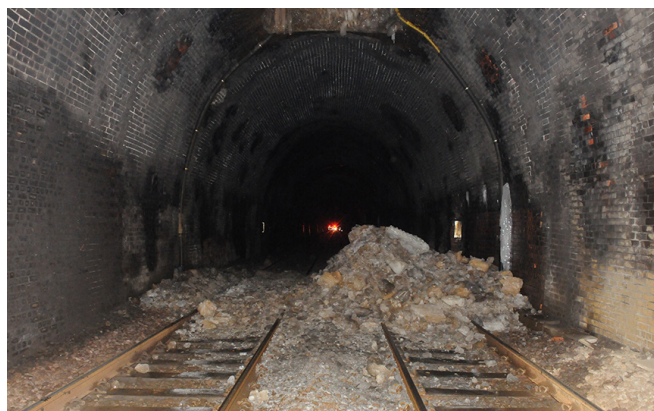
Ice found below a ventilation shaft after the derailment at Summit tunnel (courtesy of British Transport Police).

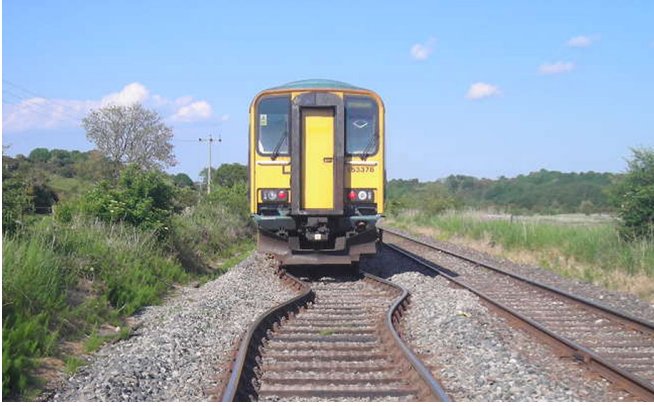
As the temperature rises and falls, rails expand and contract. Railway track is designed and constructed to cater for this, but in hot weather instability in the track support, and/or a restriction on the ability of rails to move longitudinally, can create conditions in which the track moves laterally (known as buckling), possibly immediately before or during the passage of a train. RAIB has investigated derailments caused by buckling, at Cummersdale, Cumbria in 2009 ([report 06/2010](#)) and at Langworth, Lincolnshire in 2015 ([report 11/2016](#)). These investigations highlighted the importance of good maintenance practice, and the need for clarity in the Rules relating to trains passing over sections of track where defects have been reported.

Severe track buckle at Cummersdale.
