7. The safe management of weather-related events which affect train operation

Purpose of this summary

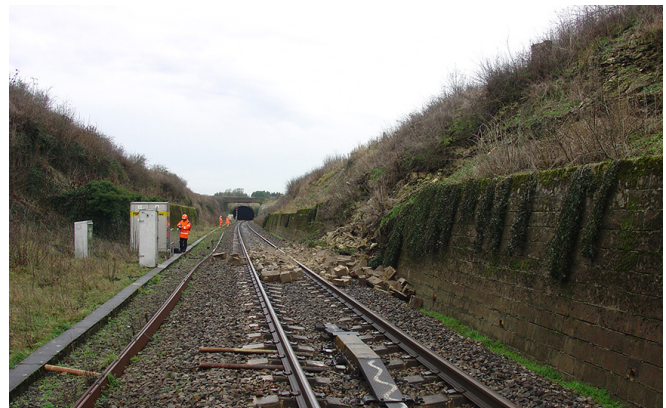
Collapsed wall following landslip at Kemble.

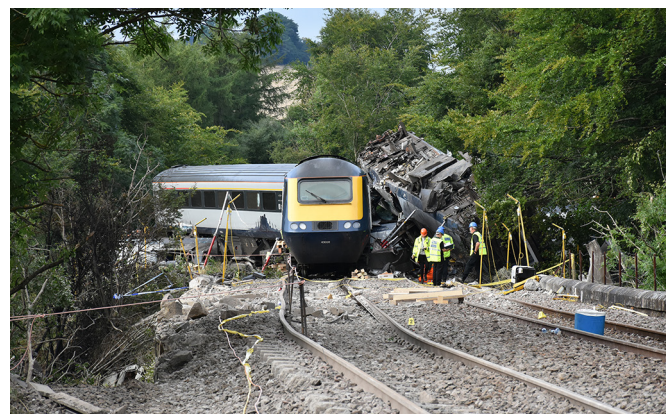
Train following derailment at Carmont.

The Carmont derailment resulted from gravel being washed out from a drainage trench, onto the track below, during intense rainfall. RAIB's investigation found that route controllers did not have the information, procedures or training that they needed to effectively manage a widespread and potentially dangerous weather event of this type. Consequently, no instruction was given to train 1T08 to reduce its speed on its return journey north. RAIB also found that, before this derailment, Network Rail's approach to the management of risk to its infrastructure from extreme rainfall was primarily focused on those assets known to be at risk. There were no standard procedures in place to address the more general risk to assets during the most severe type of storms.

Modern weather forecasting and monitoring systems can spot truly exceptional events before they occur and as they happen, so allowing railway operators to implement precautionary measures when it is prudent to do so. This would benefit the safety of the line (by restricting train speeds, or suspending operations, when necessary) while reducing the need for imposing blanket speed restrictions over areas that are not at significant risk. RAIB has recommended improved operational responses to extreme rainfall events, exploiting the full capability of modern technology, and based on a detailed understanding of the risk associated with extreme rainfall. It has also recommended improved training for operational decision-makers so as to enhance their capability to respond to this type of event.

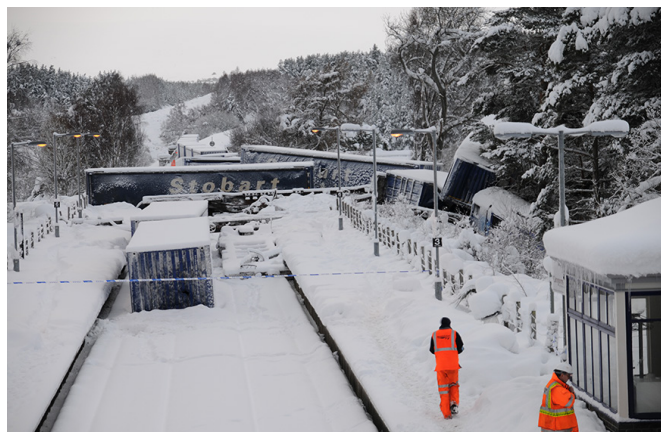
Wagons following derailment at Carrbridge.

an incident at Carstairs ([report 02/2011](#)) and an accident at Carrbridge ([report 03/2011](#)), which both occurred in Scotland during the winter of 2009-10, found that a build-up of snow on rail vehicles, occurring during a journey, could lead to impaired braking performance affecting the trains' ability to stop safely. As well as changes to the operating rules to improve the effectiveness of brake tests carried out by train drivers, there was also a need for the extreme weather actions described above to include measures to deal with risks from wintry weather.

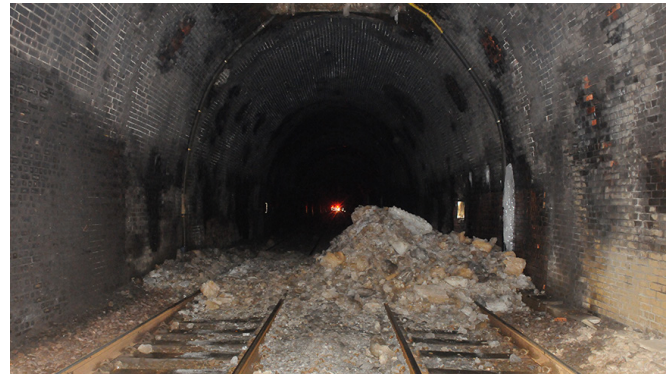
Failure to implement a strategy for risk mitigation in wintry weather was also a factor in the accident in Summit tunnel, West Yorkshire, in 2010 ([report 16/2011](#)), when a train derailed after hitting a pile of ice which had fallen onto the track. When train operations are disrupted by adverse weather conditions, the situation needs to be properly managed. We have commented on this in [Summary of Learning number 4](#) covering the management of abnormal train operating events.

Ice found below a ventilation shaft after the derailment at Summit tunnel (courtesy of British Transport Police).

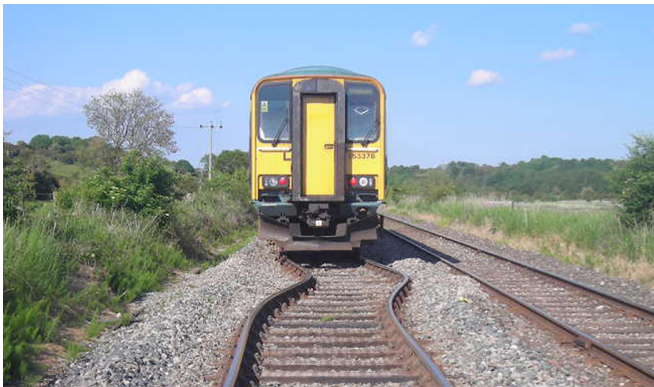
Severe track buckle at Cummersdale.

As the temperature rises and falls, rails expand and contract. Railway track is designed and constructed to cater for this, but in hot weather instability in the track support, and/or a restriction on the ability of rails to move longitudinally, can create conditions in which the track moves laterally (known as buckling), possibly immediately before or during the passage of a train. RAIB has investigated derailments caused by buckling, at Cummersdale, Cumbria in 2009 ([report 06/2010](#)) and at Langworth, Lincolnshire in

2015 ([report 11/2016](#)). These investigations highlighted the importance of good maintenance practice, and the need for clarity in the Rules relating to trains passing over sections of track where defects have been reported.
