## 8. The integrity of train braking systems

### Purpose of this summary

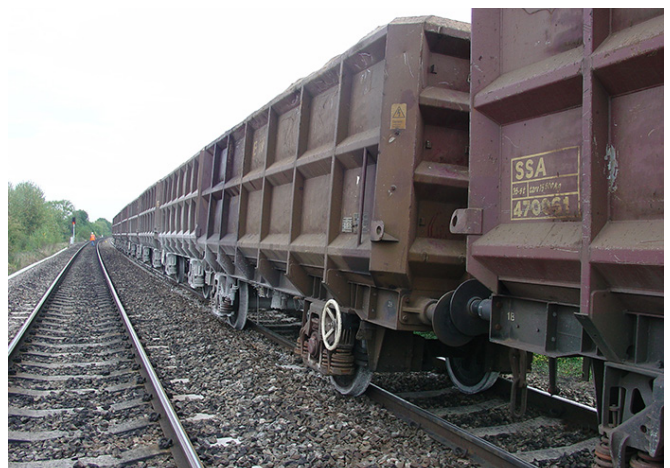
The very first accident to be investigated by RAIB, a derailment at Hatherley, Gloucestershire, in 2005 ([report 08/2006](#)), happened because a handbrake was left applied on a wagon in a freight train after it had entered service. Since then, we have investigated many accidents and incidents connected with brakes and identified a number of areas of concern.

Wagons following derailment at Hatherley.

Handbrakes must be released before a train departs, and the rotation of all the wheels should be the subject of a visual 'roll-by' examination as the train moves off. Failure to release a handbrake, and an inadequate roll-by check resulted in the derailment at Hatherley in 2006 ([report 08/2006](#)). It is also likely that a handbrake being left applied, and/or incorrectly adjusted, was the cause of the derailment of a railhead treatment train at Dunkeld & Birnam station in 2018 ([safety digest 01/2019](#)).

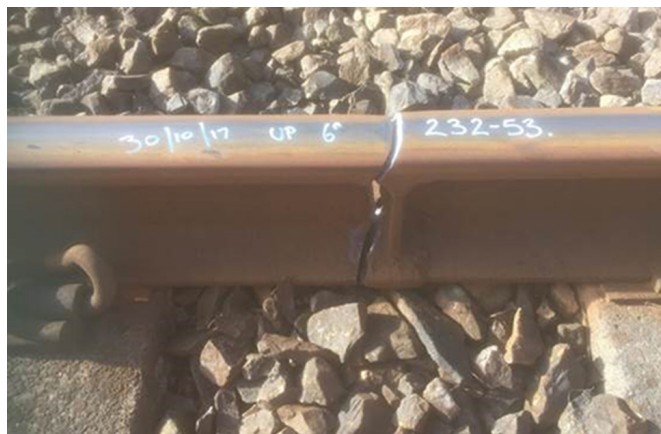
Example of track damage between Ferryside and Llangennech.

Extensive track damage was caused between Ferryside and Llangennech in 2017 ([report 17/2018](#)) when the wheelset on one of the wagons in a freight train ceased to rotate, leading to flats being created on the wheel tread. It was impacts from these wheel flats that damaged the track. A probable cause of the wheel ceasing to rotate was that the maintenance of the braking system on the wagons was being carried out in conditions

which were not conducive to a consistently high standard of work. RAIB's report recommended that the wagon owner and ECM should carry out a risk assessment of the facilities and process used for maintenance of the tank wagons concerned.

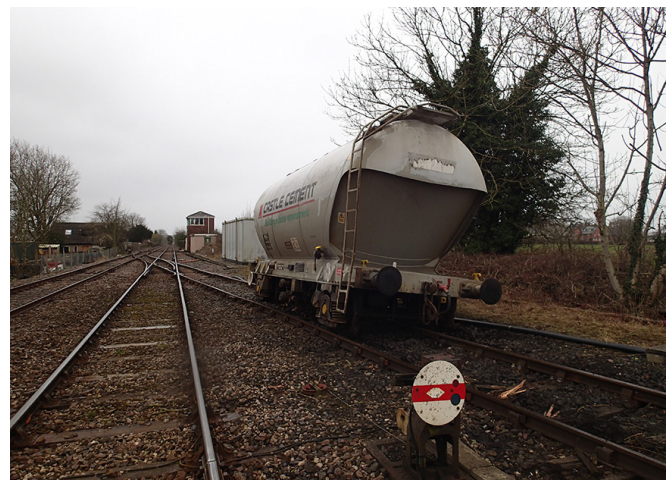
At Clitheroe in 2020 ([report 16/2020](#)), a wagon ran away from a cement works and derailed on trap points when it reached the main line. The runaway occurred in part because the wagon's handbrake was providing insufficient brake force, most likely because the slack adjuster was not working correctly. The investigation found that a scheduled maintenance examination, which would probably have identified this defect, had not been carried out when it was due.

Derailed wagon following runaway at Clitheroe.

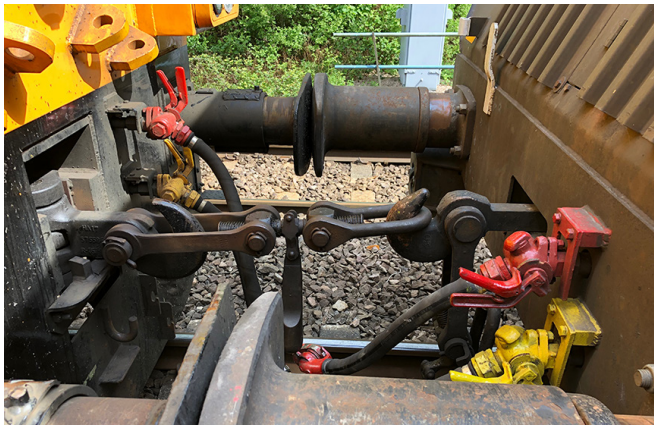
The need for brake continuity tests to be the final duty undertaken before departure was further demonstrated in the incident at Crofton West Junction in 2020 ([safety digest 06/2020](#)). In this incident, a freight train was prepared for departure, including a brake continuity test, during the evening before departure. However, after train preparation was completed, but before departure, a group of trainees and an instructor visited the sidings and used the train to practise train preparation procedures. This led to the brake pipe valves between the locomotive and the wagons being closed, rendering the air brakes on the wagons non-operational. This

Positions of brake pipe valves on locomotive involved in the SPADs at Crofton.

was not detected before the train moved off the next morning and a running brake test was not carried out in accordance with the railway Rule Book once the journey was underway. The closure of these valves and the absence of a test which could have identified that inadequate brake force was available meant that the driver was unable to stop the train when it encountered restrictive signal aspects. The train subsequently passed two signals at danger and crossed a junction which was being protected by one of the signals.
