2. Protection of track workers from moving trains

Purpose of this summary

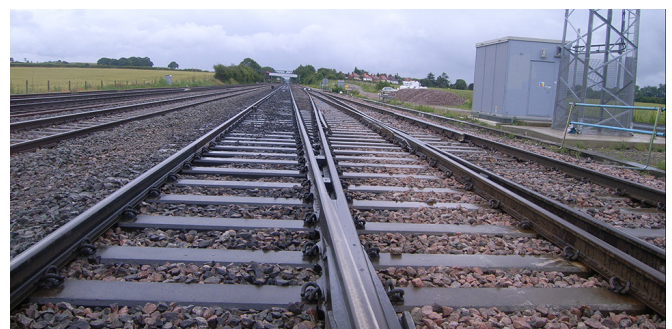
The site of the fatal accident at Ruscombe Junction.

At Ruscombe in 2007 three people were involved in welding repairs to a crossing: a welder, a lookout, and a Controller of Site Safety (COSS). The COSS and the lookout deferred to the seniority and experience of the welder, who was very reluctant to interrupt his work to move clear of the line when trains passed on adjacent lines. As a result, the welder was taken unawares when a train was routed from an adjacent line through a crossover towards the place where he was working, and he was struck and killed. The issues identified during the investigation included the influence of peer pressure, the interaction between the welder and his less experienced colleagues, leadership and authority in small teams, and communications within the team ([report 04/2008](#)).

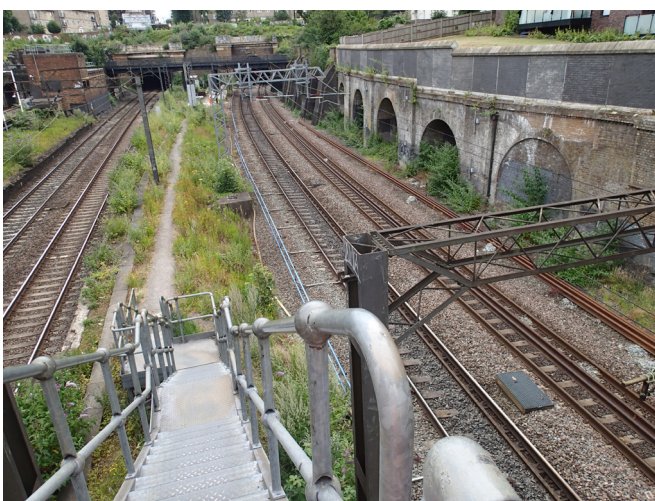
The view of the two sets of lines at South Hampstead from the access steps.

At South Hampstead in 2018, there was no signage at the access point used by a work group to get onto the track. The staff therefore had no visual indication of which lines were which, and placed equipment on the fast lines, which were open to traffic, instead of on the slow lines, which were under possession. While they were doing this, a train approached on the fast lines, and the staff managed to move their equipment and themselves clear of the line with around two seconds to spare ([report 20/2018](#)).

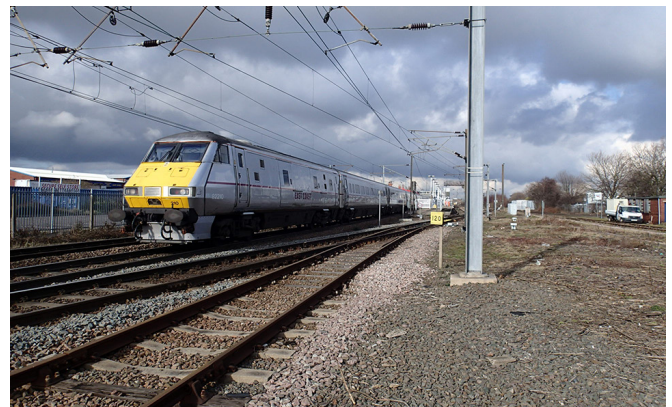
At Newark on the East Coast Main Line in 2014, the person who was acting as lookout moved into the path of an approaching train and was killed. There had been a breakdown in safety discipline and vigilance at the worksite, and the COSS who was in charge of the work was not monitoring the actions of the team ([report 01/2015](#)). Problems with lookout protection have been a factor in many accidents and incidents that we have investigated. Among those where it was a significant issue are Tinsley Green ([report 43/2007](#)), Leatherhead ([report 19/2008](#)), Kennington Junction ([report 29/2009](#)), Dalston Junction ([report 30/2009](#)), Roydon ([report 07/2013](#)), Redhill ([report 06/2015](#)), Hest Bank ([report 08/2015](#)) and Peterborough ([report 04/2019](#)). The Peterborough report includes a full list of all the events that we have investigated in which the planned system of work used lookout warning, with a description of what happened and the causes.

The site of the fatal accident at Newark.

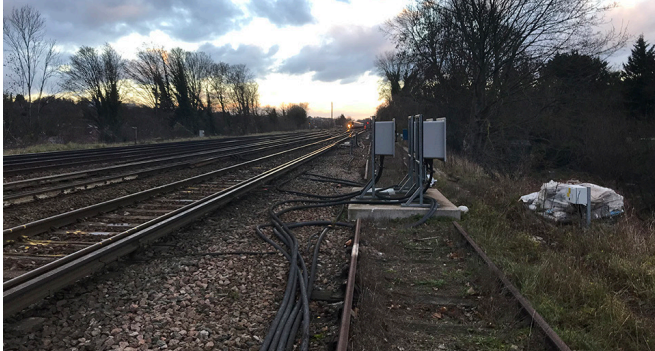
Outside the limits of protection at Stoats Nest Junction.

At Stoats Nest Junction, on the line between London and Brighton, near Purley in November 2018, a member of staff was killed by a train shortly after they had placed protection equipment for a routine possession, and had then moved outside the protected area onto an open line ([report 07/2019](#)).

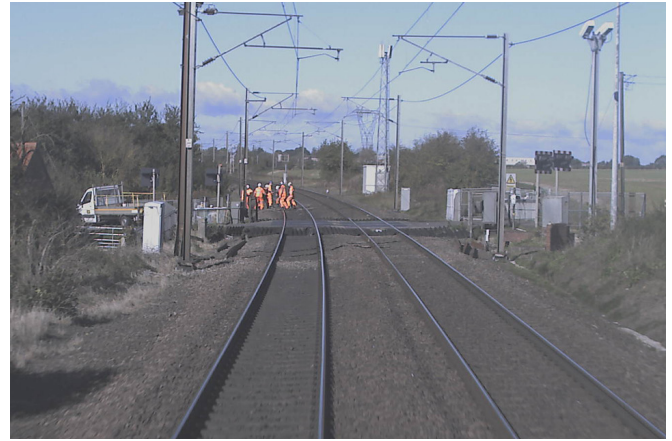
At Egmonton in 2017, contract staff working on lifting and packing ballast on the East Coast Main Line under the direction of a Network Rail team leader had little confidence in the systems of work that the team leader was adopting. However, they felt unable to challenge him because they feared losing work, and because of peer pressure from the rest of the group to continue working. A series of misunderstandings and miscommunications resulted in the group working without anyone acting in the role of lookout, and having to jump clear of the line with less than two seconds to spare when a train approached at 125 mph ([report 11/2018](#)).

The work group clearing the line at Egmonton, less than two seconds before a train reached the place where they had been working.
