5. Freight train derailments

Purpose of this summary

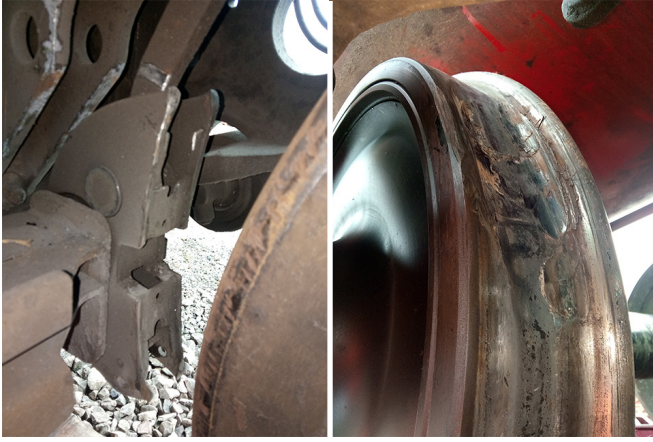
A poor standard of maintenance was also found in our investigation into an accident at Carpenters Road North Junction, London, in 2019 ([safety digest 07/2019](#)), when components of a wagon's braking system fell off during the journey, and got under the wagon's wheels and derailed it.

Missing components and damaged wheel treads following locking of a wagon brake mechanism.

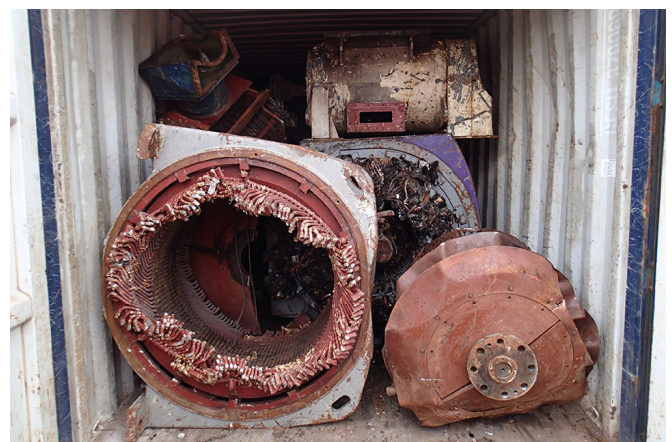
If the payload carried by a wagon, such as bulk material or discrete items, is not centred both laterally and longitudinally, there will be uneven distribution of weight through the wheels of the wagon. The resulting unequal forces between wheel and rail can lead to some wheels becoming sufficiently unloaded to the degree that, on curves, they can climb up and over the head of the rail, resulting in derailment of the vehicle. If an unevenly loaded wagon encounters track with a twist fault, conditions for derailment may be set up.

An example of asymmetric loading of heavy scrap electrical machinery.

While liquids will find their own level, bulk loads of sand, aggregate or stone may not settle and can remain offset. It is important that loading is done in a way that ensures as far as possible that the load is evenly distributed and centred. Following a derailment at Angerstein Junction in 2014 ([report 11/2015](#)), RAIB's investigation found that a mineral load (crushed rock fines) had adhered to the interior of a wagon (from which the load was supposed to have been discharged) in a way that created significantly uneven wheel loads. Heavy, discrete items, such as electrical machines, may be presented for rail transport loaded in sealed containers, and so it is equally important that the position of the centre of gravity of the load is considered when the container is being packed. In our investigation of a derailment at Reading West Junction in 2012 ([report 02/2013](#)), we found that pallets loaded with automotive components, which had been placed along the centre line of a container, had moved to one side while the container was being transported by road, resulting in a significant lateral offset to the load when the container was placed on a rail wagon. We recommended that freight terminal operators should improve their arrangements for both reducing the likelihood that inadequately packed containers are presented for rail transport, and for detecting asymmetric loads when containers are being handled before loading.

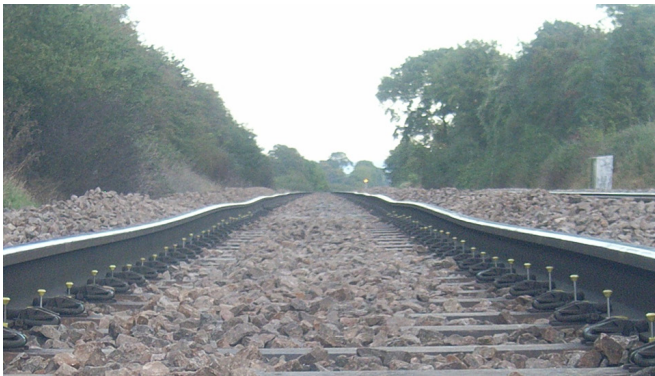
The geometry of the track, in terms of its vertical alignment ('top'), horizontal alignment ('line'), the change in relative height of the two rails ('twist'), and the distance between the rails ('gauge'), must be maintained to suitable standards to prevent derailments. Other factors, including rail wear and railhead condition, can also be among the causes of accidents. Many RAIB investigations have identified deficiencies in maintenance which have led to derailments, either on their own or in combination with vehicle defects.

An example of poor track geometry which resulted in derailment of a freight train.
